# Enamel loss and adhesive remnants following bracket removal and various clean-up procedures *in vitro*

**SUMMARY** This study evaluated the enamel loss and composite remnants after debonding and clean-up. The tested null hypothesis is that there are no differences between different polishing systems regarding removing composite remnants without damaging the tooth surface. Brackets were bonded to 75 extracted human molars and removed after a storage period of 100 hours. The adhesive remnant index (ARI) was evaluated. The clean-up was carried out with five different procedures: 1. carbide bur; 2. carbide bur and Brownie and Greenie silicone polishers; 3. carbide bur and Astropol polishers; 4. carbide bur and Renew polishers; and 5. carbide bur, Brownie, Greenie and PoGo polishers. Silicone impressions were made at baseline (T0) and after debonding (T1) and polishing (T2) to produce plaster replicas. The replicas were analysed with a three-dimensional laser scanner and measured with analytical software. Statistical analysis was performed with the Kruskal–Wallis test and pairwise Wilcoxon tests with Bonferroni–Holm adjustment ( $\alpha = 0.05$ ).

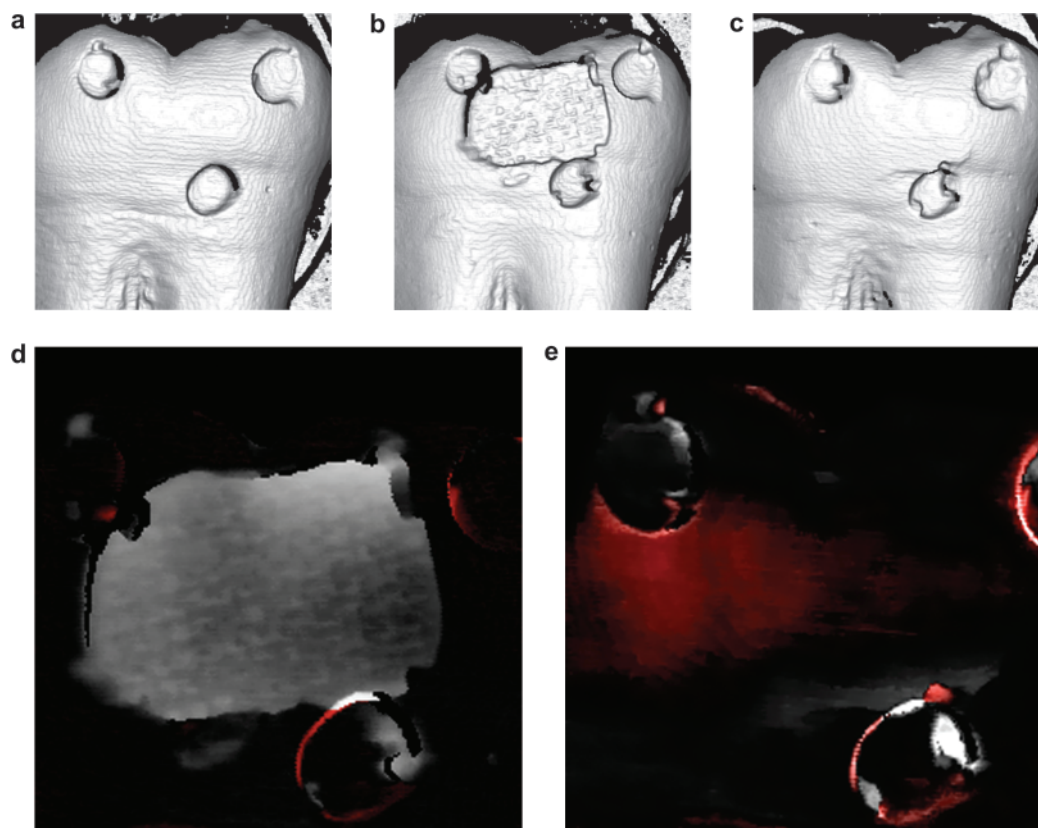
**Figure 1** Images at baseline (T0). (a), after bracket removal (T1) (b) with a clearly visible resin remnant, after clean-up (c) and differences after overlapping baseline T0 and T1 (d). Resin remnant is shown (white) and (e) T0 and T2. Loss of surface substance (red) and resin remnants (white) are visible.

Silicone impressions (President microSystem light/regular body; Coltène/Whaledent AG, Altstätten, Switzerland) were taken of the buccal surfaces of the teeth. Baseline models (T0) were produced in dental stone (Fuji Super Hardrock, GC, Leuven, Belgium) and scanned with the 3D imaging device (Laserscan 3-D Pro; Willytec GmbH, Gräfelfingen, Germany) to establish T0 data (Figure 1a).

The brackets were debonded by gently squeezing with Weingart pliers (3M Unitek). A second impression was taken of the buccal surfaces of the teeth after debonding (T1), and replicas were made in dental stone (Figure 1b).

A third impression (T2) was then taken of the surface of every tooth (Figure 1c).

By matching T1 to T0, the height and volume of composite remnant was recorded (Figure 1d). If present, enamel defects were recorded in terms of depth of lesion and volume loss. Therefore, the areas of interest analysed from the differential image were selected and separately measured. Comparing the T2 with the T0 models, vertical and volumetric changes in surface geometry were measured (Figure 1e). However, enamel breakouts that were recorded by superimposing T1 on T0 were always at the margin of the area of interest and excluded from further surface analysis. If defined, composite remnants were left, and the height and volume of the remnants were separately recorded.

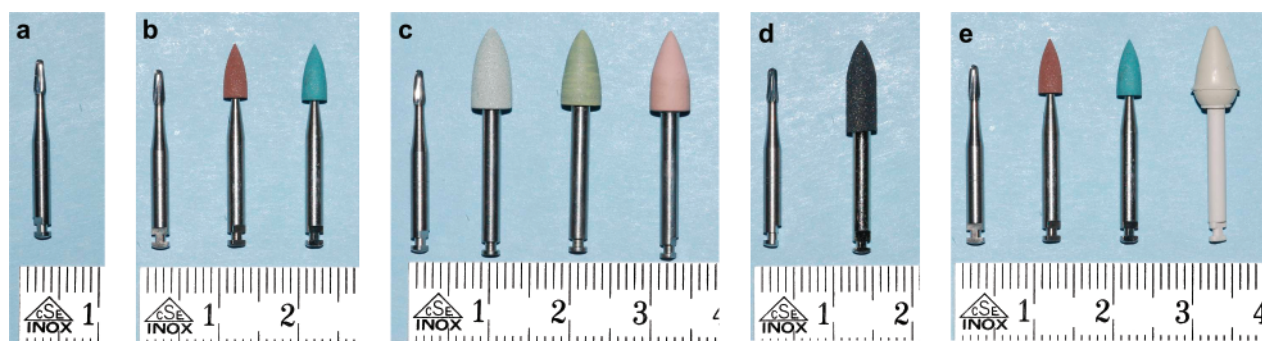
**Figure 2** (a) Group 1 (carbide bur). (b) Group 2 (carbide bur, Shofu Brownie and Shofu Greenie). (c) Group 3 (carbide bur, Astropol polishing system: F, P, and HP). (d) Group 4 (carbide bur, Renew System). (e) Group 5 (carbide bur, Shofu Brownie, Shofu Greenie, and PoGo polisher).

The residual adhesive on each tooth in the five groups was removed using one of the five following protocols: group 1, carbide bur (Figure 2a); group 2, carbide bur followed by Brownies and Greenies (Figure 2b); group 3, carbide bur followed by Astropol F, P, and HP polishers (Figure 2c); group 4, carbide bur followed by the Renew System (Figure 2d); and group 5, carbide bur followed by Brownies and Greenies and finished with a PoGo polisher (Figure 2e).

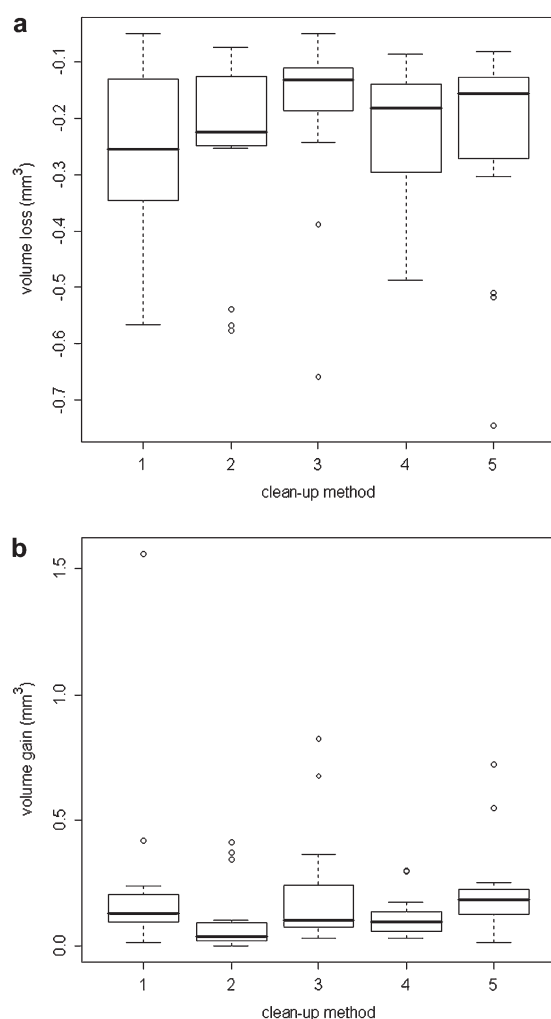
**Figure 4** Loss of volume (a) and composite remnants (b) after clean-up with five different methods. Groups as listed in Table 2.

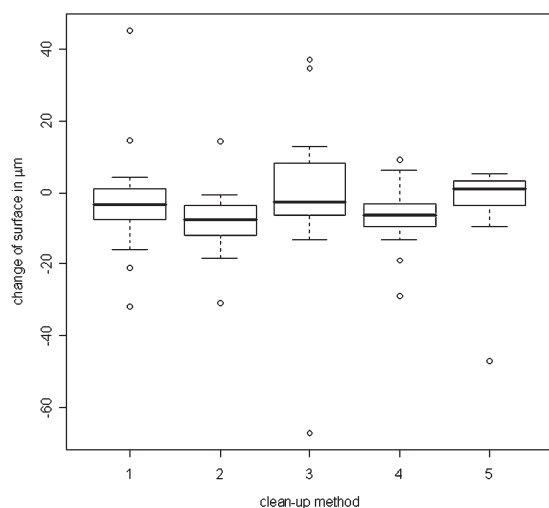
**Figure 5** Surface alteration after clean-up with five different methods. Groups as listed in Table 2.

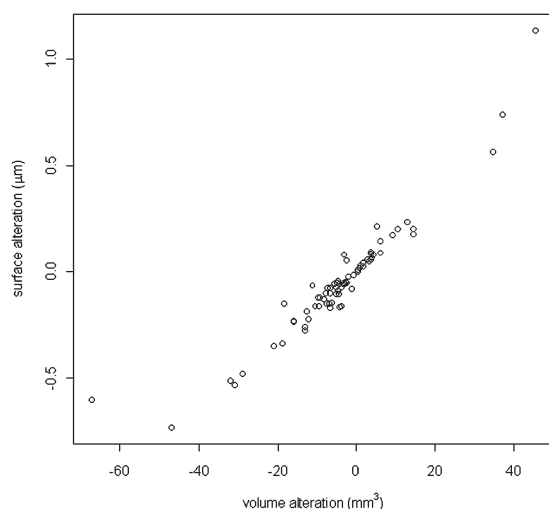
**Figure 6** Correlation of linear versus volumetric surface changes. Spearman rank correlation coefficient = 0.95.

other groups showed no significant differences, although the difference between groups 4 and 5 was almost significant ( $P = 0.04$ ; but not significant due to Bonferroni correction). Comparisons of the variances of the different clean-up procedures' total volume loss and composite remnants showed that there were differences, although not significant, between the groups (Figure 4a and 4b). The least aggressive method for enamel, with minor removal of hard dental substance, was found in group 3. The method in group 1 seemed to be more aggressive. However, all methods left some remaining composite on the tooth surface, with group 5 leaving the most. Spearman correlation showed a clear linear correlation of volume alteration to linear surface alterations (correlation coefficient: 0.95; Figure 6).
