How a Catastrophic Flood of the Gürbe River Triggered the Rethinking of Local Flood Protection

Melanie Salvisberg

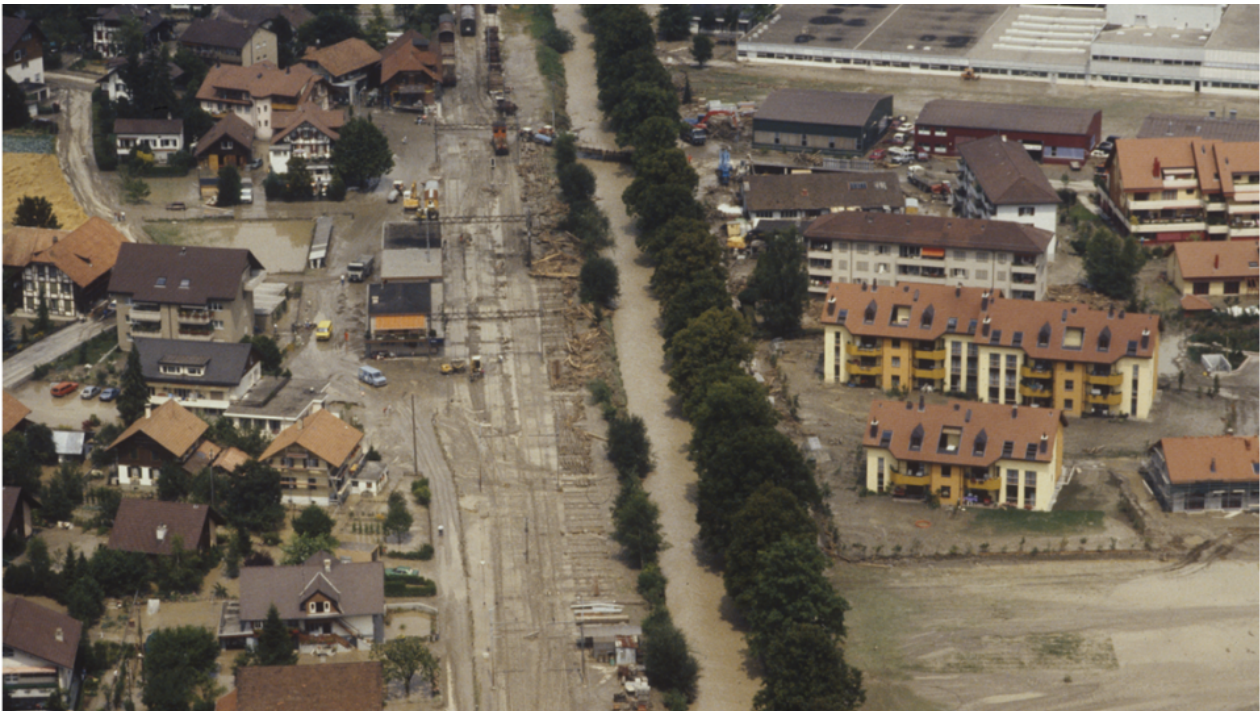
Flooded settlement in Toffen after the event of 29 July 1990.

On the evening of 29 July 1990, after a warm and sunny day, the sky over the Gantrisch region in the Swiss pre-Alps suddenly darkened. A huge thunderstorm appeared—a thunderstorm that not only set a meteorological record, but also changed the approach to flood protection in the Gürbe River area profoundly. Within a short period, the water level rose rapidly, causing the 29-kilometer-long river, a tributary that joins the Aare River south of Bern, to overflow. The water and the bed load caused severe damage to hydraulic structures, farmland, settlements, and traffic facilities near the river. The total cost of the damage was estimated to be 40 million Swiss francs.

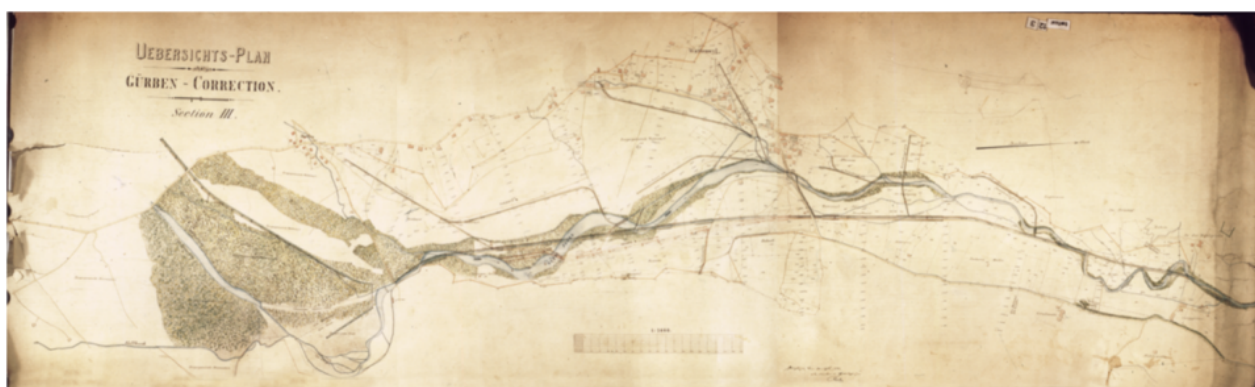
Plan of the natural course of the Gürbe River and the planned channel in Wattenwil, 1881.

Although the Gürbe Valley was known to be flood-prone, due to frequent thunderstorms, steep slopes, soil with low water-storage capacity, and soft rock in the upper reaches, the extent of the event was a shock, especially because extensive measures had been taken to prevent inundations since the mid-nineteenth century. The efforts had started with alterations to the Gürbe River from 1855 to 1881. With the intent of protecting the Gürbe Valley from flooding but also of reclaiming new land from the swampy flood plain, the previously meandering

river was straightened and channelized in its flat lower course. In the steep upper reaches, numerous workers erected dozens of wooden and stone dams to control discharge and sediment transport. Dikes to deflect the flow of debris, drainage systems, and slope stabilizations completed the torrent control.

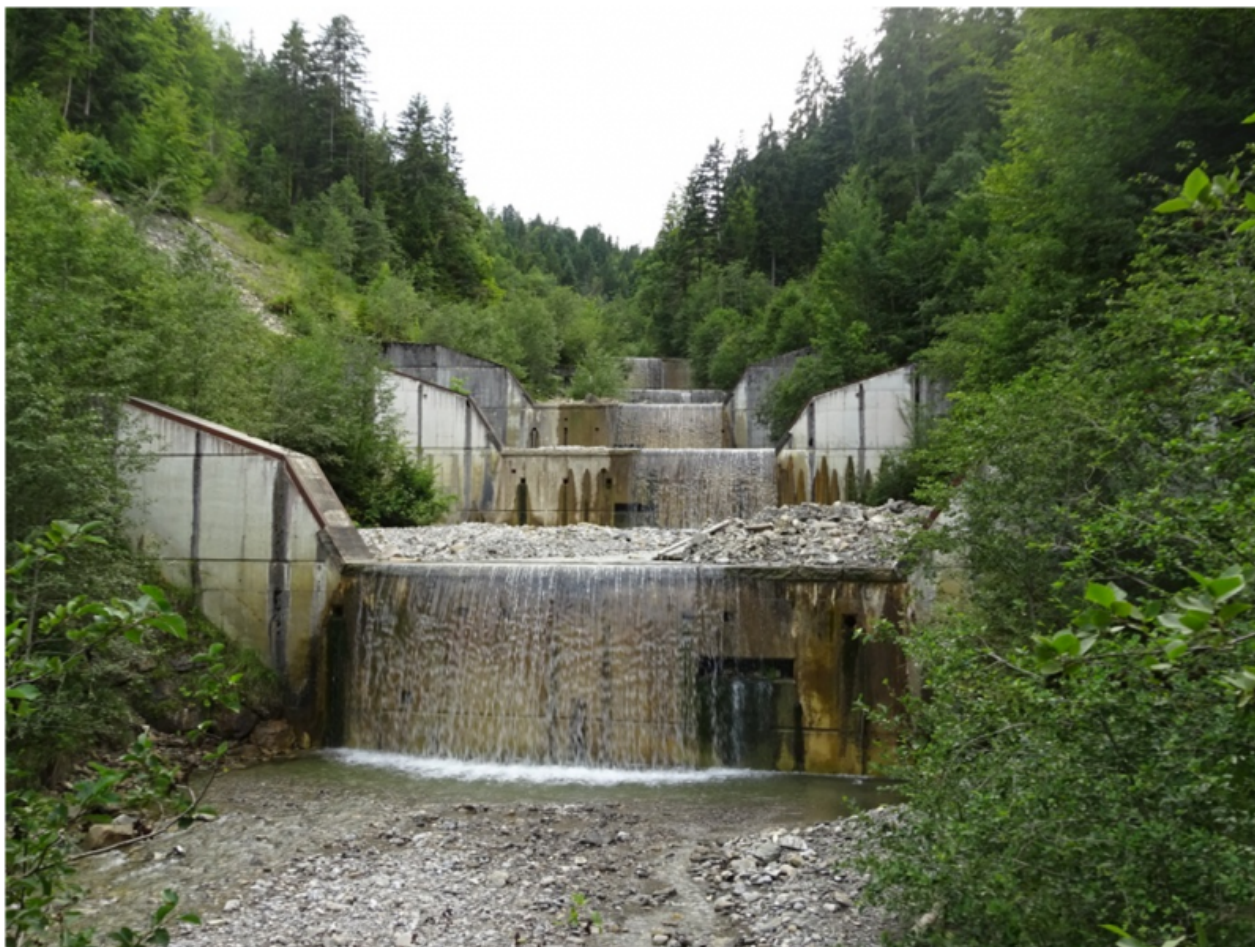
Torrent check dams in the gorge of the Gürbe River.

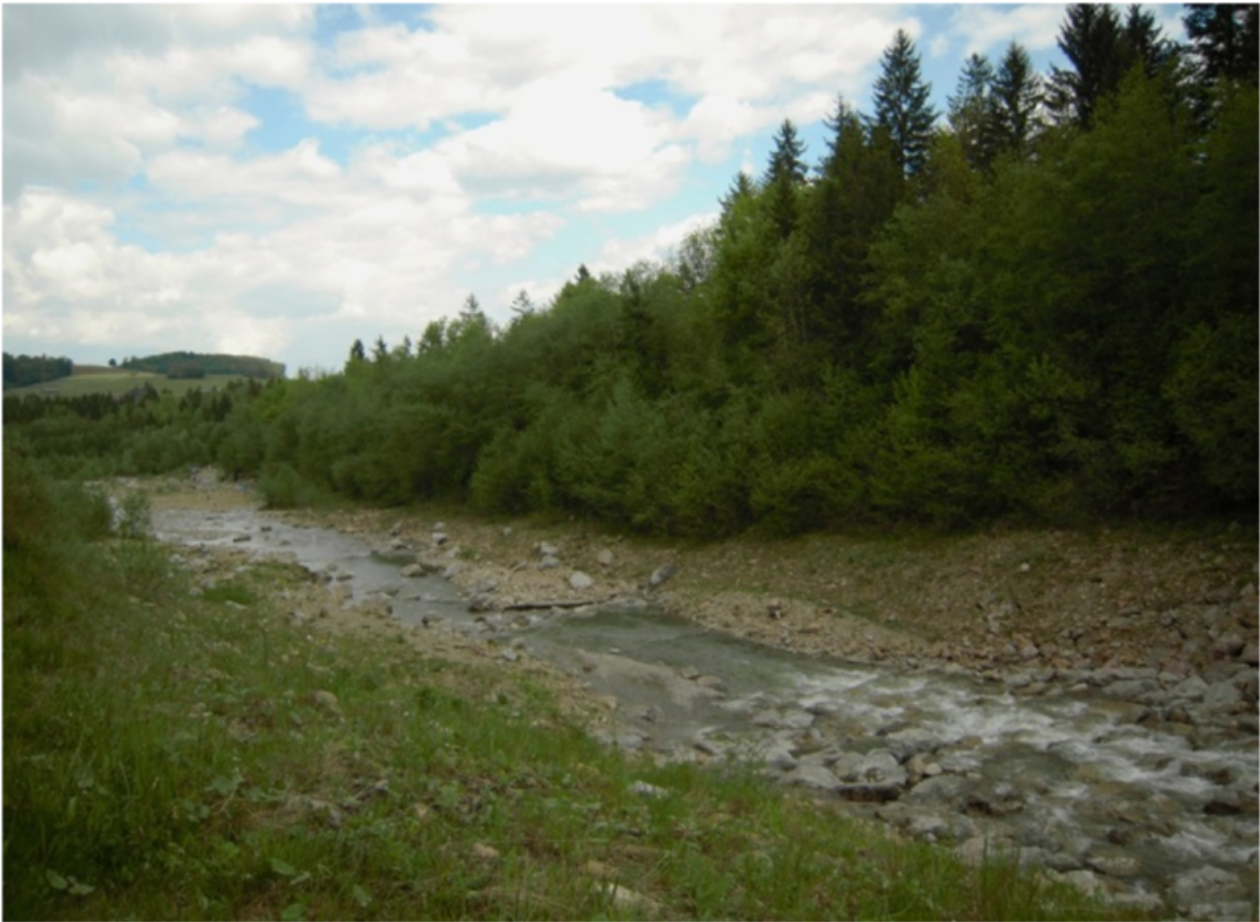
Partly restored stretch of the Gürbe River on the alluvial fan today.

As with many other Swiss rivers, the renaturation of the Gürbe River was only partially feasible due to the intense use of the riverine zone. Larger revitalized stretches could, however, be developed in the area of the river mouth and on the alluvial fan. For the valley floor, the hydraulic engineers planned retention areas.
