# The use of flat panel angioCT (DynaCT) for navigation through a deformed and fractured carotid stent

**Keywords** DynaCT · Carotid stent · Navigation · Restenting

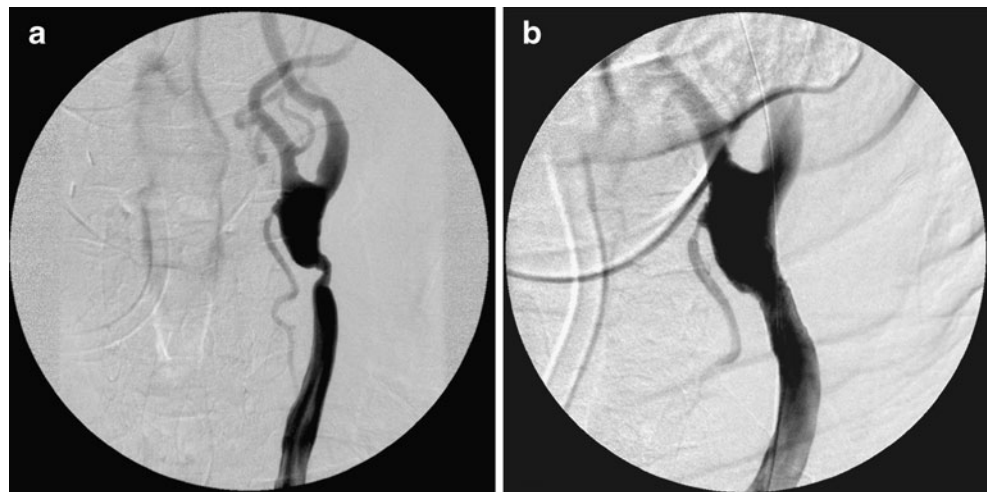
**Fig. 1** **a** DSA depicting recurrent high-grade stenosis after carotid endarterectomy using a venous patch. **b** Post-interventional angiogram illustrating vessel lumen reconstruction and correct stent placement

using a venous patch. At 6 months follow-up ultrasonography control showed significant recurrence of the stenosis. The patient was treated with carotid stenting using an Acculink stent (10×20 mm, Abbott Laboratories, Abbott Park, USA). Although the check angiogram after the intervention illustrated normal stent placement and structure (Fig. 1), a follow-up magnetic resonance angiography 6 months later depicted significant asymptomatic recurrence of the stenosis (Fig. 2a). The stent structure showed deformity and fracture of the stent meshes at the distal end (Fig. 2b, c). A decision was made for re-stenting of the stenosis in combination with balloon angioplasty.

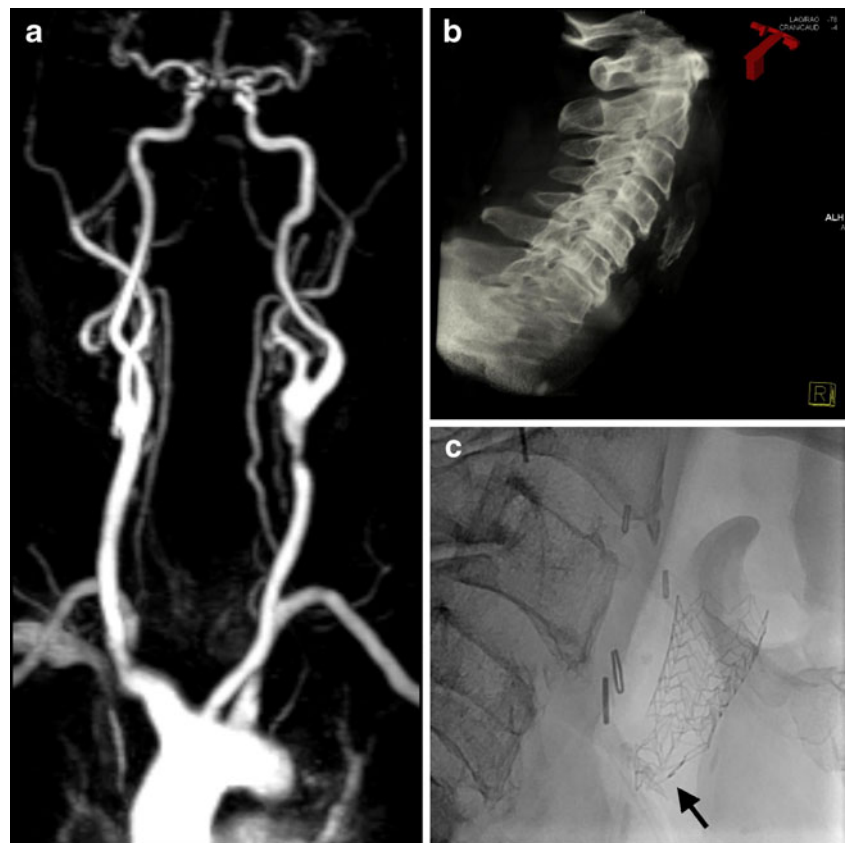
**Fig. 2** **a** Pre-interventional follow-up magnetic resonance angiography showing an asymptomatic high-grade in-stent stenosis of the left CCA. **b** Right lateral 3D reconstruction of the DynaCT data set showing the deformity of the carotid stent. **c** Right lateral fluoroscopic image depicting the fractured stent meshes (arrows) of the proximal stent

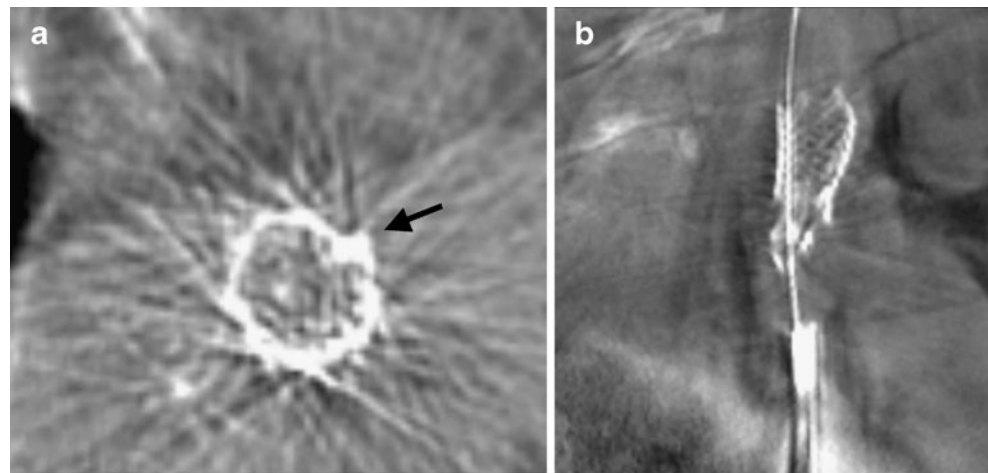
**Fig. 3** **a, b** Axial and sagittal multiplanar DynaCT reconstructions illustrating the correct position of the guidewire within the stent not entering through stent meshes (arrow)

The DynaCT elegantly illustrated the correct placement of the microwire within the stent. Review of the sagittal and axial reconstructed images excluded that the microwire was navigated across the stent struts (Fig. 3).

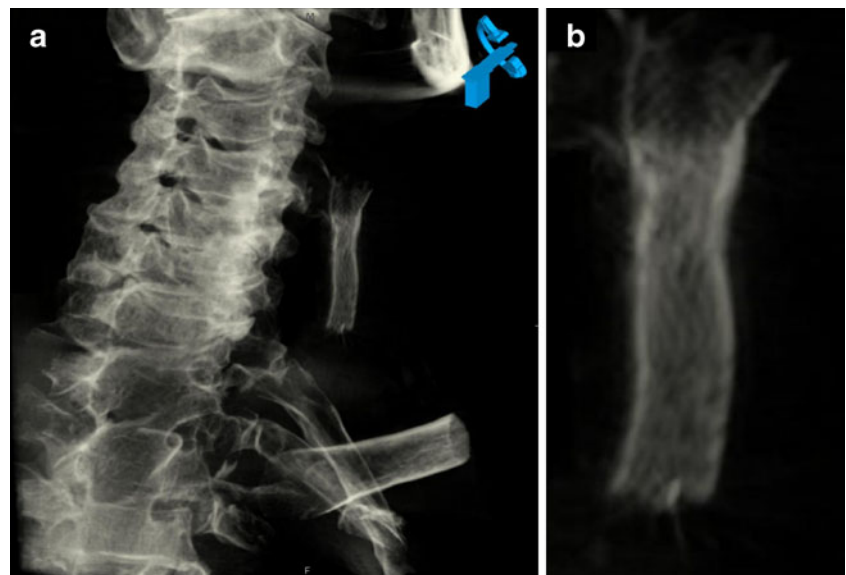
**Fig. 4** **a** Post-interventional 3D reconstruction showing stents in the internal carotid artery. **b** Magnification of the stent-in-stent reconstruction

A Cristallo ideale stent (6–9×30 mm, Invatec, Roncadelle, Italy) was navigated along the microwire, and the stent was deployed without complications. An Avion 4.5×20 mm balloon (Invatec, Roncadelle, Italy) was also navigated across the stenosis, and balloon angioplasty was performed without difficulty (Fig. 4). The post-interventional duplex sonography control after 3 months showed no restenosis.
