Taming the torrent: changes in flood protection at the Gürbe River (Switzerland) from the nineteenth century until today

Melanie Salvisberg¹

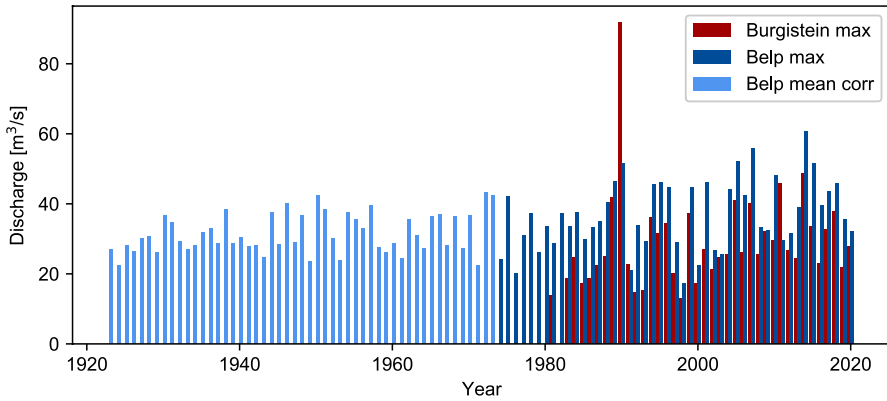
Fig. 1 Yearly maximum discharge measurement from measurement stations in Burgistein (red) and in Belp (light blue and dark blue). Before 1974 only daily mean discharge values are available for the Belp. These data are corrected (light blue) using a linear regression of data from 1974 to 2020, where both daily maximum and daily mean discharge values are available ($Q_{\max} = 14.6 \text{ [m}^3\text{/s]} + 1.109 \times Q_{\text{mean}}$, $R_{\text{Pearson}} = 0.793$). Data Belp: BAFU 2021, data Burgistein: AWA (2021)

The long-term annual mean discharge of the Gürbe River is 1.33 m³/s in the upper reach (Burgstein) and 2.62 m³/s in the lower reach (Belp) (measuring period 1923–2020 resp. 1982–2020). As is typical for a mountain torrent, the discharge fluctuates heavily. The highest daily maximum discharge measured in Burgstein is 91.9 m³/s (29th Juli 1990), while the lowest is 0.13 m³/s (30th October 1985), the ones in Belp amount to 60.8 m³/s on 11th August 2014 resp. 0.15 m³/s on 18th–20th September 1947 (see Fig. 1). The considerable difference

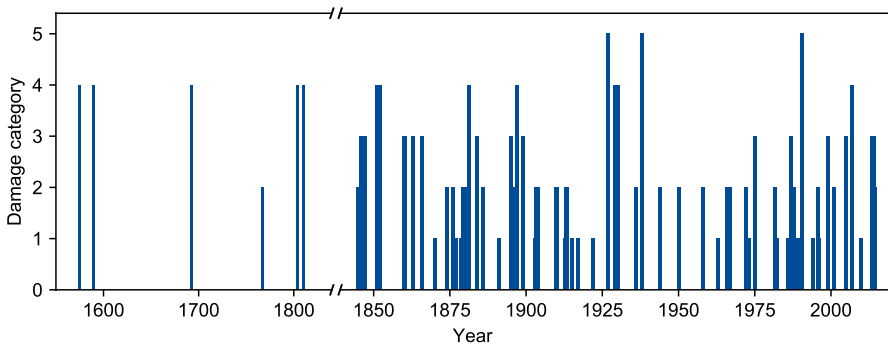
Fig. 2 Flooding chronicle of the Gürbe River, 1575–2020

The discharge measurements already indicate the considerable flood hazard in the Gürbe valley: With an annual precipitation of over 2000 mm, the upper reaches belong to the area with the highest precipitation of Switzerland. During the summer months, there are often heavy thunderstorms, and daily precipitation of 40–50 mm is frequent (Schwarb et al. 2001). In combination with steep slopes, soft rock, and soils with low water storage capacity, these factors often lead to floods, landslides and debris flows (Fig. 2).

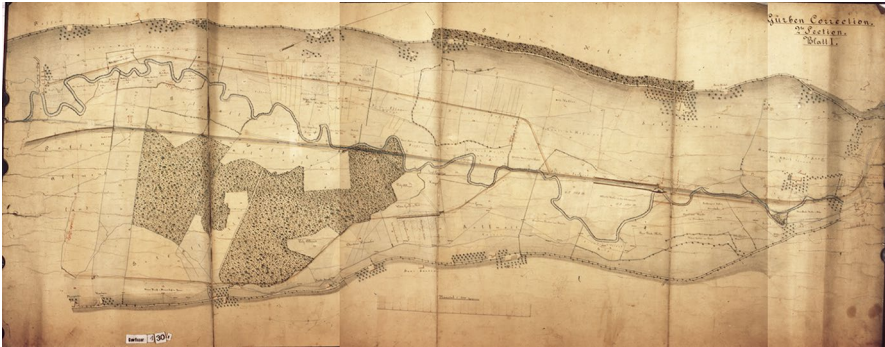
Fig. 3 Map of the Gürbe River between Toffen and Belp, 1870. The map shows the old meandering course of the river and the new straight channel. State archive of the Canton of Bern, StAB AA V 130

The first attempts at a coordinated flood protection project of the Gürbe River had already been made in the early 1800s, the 1830s and the early 1840s by local residents, but they all failed for financial reasons (Salvisberg 2017). A petition, filed by dozens of landowners in 1846—a year with a severe flood—was finally successful. The Canton of Bern decided to support and co-finance the river correction. After some years of preparation (the Canton of Bern even passed a law for the project), the so called “Grosse Gürbekorrektion” was implemented from 1855 to 1881. The previously meandering Gürbe River was straightened and channelised (Fig. 3), as with most of the Swiss alpine rivers (Hohensinner et al. 2020).

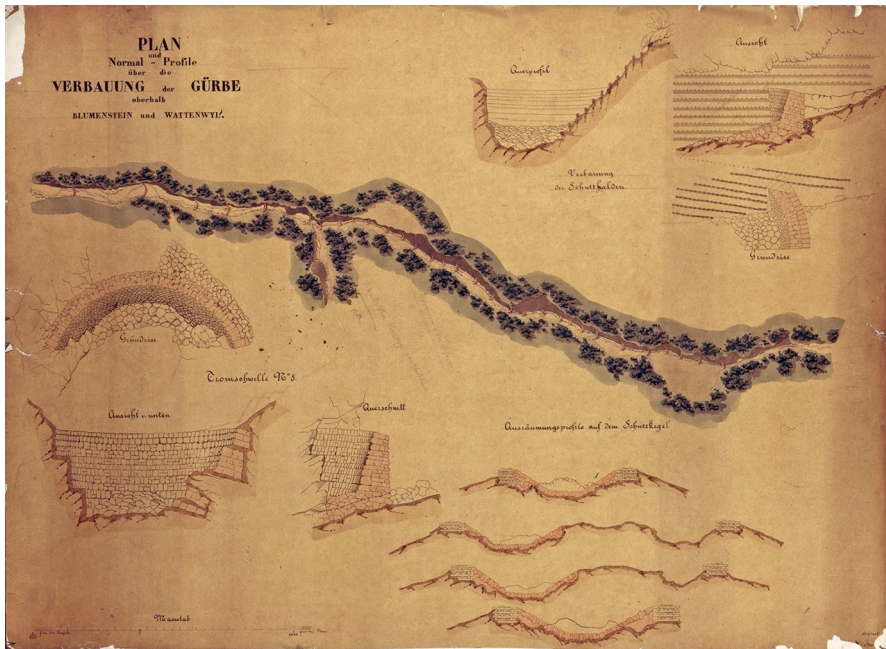
Fig. 4 Overall plan and profiles for the construction of the check dams in the gorge of the Gürbe River, ca. 1860. State archive of the Canton of Bern, StAB AA V 116b

In the steep upper reaches, the construction workers raised a series of dams, built of logs and local stone, to limit the geomorphic activity (Hess 1876). Debris flow deflection dikes, drainage systems and slope stabilisations completed the system (Fig. 4). The series of check dams had been developed by the Tirolean Joseph Duile (see Duile 1826) and had until then only been implemented in a few mountain torrents in the Canton of Glarus in the 1840s. In the following decades, Duile’s technique spread internationally (Vischer 2003).

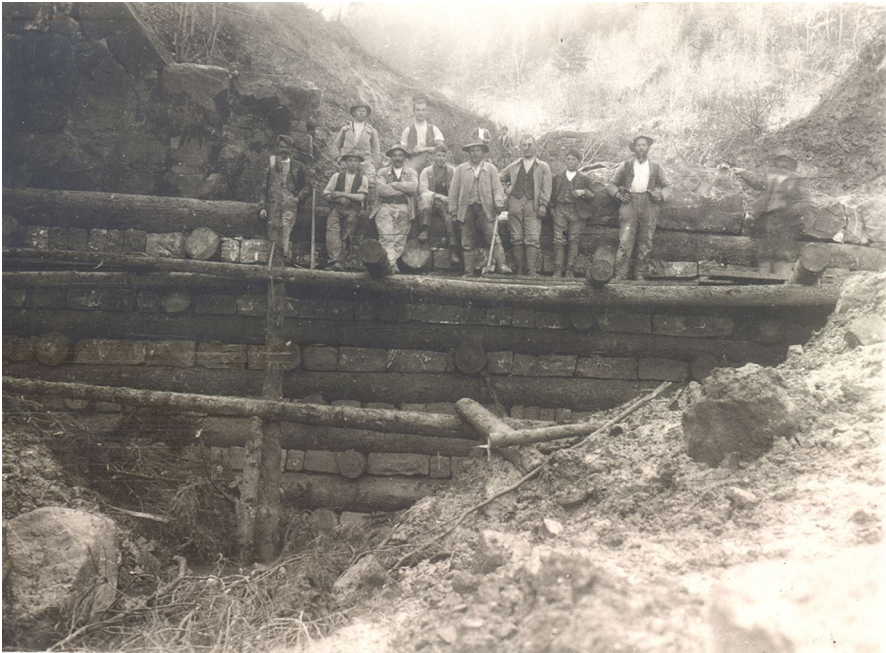
Fig. 5 Construction workers raising check dams in the gorge of the Gürbe River, ca. 1900. Copyright: Lieselotte Kappeler

As a result, the protection system became not only bigger but also denser and larger. From 1900 onwards, the torrent check dams were built of concrete instead of stones and timber. The hydraulic engineers announced the prospects of success of the flood protection projects each time optimistically. Friedrich von Werdt, a government member of the Canton of Bern was sure that the Gürbe Valley would be safe from floods after the implementation of the project: “It is quite safe to assume that after the project has been carried out, the valley will no longer have to suffer much from the devastation of the Gürbe River.” (Protokoll Ausschuss Gürbekorrektion, 15.10.1892).¹
