# **Conceptualizing rill erosion as a tool for planning and evaluating soil conservation in Angereb watershed, Ethiopia: Methodological development**

**Research Report for Q505 project supported by Eastern and Southern Africa Partnership Program (ESAPP)**

**Gizaw Desta (2010)**

**Amhara Region Agricultural Research Institute (ARARI)**

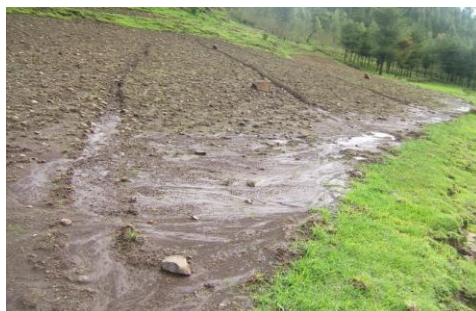
Fig. 8 Accumulation of sediment behind erosion control structures

- after a few seasons, the soil close to the terrace is relatively rich in organic matter as well as being deep; hence the crop yield is comparatively high at this position;
- meanwhile, the farmer harvests grasses to feed their animals;
- after some years, when the terrace filled with sediment, the farmer remove the old terrace, and plants with crops in the accumulated rich soil; at the same time, a new terrace is constructed some distance down slope from old terrace position.

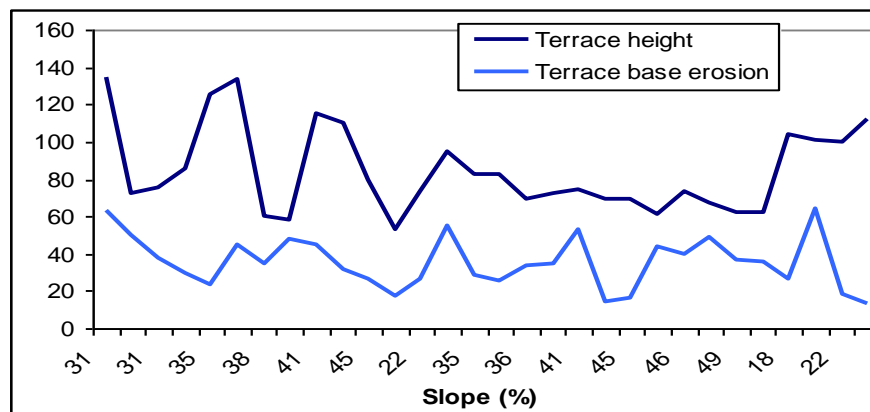
Fig. 9 Erosion underneath the terrace structure due to tillage

Tillage has made annually using *maresha*, a wooden plough pulled by pair of oxen. A typical indicator of tillage erosion was clearly observed beneath the terrace where the soil surface is significantly lower than the base of the terrace since the construction of the terrace in 1991/92. With the tillage practice on steeper slopes, the surface soil was washed down slope. According to Nyssen et al. (2000), tillage translocation has contributed half of the sediment accumulation behind newly constructed stone bunds in Tigray area. On slopes steeper than 15 %, all soil is thrown to the lower side of the tillage furrow (Nyssen, et al, 2000). During the last sixteen years, since the construction of new terraces in the study area, the contribution of tillage erosion was in the range of 15-65 cm reduction of surface soil underneath the terrace structure (Fig. 9 and 10). This means there was an estimated annual tillage erosion range of 1-4 cm close to lower-side of terrace structures. Unlike the results obtained by Nyssen, et al (2000), on the steepest slopes the amount of soil moved by tillage beneath the stone terraces was low, because it is difficult to operate the plough with the oxen very close to terrace structures. Moreover, assessment was made at point depth samples rather than the down slope areal samples. Any way the assessment result has provided that we have a situation where erosion has been aggravated by the farmer unnoticeably. The answer as to whether the farmer perceive tillage as an erosion problem must, therefore, depend upon the farmer perspective through which the judgment is made. In the study area, farmers were less aware and may not consider the soil movement by tillage as an erosion problem.

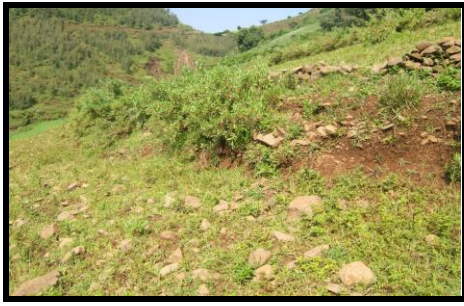
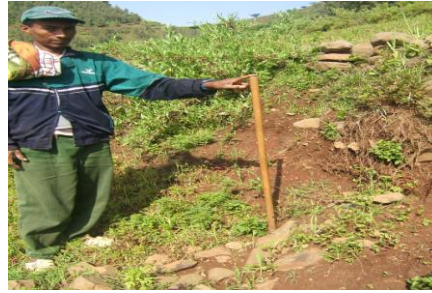
Fig. 10 Evidences of tillage erosion underneath stone structures

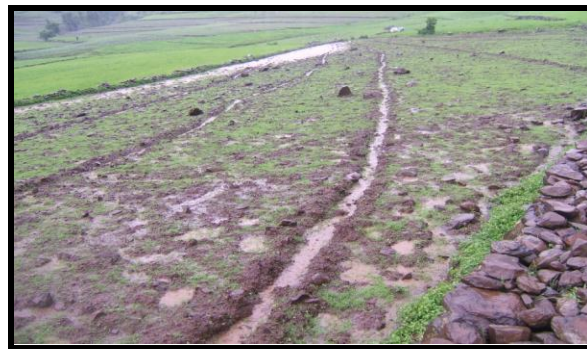
Fig. 11 Runoff erosion due to traditional ditches inside farms

On most of the farmers' field, farmers have constructed a small drainage ditch across the slope to protect the lower field from concentrated runoff during heavy storms. The farmer has to construct this drainage ditch each year randomly on the plot. It is obvious that sediments eroded from ditches and accumulated down slope were common indicators of erosion on farmers' field (Fig. 11). For example drainage ditches in the case study field plots were constructed with an average gradient 4-7 %. This implies that a large amount of sediment has been washed completely out of the field and sometimes the runoff discharged from ditches damage terrace structures and formed gullies down slope.

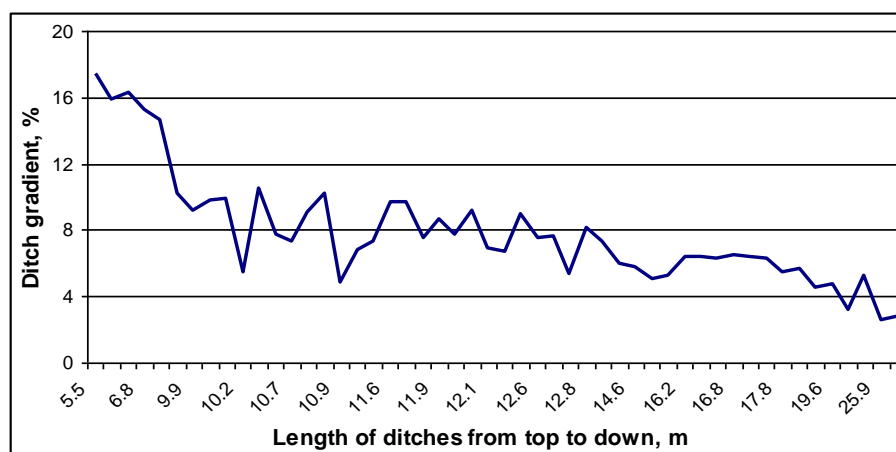
Fig. 12 The change in gradient of ditches along the longitudinal section of the ditch

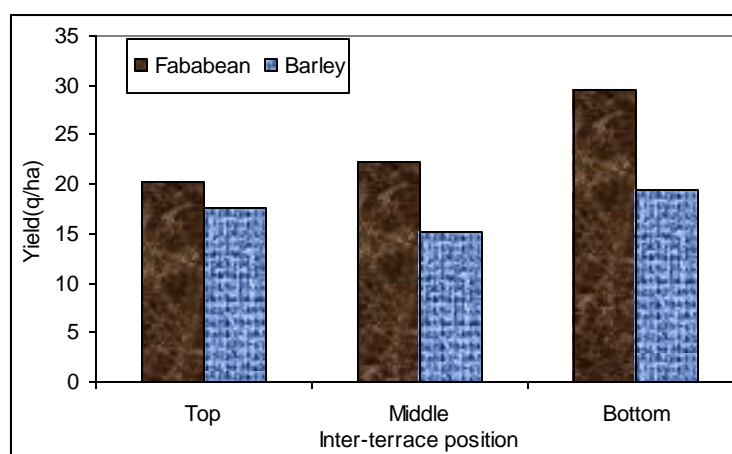
Fig. 13 Crop yield variability over slope length in the inter-terrace area (Gizaw, unpublished)

Farmers have experienced variation in crop growth and yield reduction in the area between terrace structures. This is the most frequent indicator of farmers to explain the problem of local erosion. Extreme erosion damage on shallow root crops expose the roots on the surface by which the land users can easily perceive and aware of erosion at the first stage. Subsequent erosion causes significant within-field variation of crop growth condition, where the upper parts are generally producing the poorest. At the top of the plot, plants were stunted and yellow-looking. Towards the lower and middle parts of the field some of the plants have a purplish color on new leaves, but those plants growing in the sediment accumulation along the boundary were vigorous and deep green in color. Crop production monitoring within the terrace area has clearly indicated the yield reduction over the slope length (Fig. 13). It was also pointed out by farmers that 5-7 % annual yield reduction was observed on erosion prone fields. Based on quantitative crop yield results from other studies, the yield variability in the terrace area has showed the impact of soil erosion over the slope length. There has been a non-linear increase of yield from top to bottom position. About 10 to 46 % yield increase at bottom position was obtained over the top position. Moreover, change in the cropping pattern to adapt the level of soil degradation is another local erosion indicator for farmers. Several of the barley landraces of better productivity were abandoned in the production system as a result of the change in the soil function. Among many of the locally named barley landraces, *Temej*, *Awura gebes*, , *Worehimen*, and others such as *Aja*, *Zengada*, and *Dagusa* landraces were some mentioned by farmers. On the other hand, crops like lentil and fenugreek were adapting to degraded and depleted soils.

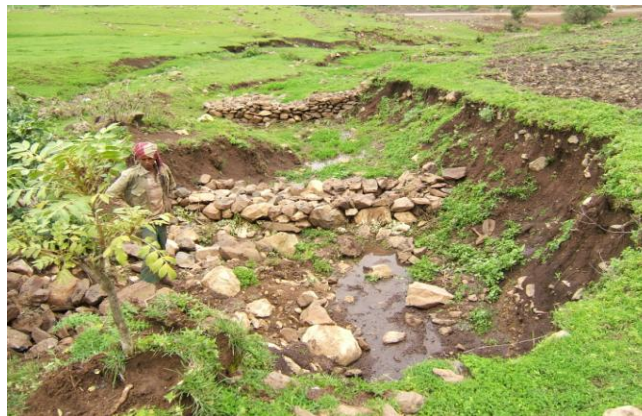
Fig. 14 Active gully damage and land sliding

Farmers are much aware of land degradation when they observe gullies and landslides despite they have less capable to mitigate these forms of erosion problems. External assistance and catchment level soil conservation planning is needed.

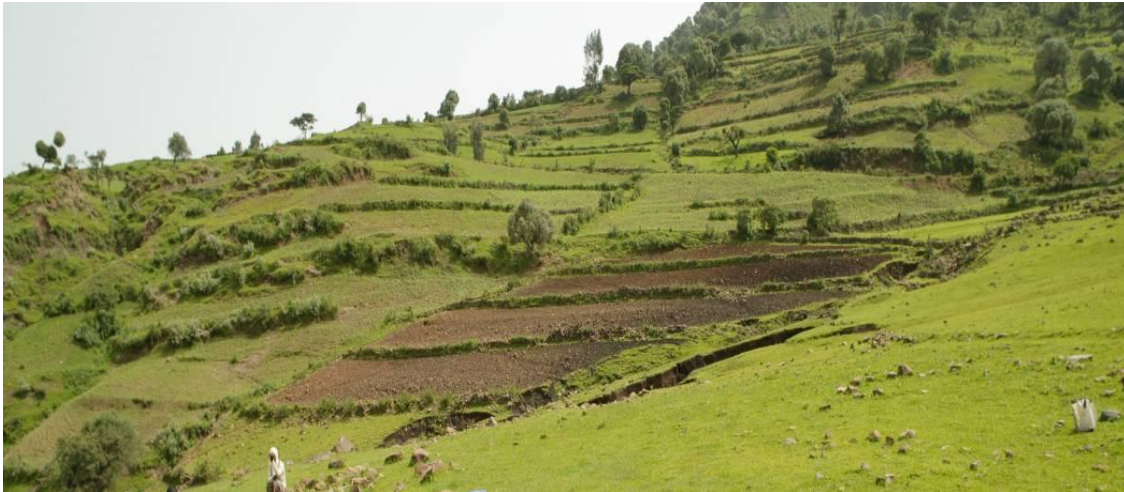
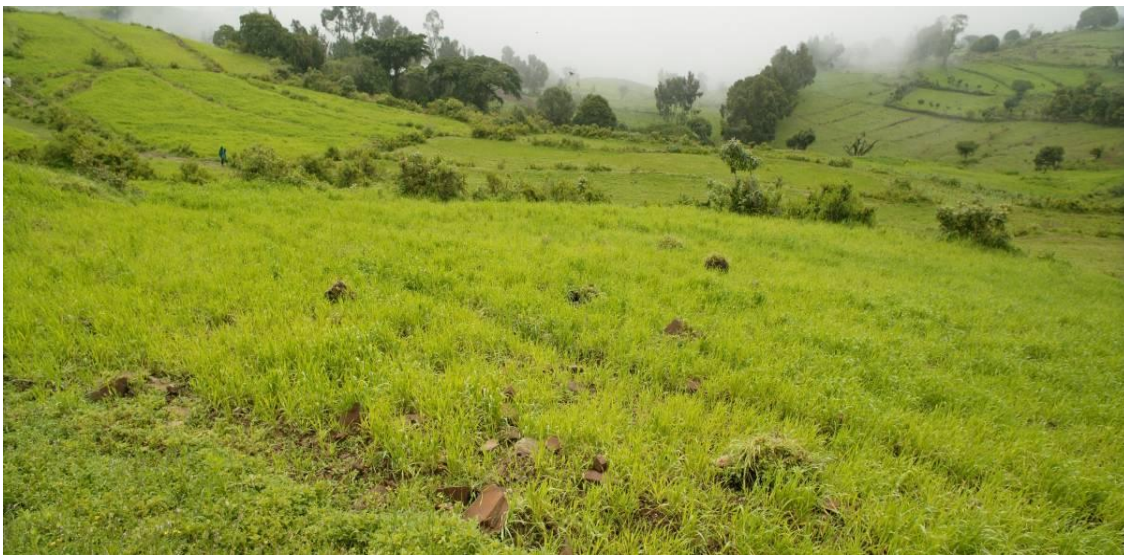
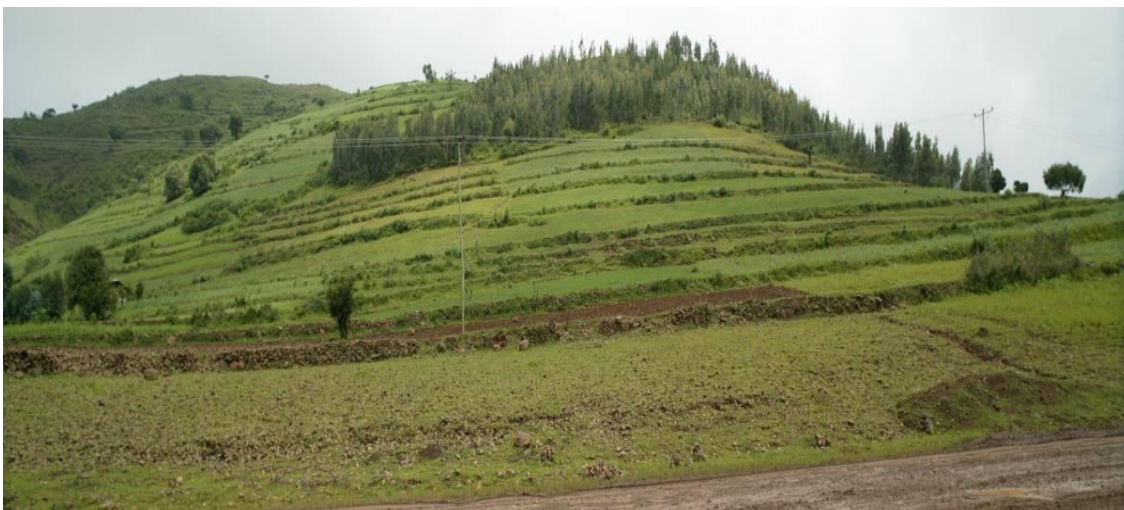
Fig. 16 View of case-study catchments: Godguadit (top), Kiltimsebari (middle) and Embestig (bottom)  
(Photo by Gizaw, 2008)

The topography of the catchment at Godguadit site was undulating with concave shape at the central part. About 60-70 % of the catchment was drained by a manmade waterway (or foot path) from North West to South East direction. Manmade waterway protected the overflow of concentrated runoff to the lower fields. Runoff emerging within the fields, fragmented land units, traditional runoff ditches, and damaged stone terraces were the main causes for rill formation and its development. Godguadit catchment is generally characterized by very shallow soil depth and high soil degradation compared to

other catchments. For a shallow soil depth, the infiltration is reduced and led to high amount of overland flow. Kiltimsebari catchment has linear geomorphology (linear slope) extended from top to middle of the slope and undulating topography at lower slope area. However, the middle catchment area is concave shape in the lower part. Comparatively, Embestig catchment has better soil depth and less degradation. The catchment is represented by linear steep slope. Most of the fields in the upper part of the catchment were covered with high intensity stone mulches and classified as no erosion area. However, the lower part of the catchment was affected by erosion due to the runoff generated from upslope tree plantation area located at the middle of the catchment. Rill erosion assessment was therefore made only from fields at the lower part of the catchment at Embestig (Fig. 16). Table 4 shows the average slope gradient and number and spacing of stone terraces for about 23 rill survey field plots in the three catchments.

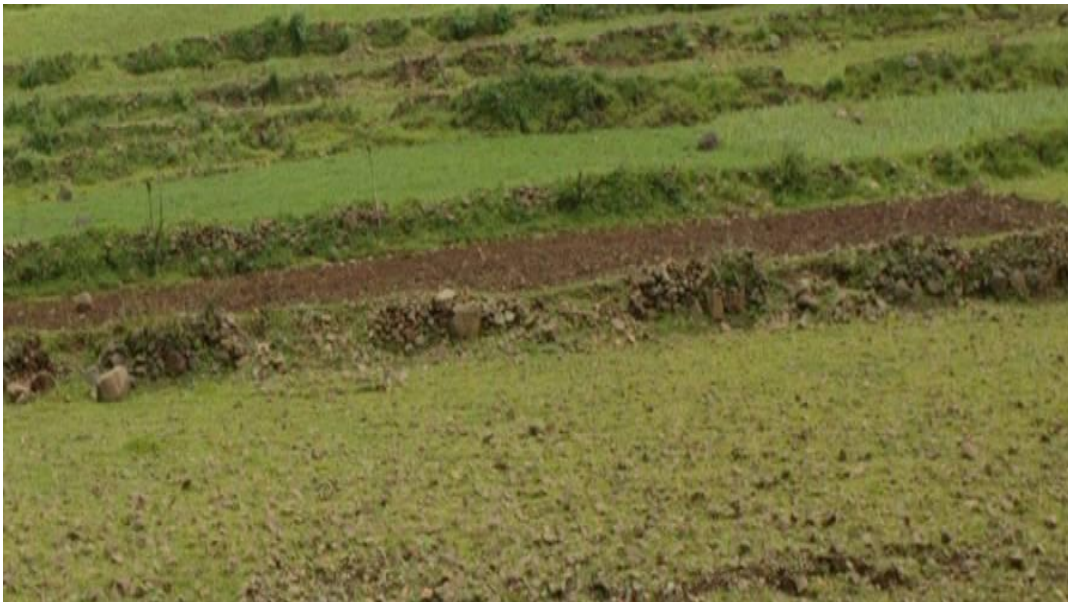
Fig. 22 Unstable and damaged stone terraces due to tillage of the terrace base on steep slopes  
(Photo by Gizaw, 2008)

smaller value of the design specification (i.e, 100 cm). The terrace cross section was therefore smaller than the design value indicated in the guidelines because of damage caused by animals, low maintenance, and instability. In conclusion the terraces in the study area were not in a stable condition to perform its function properly. As per the discussion with the farmers, maintenance and improvements in such condition became difficult. On steep slopes the risers become very steep and it is impossible to add stones and maintain on the top. Either a supporting terrace on the foot of the original terrace or complete removal and new establishment were the options suggested by farmers. But in a situation where sediments were accumulated over the years and formed a heap, the option of complete removal of terraces was not supported by majority of the participant farmers. Farmers believe that removing the old stabilized terraces could bring more soil loss by washing the accumulated sediments farther down slope.

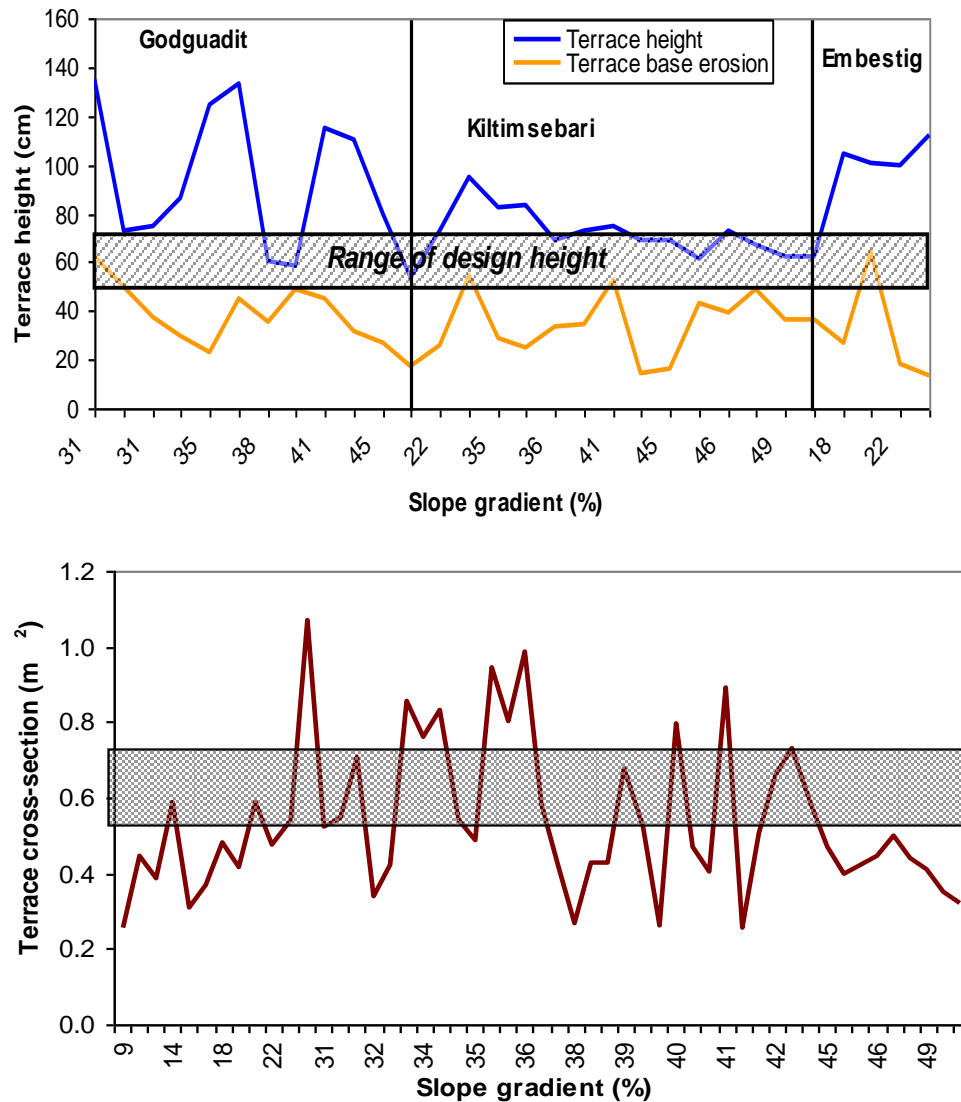
Fig. 23 Existing terrace height (top) and cross-section (bottom) in relation to the design specification (shaded part)

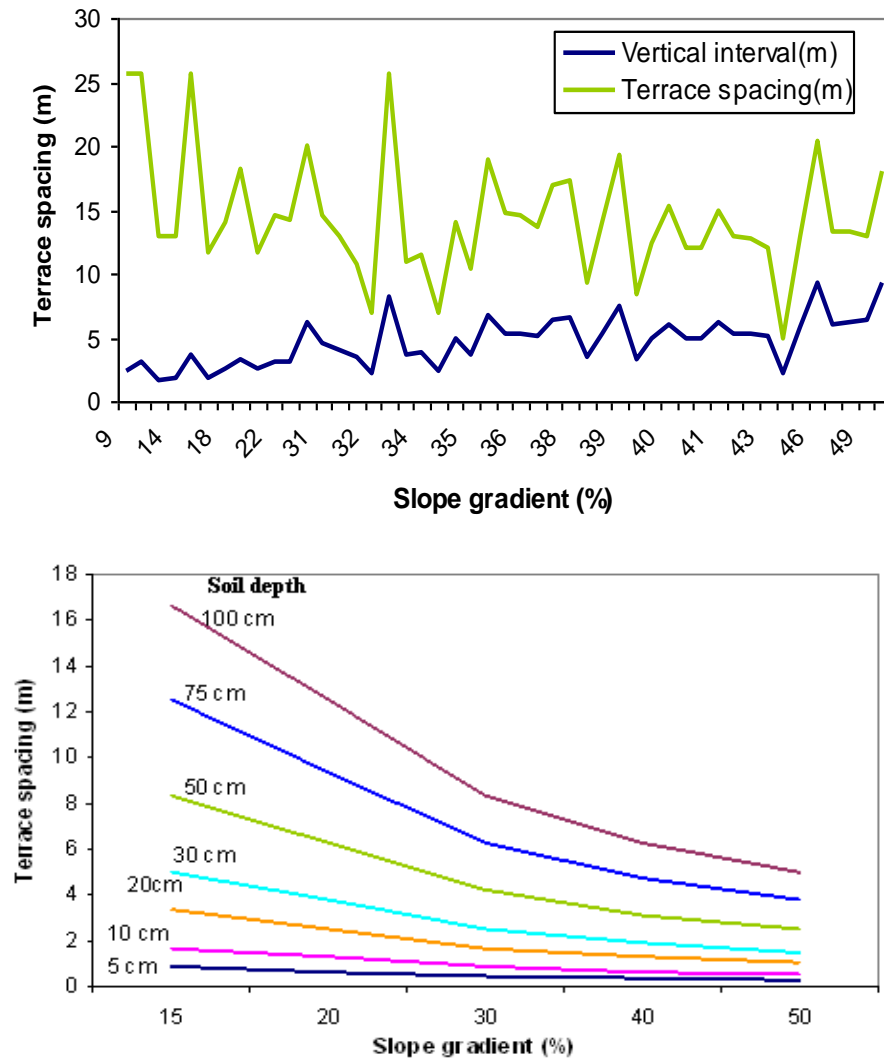
Fig. 24 Existing terrace spacing and vertical interval (top) and design spacing at different soil depths (bottom)

structures. From a technical point of view, deciding a suitable spacing for the terraces is necessary to estimate the critical slope length. Spacing between terraces and/or vertical interval was therefore taken as an indicator to evaluate the effectiveness of terraces (Fig. 24).

In principle, the spacing should decrease when slope increases. However, terraces implemented by the farmers have shown increased trend of vertical interval for steeper slopes. Similarly, the spacing was more or less uniform for slopes >30 %. The spacing between existing terraces was in between 5 to 25 m with an average of 14 m. In addition to the damaged and instable terrace structures such wide spacing between terrace structures generated greater runoff concentration that led to excessive erosion. The combined effects of smaller terrace cross section and larger spacing have reduced its

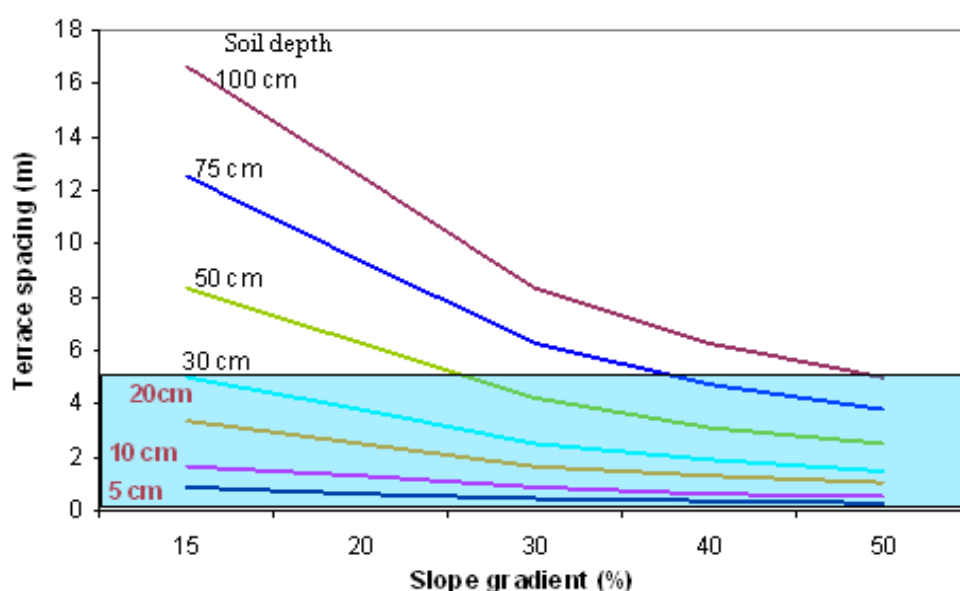
Fig. 25 Unacceptable range of terrace spacing (shaded range) from farmers' perspective

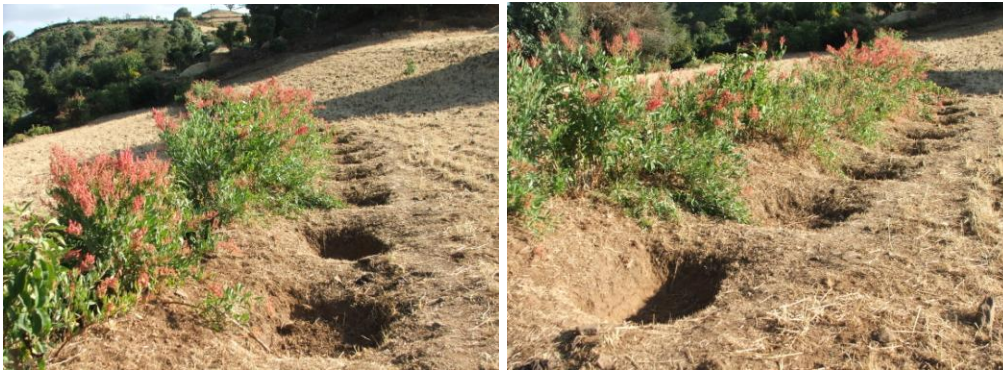
Fig. 26 Improved terrace structures using trenches

- Retain the excess runoff water which otherwise overtops the terrace and cause damage to the structure and to down slope plots;
- Avoid sediment loss and off-site damage on side waterways and adjacent plots from excess drainage water from terrace channels;
- Retain sediment eroded from terrace area;
- Increase the amount of water goes to infiltration by reducing the overland runoff component;
- Increase available soil moisture during terminal drought and thus improves productivity of crops cultivated below the terrace structure;
- Increase the interflow and in the long term it might improve recharging;
- Use for compost preparation from weeds and other shrub species collected during cultivation period;

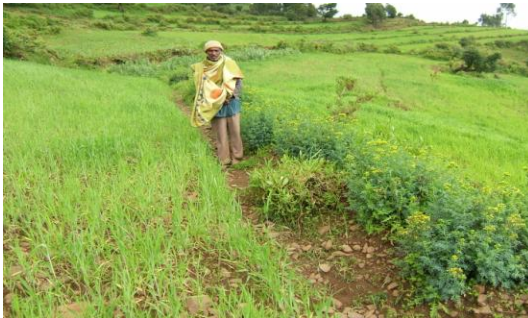
Fig. 27 Improved terrace structures using high value spice plants

Free grazing is the challenge to promote multi-purpose tree plantation and biological conservation measures on terrace structures. Despite the grazing problem, in addition to local shrubs naturally grown along terrace structures, currently some farmers adapt some value-added plantations such as *tena adam* (Fig. 27) and grass pea and weeds for feed that fit into the annual cropping system, and *chibha* tree plantation.

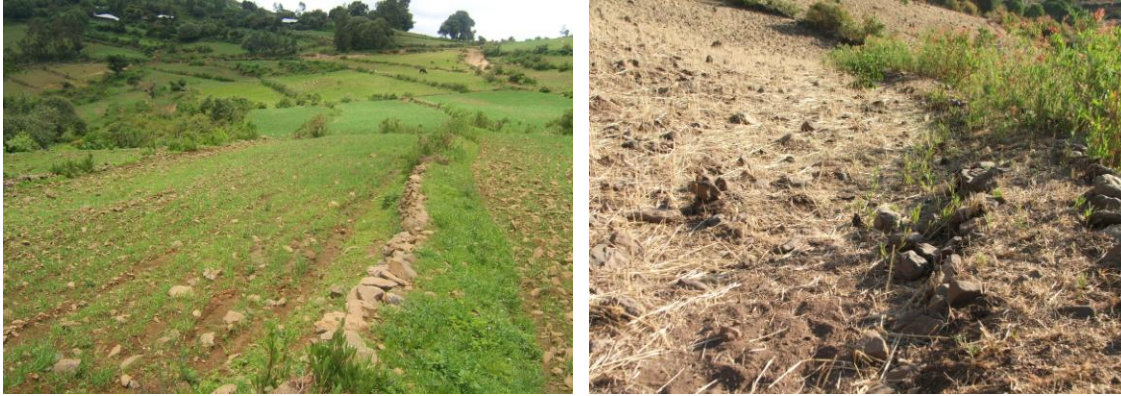
Fig. 28 Improvement on the cross section of terrace structures

Damage to stone terraces due to instable cross sections is common. It is also difficult to maintain or improve stone terraces on steep slopes by adding more stones on top of it. Improvements are made on the top cross section of the terrace structure. The height of structures on the top side is limited up to the ground surface while the bottom riser height is increased to retain maximum sediments. This type of improvements increases structural stability and does not liable to mechanical damage. The inclined top cross section of the structure is developed through time by adding soil and local vegetation when the storage capacity is filled up by eroded sediments.

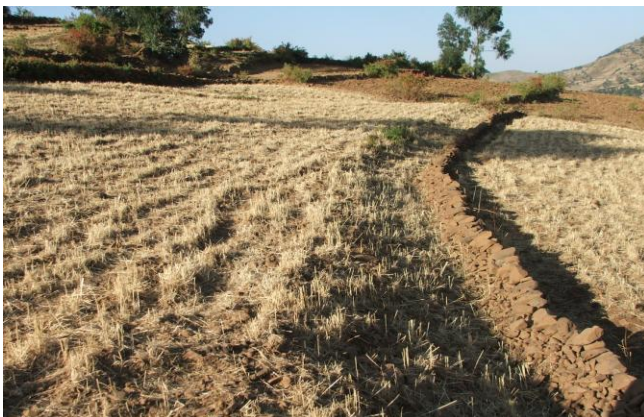
Fig. 29 Old terrace structures moved down slope

Shifting terraces upward or down ward within an interval of 4-5 years is common farmers' practice in the highlands. The farmers' reasoning to do this practice is that the deposited soil on the previous terrace structure is presumed to be fertile in comparison to the soil at a distant from the structure. And hence, crop yield increases when planting this part of land. However, limitations are observed after a certain period of years. This practice has caused disturbance of the already long deposited soil formed in the form of bench terrace and then the soil washed further down slope.

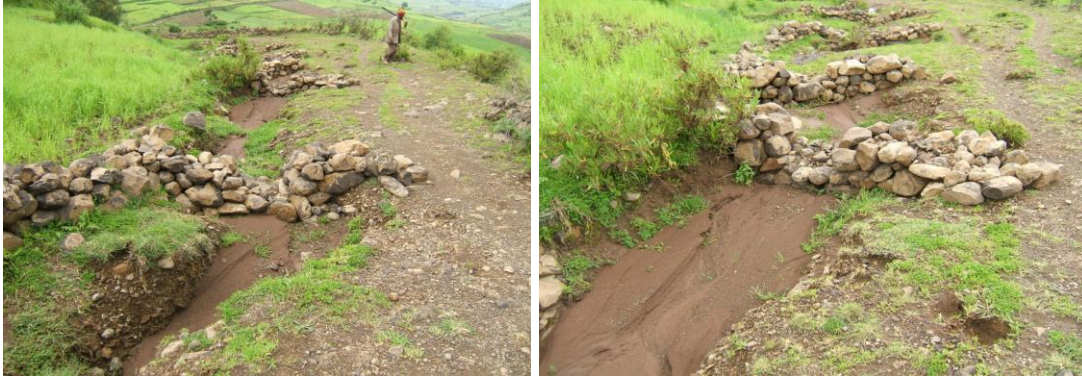
Fig. 30 Series of check dams constructed along path ways

Farmers have been constructing check dams on erosion risk waterways, foot paths and gullies. Farmers try to quantify sediments retained in the check dams every rainfall storms and during the whole season in order to increase their awareness about soil and nutrient loss from farm plots.

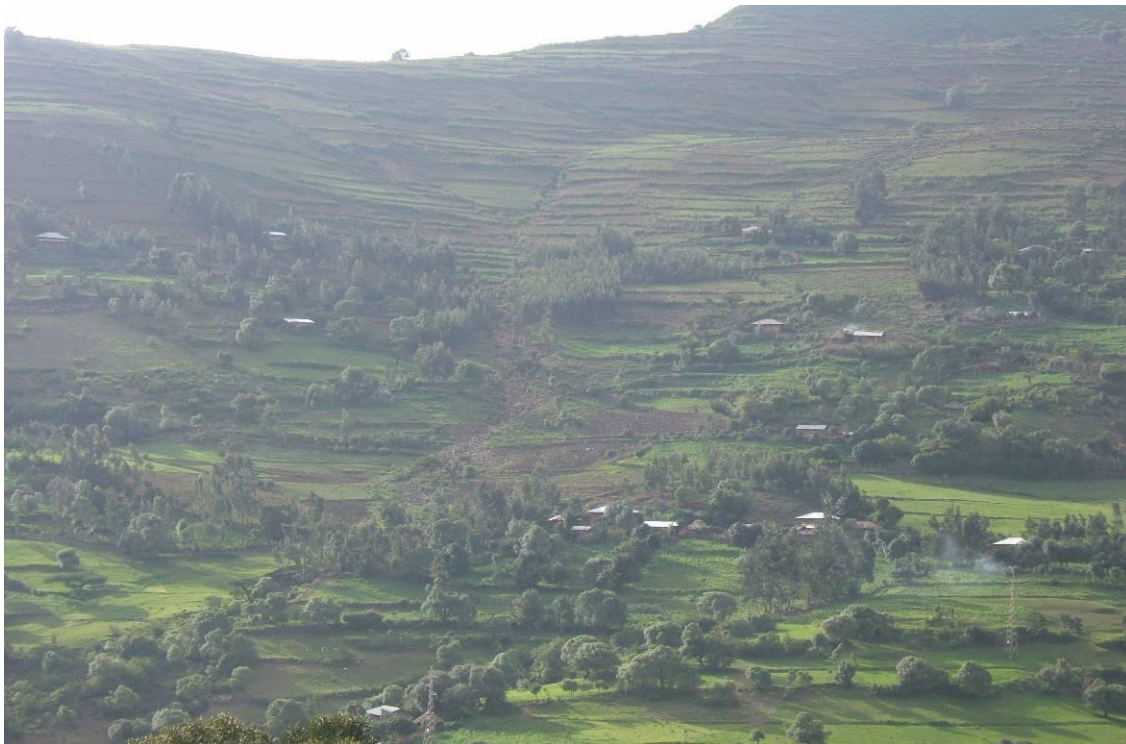
Figure B. Terraced hillslope exposed with soil erosion hazard
