Conceptualizing rill erosion as a tool for planning and evaluating soil conservation in Angereb watershed, Ethiopia: Methodological development

Research Report for Q505 project supported by Eastern and Southern Africa Partnership Program (ESAPP)

Gizaw Desta (2010)

Amhara Region Agricultural Research Institute (ARARI)

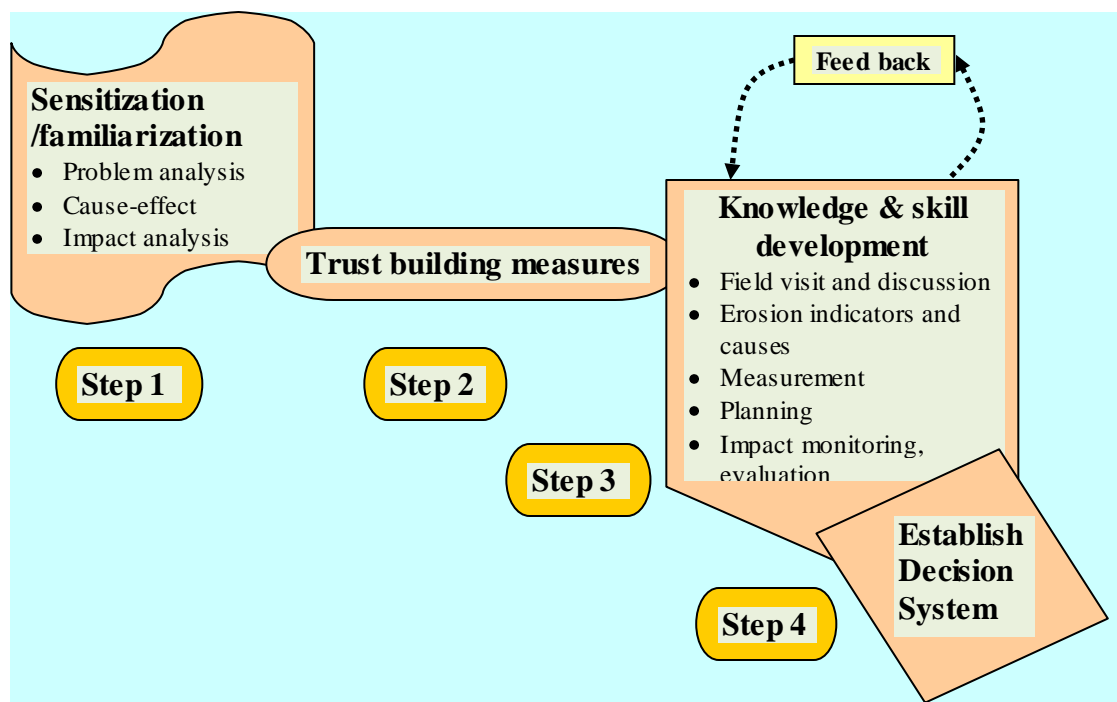
Fig.1 Steps for the participatory process

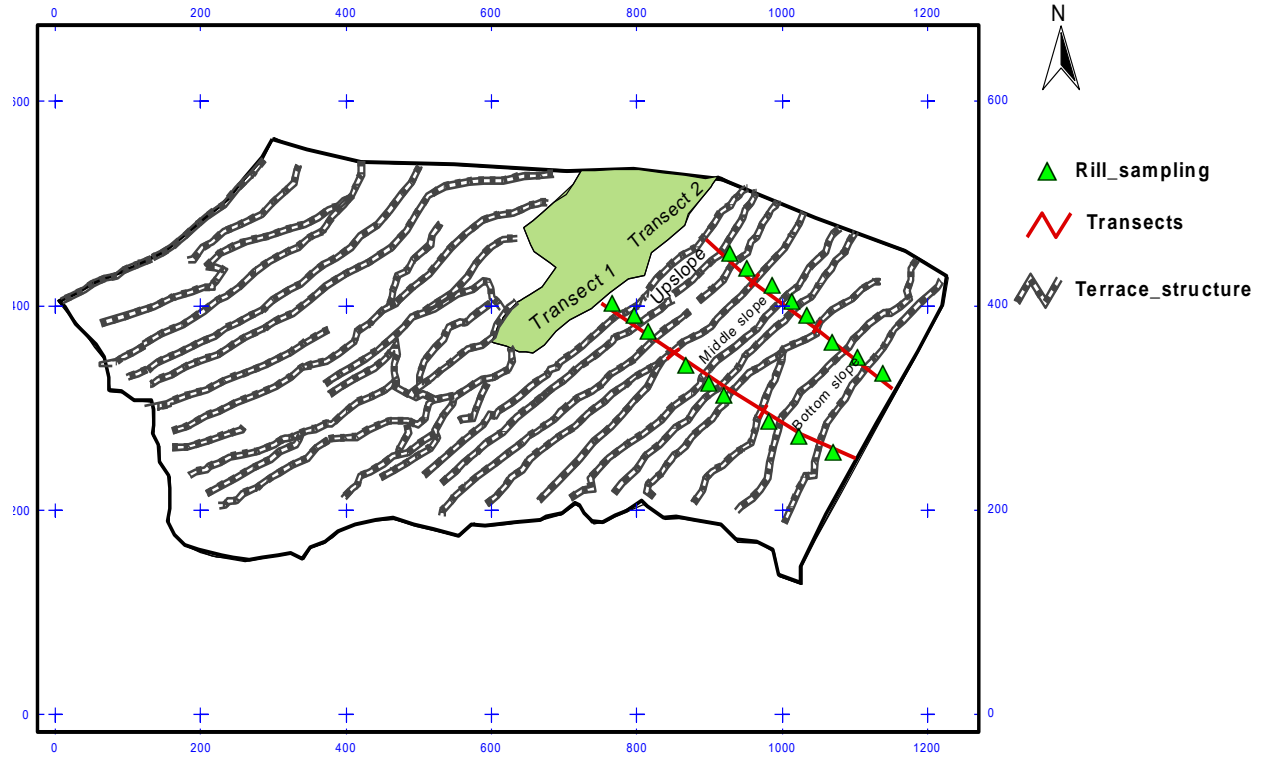
Fig. 2 Illustrations of rill survey sampling plots along transects at catchment scale

Topo-sequence survey: Rill survey at landscape units was made following the direction of runoff flow along the topo-sequence. The catchments were divided longitudinally into two transect sections (Fig. 2). Based on their relative position, sample plots within the transect section were grouped into upslope, middle slope and lower slope of the catchment in order to assess rill development along the topo-sequence. Each sample plots further classified and measurements were carried out between intra-terrace area (top, middle, and bottom positions in the open terrace area). Rill cross sections and counts were measured three times during July to August 2008. By surveying all rills; rill count, spacing, depth and width were collected from each sample plots and aggregated into intra-terrace and landscape positions to monitor rill development. In each slope section of the catchment rill count and rill cross-sections (depth and width) were measured directly using measuring tape from three random sample points of all rills occurred with depth greater than 2.0 cm. The mean was taken for a single rill. Rill characteristics collected at plot scale are used to evaluate efficiency of terraces and illustrated the development of rills over the slope profile. It also helps to assess the performance of terraces against rill formation and development.

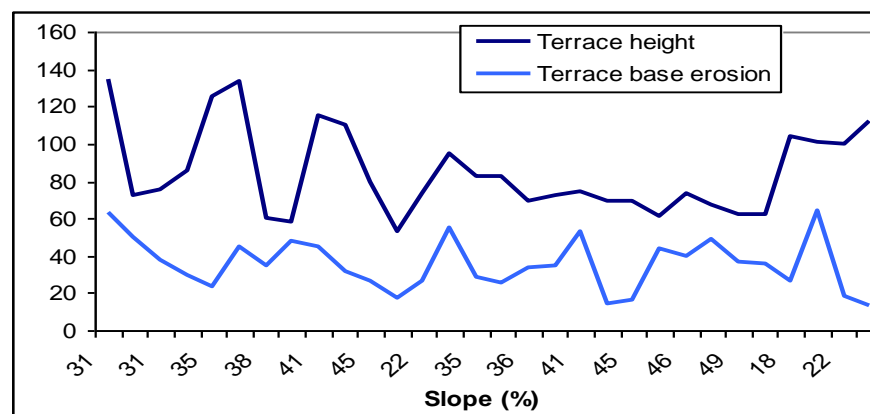
Fig. 9 Erosion underneath the terrace structure due to tillage

Tillage has made annually using *maresha*, a wooden plough pulled by pair of oxen. A typical indicator of tillage erosion was clearly observed beneath the terrace where the soil surface is significantly lower than the base of the terrace since the construction of the terrace in 1991/92. With the tillage practice on steeper slopes, the surface soil was washed down slope. According to Nyssen et al. (2000), tillage translocation has contributed half of the sediment accumulation behind newly constructed stone bunds in Tigray area. On slopes steeper than 15 %, all soil is thrown to the lower side of the tillage furrow (Nyssen, et al, 2000). During the last sixteen years, since the construction of new terraces in the study area, the contribution of tillage erosion was in the range of 15-65 cm reduction of surface soil underneath the terrace structure (Fig. 9 and 10). This means there was an estimated annual tillage erosion range of 1-4 cm close to lower-side of terrace structures. Unlike the results obtained by Nyssen, et al (2000), on the steepest slopes the amount of soil moved by tillage beneath the stone terraces was low, because it is difficult to operate the plough with the oxen very close to terrace structures. Moreover, assessment was made at point depth samples rather than the down slope areal samples. Any way the assessment result has provided that we have a situation where erosion has been aggravated by the farmer unnoticeably. The answer as to whether the farmer perceive tillage as an erosion problem must, therefore, depend upon the farmer perspective through which the judgment is made. In the study area, farmers were less aware and may not consider the soil movement by tillage as an erosion problem.

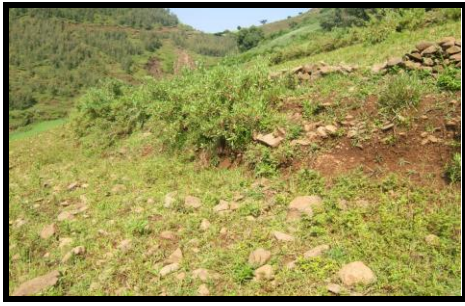
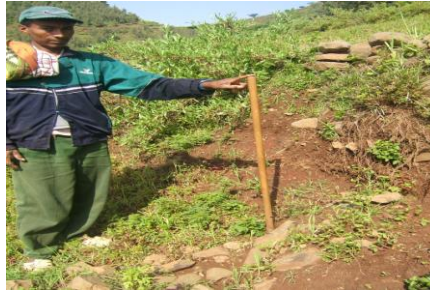
Fig. 10 Evidences of tillage erosion underneath stone structures

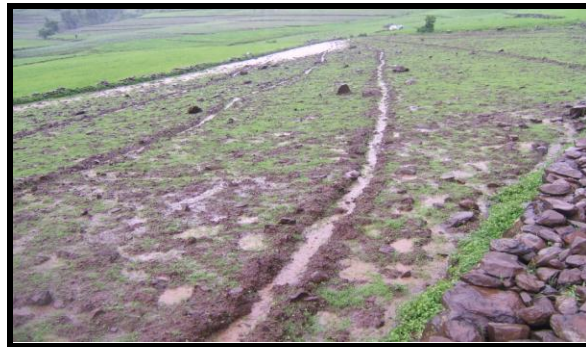
Fig. 11 Runoff erosion due to traditional ditches inside farms

On most of the farmers' field, farmers have constructed a small drainage ditch across the slope to protect the lower field from concentrated runoff during heavy storms. The farmer has to construct this drainage ditch each year randomly on the plot. It is obvious that sediments eroded from ditches and accumulated down slope were common indicators of erosion on farmers' field (Fig. 11). For example drainage ditches in the case study field plots were constructed with an average gradient 4-7 %. This implies that a large amount of sediment has been washed completely out of the field and sometimes the runoff discharged from ditches damage terrace structures and formed gullies down slope.
