Source: Mountain Research and Development, 24(1):19-23.

# Managing Debris Flow Risks

## Security Measures for a Hazard-Prone Resort in Switzerland

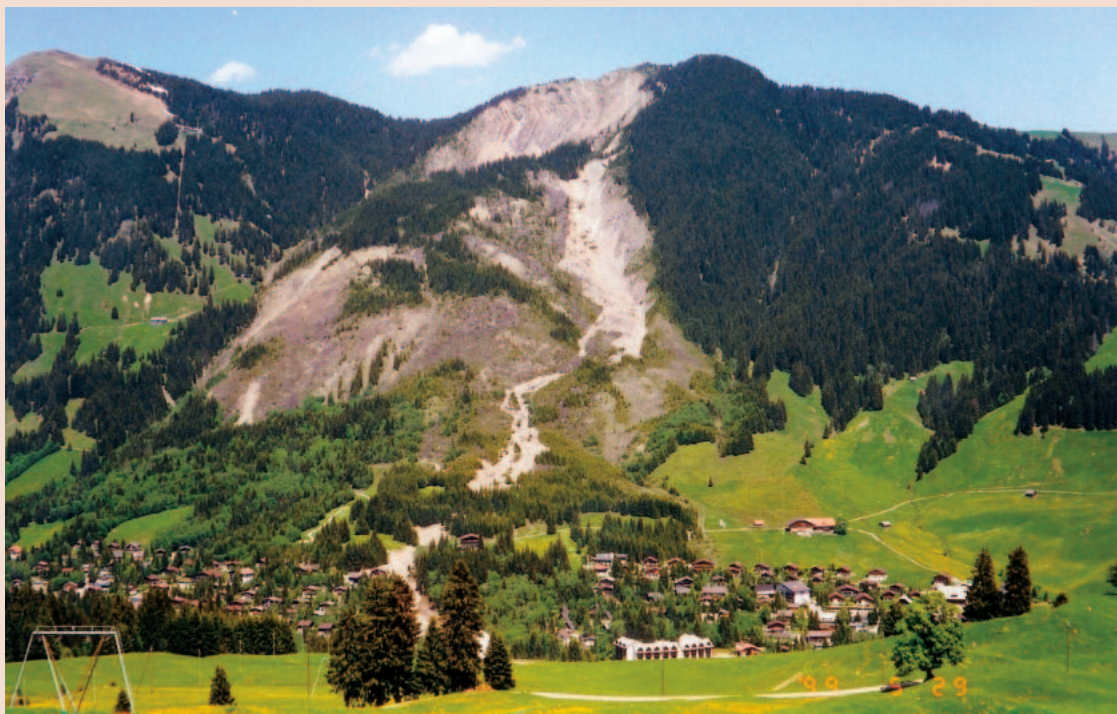
**FIGURE 1** The tourist resort of Sörenberg, located in the Entlebuch Biosphere Reserve, Central Switzerland. The village is located at the foot of a deep-seated landslide complex. The bright surfaces mark the geomorphological zones active in 1999. (Photo by author)

Sörenberg is a typical small tourist resort located on the periphery of the Swiss Alps in Central Switzerland (Figure 1). The village has developed only during the last 40 years; prior to that, it was known as a spa. Today, about 800 housing units—mainly secondary homes (chalets and tourist apartments)—are situated on old debris flow deposits. In addition, a number of sports and leisure facilities have been constructed in recent years. The slopes above the village belong to a large (15 million m<sup>3</sup>)

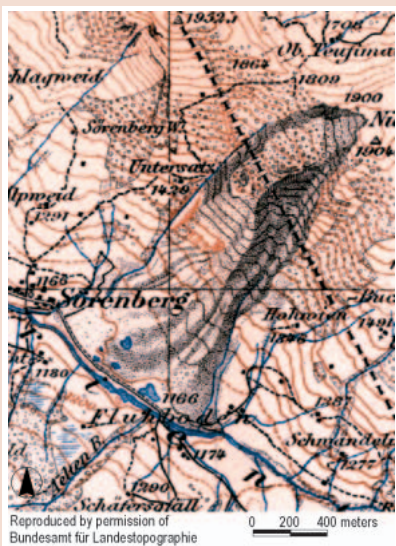
**FIGURE 2** 1918 topographic map, showing the open scars on either side of the mass and the typical accumulation features developed in 1910 and 1912. The few houses with the church (at the center of the village) are located in a safe place. (Map reproduced by permission of Bundesamt für Landestopographie, BA024084)

Analysis of past events makes an important contribution to the understanding of present and future hazards in a particular location. A number of historic documents such as maps (Figure 2), postcards or photographs, as well as a detailed description of the 1910 events by the famous geologist Albert Heim, provided the necessary information to reconstruct the sequence of landslide events in the 20<sup>th</sup> century. Between 1860 and 1910 the entire complex shifted downhill by more than 30 m in a large vertical movement. In 1910 another large vertical movement occurred, lasting several days and causing 2 major lateral collapses and massive debris flows of over 3 million m<sup>3</sup>. Throughout the rest of the 20<sup>th</sup> century development was irregular. Several lateral and frontal collapses occurred in 1912, 1922, and 1986, with 6 decades of geomorphic inactivity in between.

At the beginning of the 20<sup>th</sup> century the area now occupied by the village was used as grazing land. The map (Figure 2) indicates that the existing few houses in Sörenberg were arranged around the church in a safe place. Within the accumulation area of the 1910, 1912 and 1922 debris flows, only a very few isolated houses were destroyed.

Sörenberg's development into the tourist resort that it is today took place only over the past 30 to 40 years. The 1918 map (Figure 2) clearly shows that at that time only very few buildings were located in what was once a highly active accumulation area. Today this area is completely covered by houses (Figure 3). The long period of geomorphic inactivity following the events of 1922 was interpreted as a sign of future security. An analysis by experts in 1974 proved that there was no immediate threat, but did not altogether exclude the possibility of damaging events. An indication of the uncertainty of the situation was provided by displacement measurements begun in 1978. These clearly show that the whole mass is continuously moving about 3 to 10 cm per year. The speed of this movement increased dramatically in 1999 but has slowed down again since.

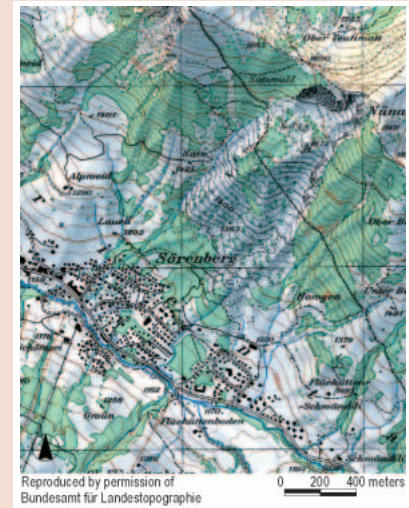
**FIGURE 3** 1993 topographic map, showing how the village has developed in the past 30 years in the area where debris flow formerly accumulated. (Map reproduced by permission of Bundesamt für Landestopographie, BA024084)

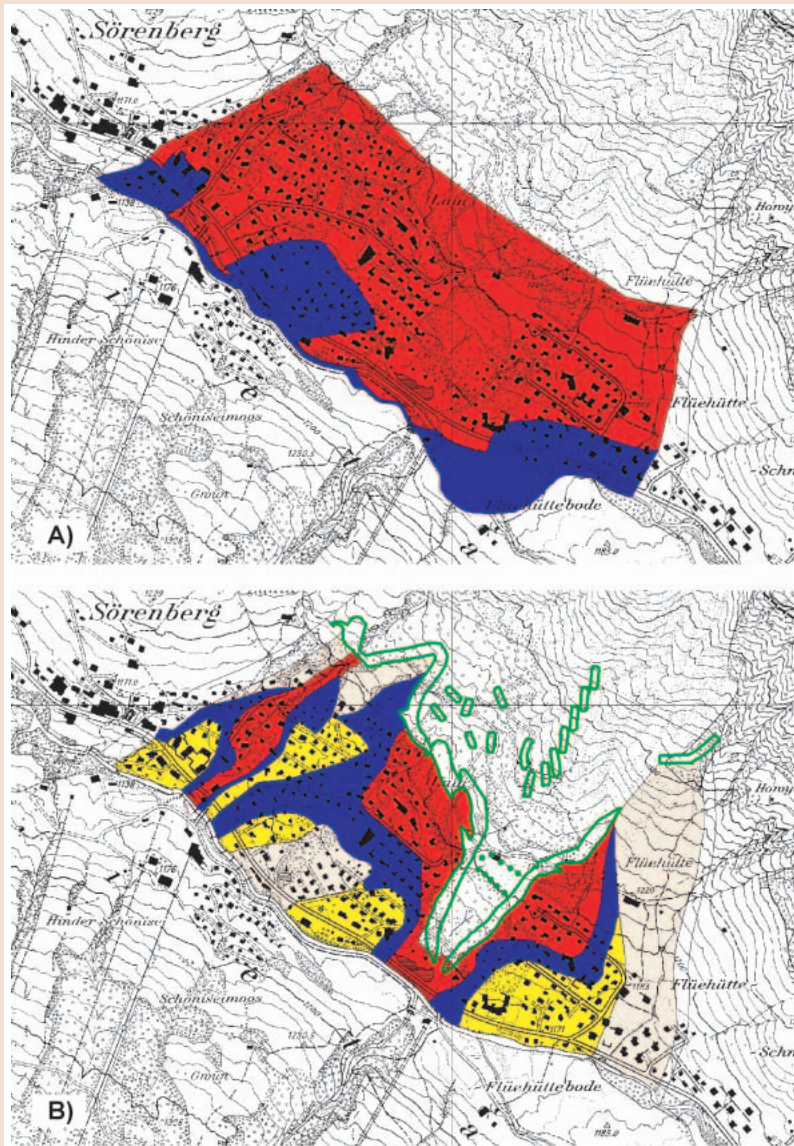
**FIGURE 4, A AND B** Hazard map for Sörenberg. Top (A) before, and bottom (B) after the implementation of the planned structural measures. Red: high degree of hazard; blue: moderate degree of hazard; yellow: low degree of hazard; yellow-white: hazards with a very low probability of occurrence; green: planned structural measures. (Maps reproduced by permission of swisstopo, BA035840)

Secondary processes caused by primary movement occur only after relatively long intervals. It can be concluded that Sörenberg remains at risk. The risk of further collapses and subsequent flows must be taken into account, even though conditions above the village are currently calm. However, it is assumed that large-scale events such as the ones in 1910 are no longer possible. These facts were considered in the hazard map that was prepared in 2001 (Figure 4A).

The first step towards definition of protective measures is a thorough investigation of all hazards and the creation of a hazard map. In Switzerland, such maps are based on definite probability and magnitude classes. Under present conditions, most of the village is within red and blue hazard zones (Figure 4A), ie those subject to a high or moderate risk, respectively. This constitutes a de facto ban on future economic development of the village: construction of new houses and major changes to existing houses are normally not permitted within the red zone. This, of course, was not acceptable to the municipal authorities. Solutions had to be found that would guarantee the safety of the population while at the same time allowing moderate development of the village.

- A set of regulations in the local land use plan and building code defines what is possible in red, blue and yellow zones. These regulations should curb further increase of vulnerability (see Table 1 and Figure 4B).
- In addition to village regulations, plans call for a complete ban on grazing throughout the landslide-prone area as well as an increase in forest cover.
- Municipal and cantonal authorities established a hazard map for the whole area in order to show whether adjacent areas are more suitable for village development. Unfortunately, there are only a few places that are appropriate as housing lots.

- People argued that the primary process should be stopped. Geophysical investigations showed, however, that control of the water table in this extremely fractured and fast-moving mass is hardly possible;
- A number of (reasonable) structural protection measures (Figure 4B, green markings) are planned to reduce the risks to a bearable level. But even with these protection measures, some parts of the village remain in the red danger zone. Owing to financial constraints, the state would like to minimize these measures. The local authorities, on the other hand, have an interest in reducing the red zone as much as possible. Costs of about CHF 14 million (US\$ 10 million) will be shared by the canton and the municipality, with heavy subsidies from the federal government. Home owners may also make contributions.
