# Journal Pre-proof

Multiscale Multimodal Characterization and Simulation of Structural Alterations in Failed Bioprosthetic Heart Valves

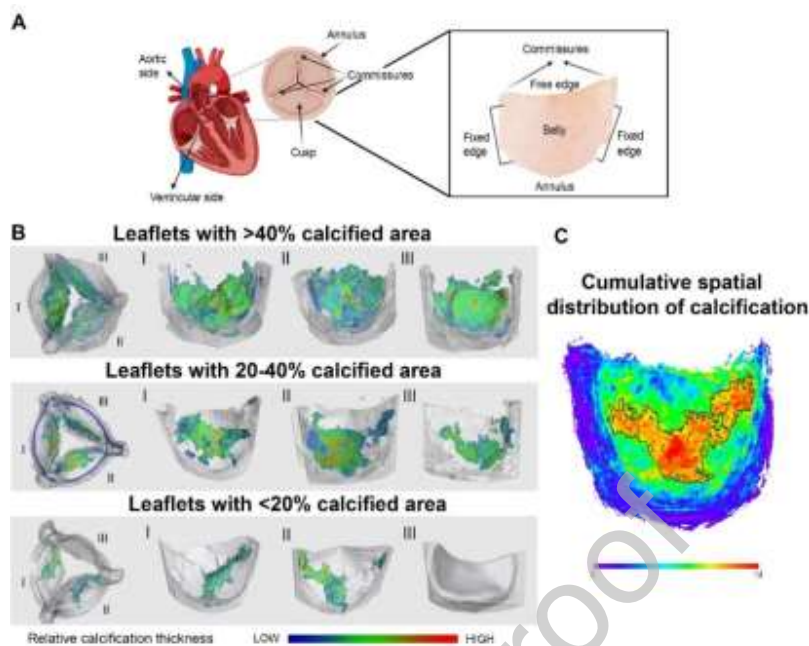
To assess the presence, amount, and anatomical location of calcification in failed explanted surgical bovine pericardium bioprosthetic valve leaflets (Fig. 1A) at the macroscale, microCT scanning and reconstruction were performed. The twenty-one valve leaflets (isolated from seven explanted heart valves from 3 female and 4 male patients) analysed by CT, contained a variable degree of macroscopic calcification (non-calcified (n=7), calcified (n=14), see Table S1). There was a trend that valves explanted from female patients (3 out of 9 leaflets calcified, 1 out of 3 valves explanted due to calcification) were less calfified than those from male patients (11 out of 12 leaflets calcified, 4 out of 4 valves explanted due to calcification). It was observed that in highly calcified leaflets, the mineral covered the entire belly area affecting the free edge and the commissures (Fig. 1B). In moderately calcified leaflets, the mineral was present in irregular patterns spreading from the lower and central parts of the belly near the annulus to the commissures, with the free edge remaining largely unaffected (Fig. 1B). A similar pattern was observed in the least calcified leaflets with commissures and free edge largely calcification-free (Fig. 1B).

Fig. 1. Macroscale anatomical analysis of calcification in bioprosthetic valves. (A) *Schematic diagram of a tricuspid aortic valve as viewed from the aortic side and individual isolated cusp with the aortic side shown for reference.* ***(B)*** *Representative global microCT of calcified bioprosthetic valves, and* ***I***, ***II*** *and* ***III*** *corresponding higher magnification global microCT of individual valvular leaflets presenting different calcification degrees.* ***(C)*** *Heatmap of the relative cumulative spatial distribution of calcification using all calcified leaflets (n=14) where purple (intensity 0) and blue correspond to non-calcified areas and red (intensity 14) corresponds to calcified areas observed in all leaflets, indicating that the central parts of the leaflet belly (black outline) was calcified in most (orange areas) or all (red areas) leaflets. Shapes aligned to outer leaflet dimensions.*

Interestingly, the calcification patterns in the different leaflets indicate that the region most commonly calcified is the central area of the leaflet belly (Fig. 1C, region indicated by black outline) with the area appearing as saturated red (corresponding to intensity value 14) being calcified in all leaflets containing microCT-detectable minerals. This data could indicate a progressive process where calcification occurs initially in the lower and central parts of the belly and extends gradually to the entire leaflet. The presence of a progressive process is further supported by strong correlations (Pearson's $r > 0.89$) between the amount of leaflet calcification and maximum mineral thickness (growing up to 1.33 mm) with the duration of implantation (Fig. S1). However, despite the observed trend of mineral accumulation in the central part of the belly, the variation in mineral patterns in the peripheral regions varies significantly, possibly due to a complex, multifaceted formation mechanism.

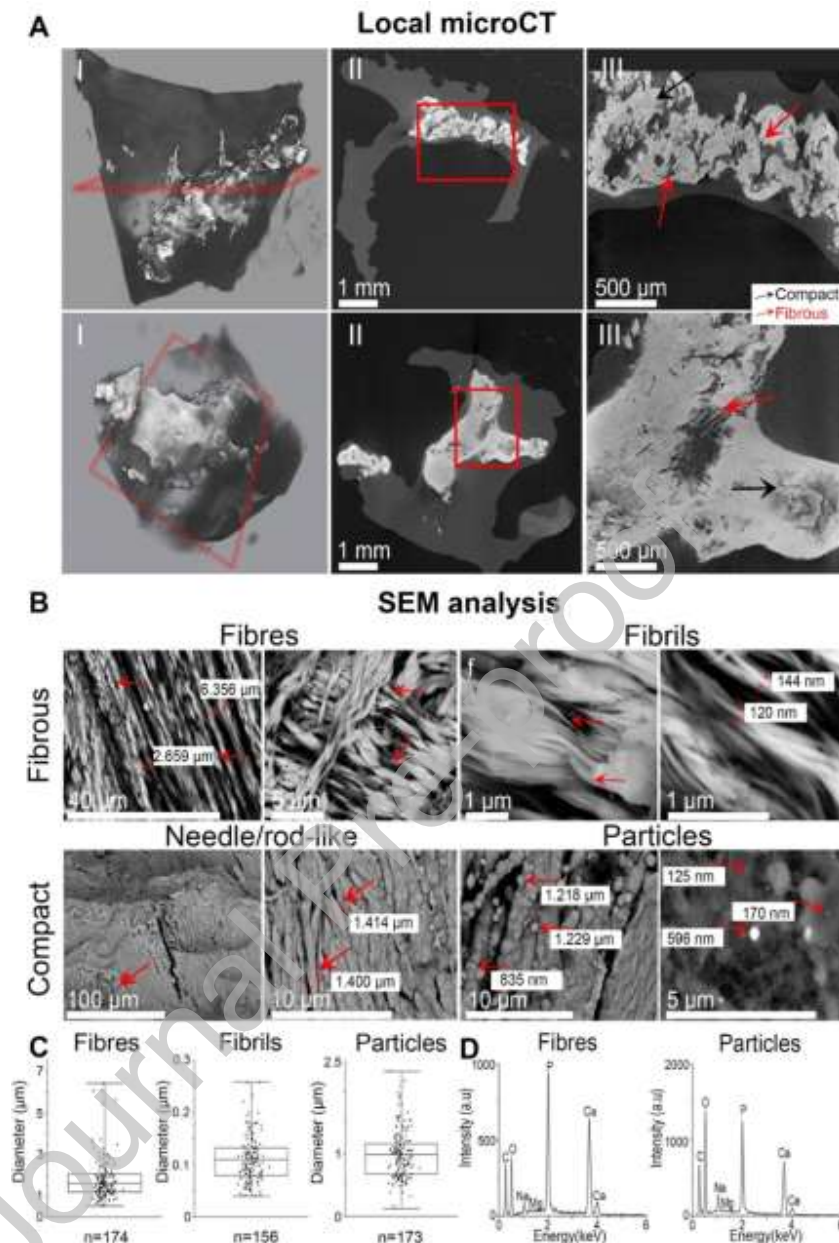
For more detailed information on the mineral structures, high-resolution microCT reconstructions (voxel size of 3 µm) of individual leaflets were carried out, revealing the presence of fibrous structures (Fig. 2A and S2) along with regions of compact calcification (Fig. 2A III top and bottom). Calcified regions were microdissected from the belly of nine macroscopically calcified leaflets isolated from seven valves and characterised by high-resolution SEM (Fig. 2B). The highly abundant calcified fibres exhibited diameters between 0.5 – 6.4 µm (average: 1.8 µm, IQR: 0.9 µm), were partially formed by organic material based on electron density (Fig. 2B, C and S3) and were observed in all macroscopically calcified leaflets analysed by SEM. Interestingly, these large calcified fibres were formed by bundles of smaller calcified fibrils (average: 109 nm, IQR: 53 nm) (Fig. 2B, C and S3) aligned to some extent along the same axis. Their characteristic diameters match the diameters of collagen type I fibrils (10 - 500 nm in diameter, also observed through SAXS measurements, *vide infra*) and fibres (1 - 20 µm in diameter) [44, 45], thus supporting the widely accepted collagen mineralization theory described for native valves [46]. These mineralised fibre and fibril structures were not detected in the native heart valves investigated by us (Fig. S4) nor in previous electron microscopy studies [2, 26, 27].

Fig. 2. High-resolution imaging of minerals within macroscopically calcified bioprosthetic cusp tissue. *Inorganic material is shown as white/light grey and organic material as dark grey/black. (**A**) **I**, Representative high-resolution microCT reconstructions of valve leaflets with different calcification percentages, 16% and 33% (top and bottom row respectively) and **II**, cross-sections (indicated as a red rectangle in **I**) of the leaflets showing the calcification shape and **III**, higher magnification microCT images showing fibrous and compact regions. (**B**) Representative high-resolution BSE micrographs of fibrous regions show calcified fibres and fibrils (arrows) and compact regions formed by highly calcified fibres, needle/rod-like structures and calcified particles (arrows) observed in macroscopically calcified leaflets. Some individual calcified particles (arrows) were observed in less calcified areas. (**C**) Fibre (n=174), fibril (n=156) and particle (n=173) diameter size distributions. (**D**) Representative EDX spectra of calcified fibres and particles obtained from macroscopically calcified leaflets.*

More recently, Gourgas *et al.* [47] also reported fibrous structures that appear (partially) mineralized in native human heart valves, however, with seemingly low abundance and of unknown origin. Extensively calcified merged fibres were also occasionally detected within the more compact mineral structures observed (Fig. 2B), resembling calcified rods and needle-like crystals (Fig. 2B and S3). Additionally, calcified particles (average diameter: 1.0 µm, IQR: 0.5 µm) were detected in all macroscopically calcified leaflet samples (Fig. 2B-D and 4D). These particles often appeared aggregated in highly calcified regions, sometimes forming larger pearl-string structures (Fig. 2B and S3) and were also detected as individual entities in tissue parts where large calcifications were absent (Fig. 2B and S3). Similar particles have also been identified in native valves (Fig. S4), well in line with earlier works [2, 26, 27]. Based on EDX analysis, all minerals observed in highly calcified regions were formed by calcium phosphate and contained magnesium in some cases (Fig. 2D and S5).

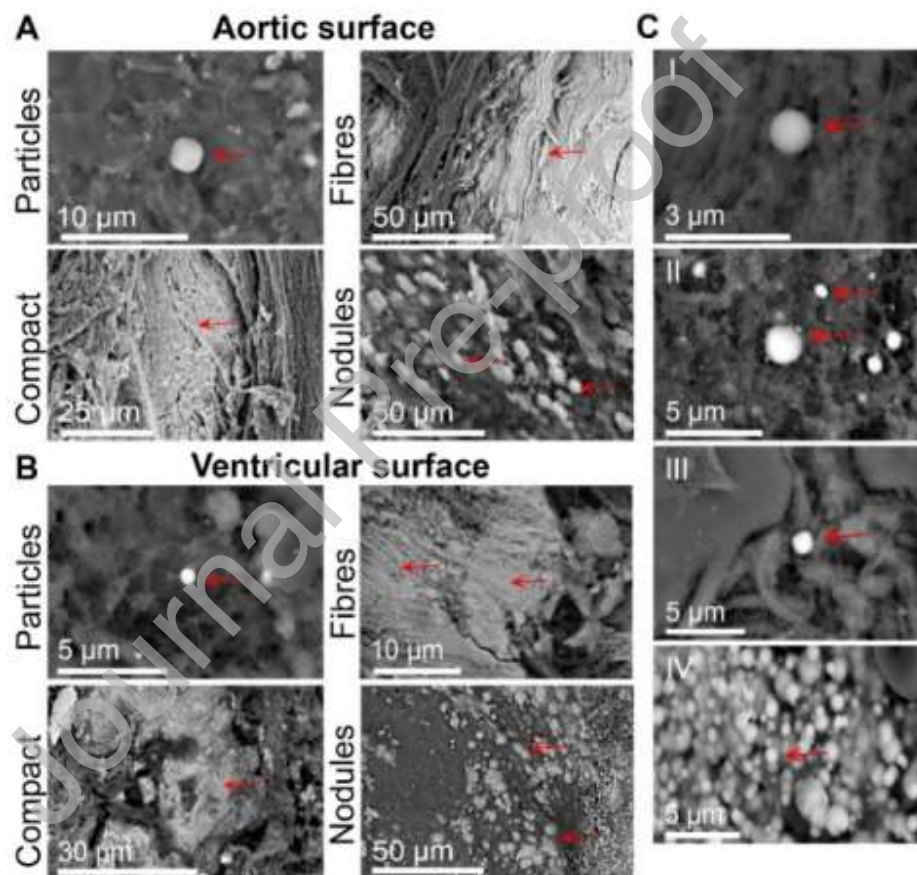
To distinguish between superficial and deep-lying materials and their characteristics, regions from the aortic and ventricular surfaces of the nine macroscopically calcified leaflets and four non macroscopically calcified leaflets were further analysed by electron microscopy. Calcified particles, fibres and compact minerals (Fig. 3A and B, S6) were found on both the aortic and ventricular surfaces. The calcified particles were predominantly detected on the surfaces (irrespectively of anatomical location (aortic or ventricular side)) of all leaflets (Fig. 3C), suggesting a possible mechanism leading to surface deposition. In contrast, the remaining minerals appeared to surface due to structural growth originating from inside the leaflet, as confirmed by microCT data, which showed that calcifications were primarily found in the middle of the leaflet walls rather than the surface. While previously, differences between the calcification extent of the fibrosa and ventricularis have been reported in bioprosthetic valves, especially porcine aortic valves, no evident differences were found in the bovine pericardial valves investigated in this study [48]. This is explained by the different tissue architecture between the porcine aortic tissue and the bovine pericardium, and, possibly by the higher sensitivity of the analytical methods used herein, leading to detection of calcification on both sides in all leaflets. To ensure that none of these structures result from precipitation

Fig. 3. Mineral presence on the aortic and ventricular side surfaces of bioprosthetic cusps. *Morphologically different minerals were found; calcified particles, calcified fibres, compact calcification and nodules on the **(A)** aortic and **(B)** ventricular surfaces. **(C)** Calcified particles were observed regardless of the degree of calcification or anatomical location. Scanning electron micrographs of particles found on **I** non-macroscopically calcified, and **II**, **III** and, **IV** macroscopically calcified explanted leaflets of increasing calcification percentages.*

The fibres likely stem from mineral precipitation on the collagen [49]. In contrast, the vast presence of the calcified particles both within and on the leaflet wall surface suggests a process of cellular origin (e.g. from macrophages or other cells, cell-derived structures or particles originating from the blood), as previously suggested [50-53] for the same particles (same shape, size and composition) in native valves. Furthermore, similar particles have also been observed in tumour vasculature [54], the Bruch's membrane of the eye [55, 56], and other cardiovascular tissues[57] suggesting a host-environment origin shared between several pathologies.

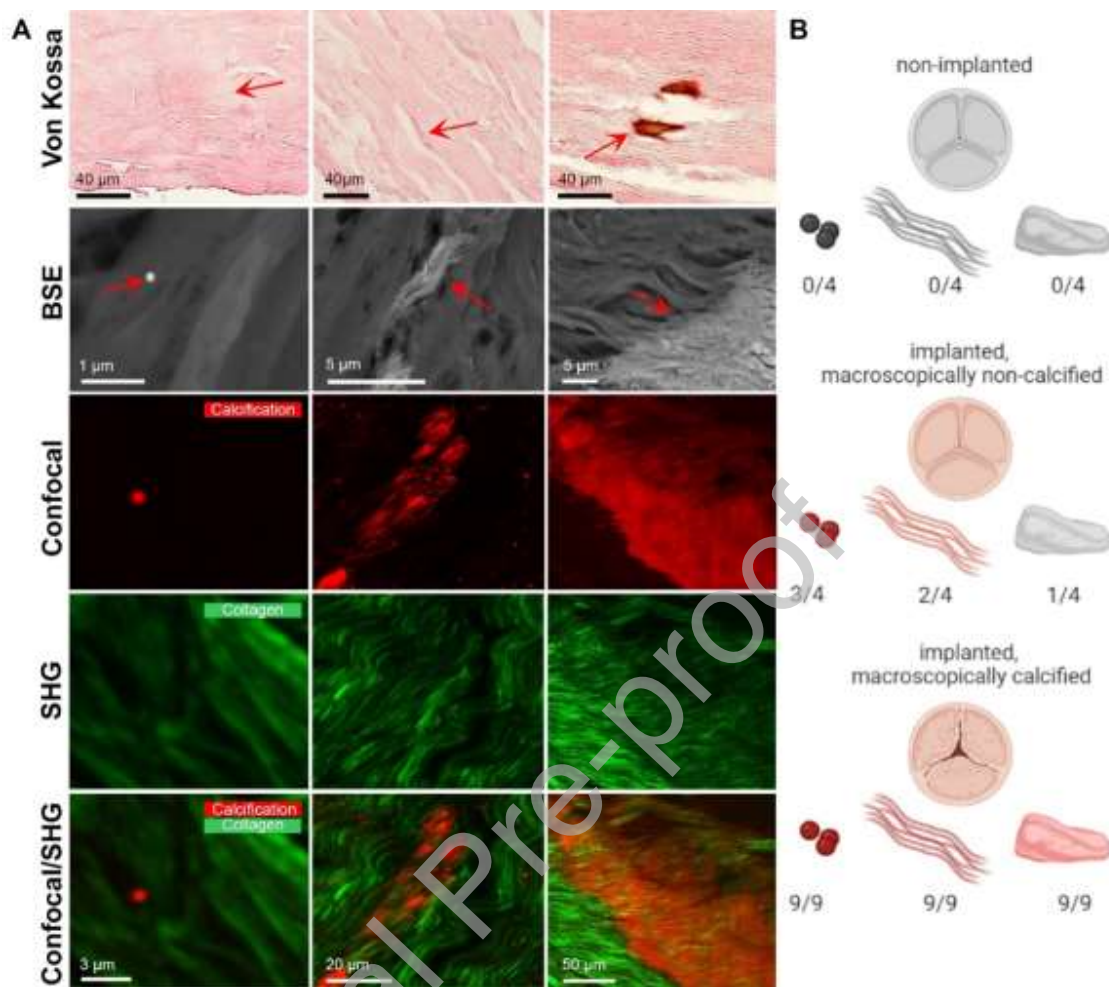
To assess the presence of early stages of mineral formation, we investigated non-calcified failed explanted bioprosthetic valve leaflets with high resolution optical and electron microscopy (Fig. 4). Calcified particles were identified (Fig. 4, S7 and S8) through Von Kossa staining and confirmed by nanoanalytical techniques in three out of four non-macroscopically calcified leaflets. Anatomically, they were scarcely observed at various positions on the valve surfaces. EDX analysis indicated that these were always composed of calcium, phosphate and magnesium (Fig. S7).

Backscattered electron microscopy also revealed the scarce presence of calcified fibres and fibrils made of calcium and phosphate (Fig. 4, S7) in half of the investigated non-macroscopically calcified leaflets. Correlative confocal and second harmonic generation (SHG) imaging (Fig. 4A and S8) indicated that these calcified fibres colocalised with collagen fibres, indicating a process of collagen mineralisation, well in line with the SEM investigations (Fig. 2). In contrast, SHG imaging suggests that the calcified particles were entrapped within collagen network gaps rather than deposited onto fibres and were not locally associated with collagen mineralisation (at least at the initial stages). This spatially independent occurrence of the two minerals (calcified collagen fibrils and calcified particles) further supports the existence of two distinct mineralisation phenomena, which may contribute to the creation of larger mineral accumulations (Fig. 2 and 3) over time.

Fig. 4. High-resolution imaging analysis of minerals within non-calcified bioprosthetic cusp tissue. (A) Calcified regions were observed in Von Kossa stained samples as brown/black spots indicated by arrows. High resolution imaging by scanning electron microscopy enabling morphological and chemical charactierzation of the mineral (BSE, arrows and EDX, see SI Figure S7). Confocal microscopy of the mineral (red), overlaid with SHG data showing the collagen network (green) enables co-localization analysis of the mineral with collagen. Calcified particles, fibres and compact calcifications were identified. (B) Prevalence of mineral structures (particles, fibres, compact (macro and micro) calcification) found in non-implanted (n=4), implanted non-macroscopically calcified (n=4) and implanted macroscopically calcified (n=9) leaflets, analysed by micro and nanoscale characterisation techniques.

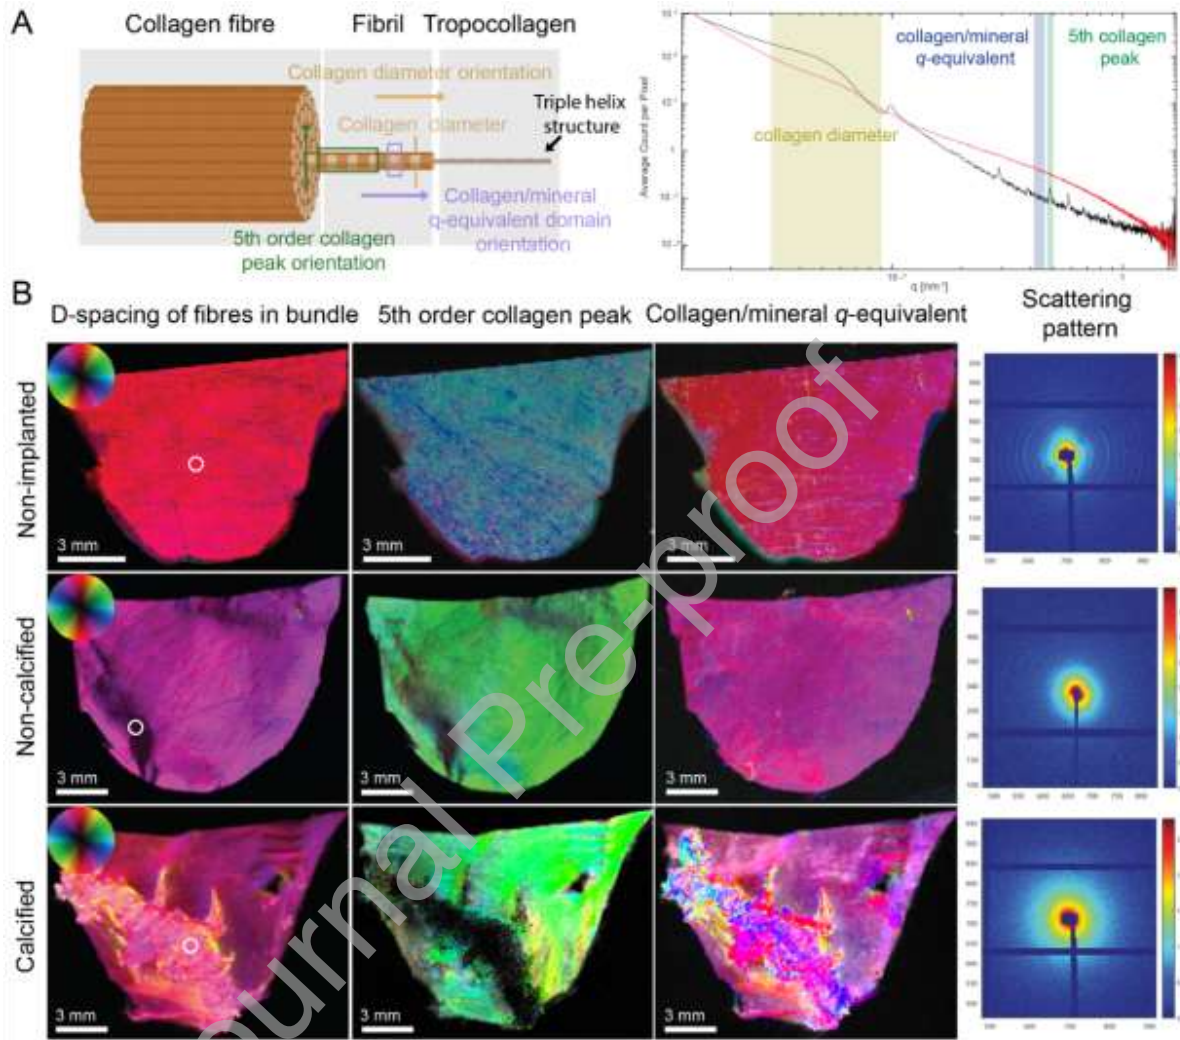
On the one hand, the non-implanted bioprosthetic valve leaflet presented homogeneously a typical fibrillary diameter of 141.46 ± 1.44 nm (Fig. S10) and a scattering pattern characteristic of healthy collagen (Fig. 5 and S11) ('eye brow' pattern), known to originate from the triple helix structure of the tropocollagen molecule [58]. Similarly, the q-regime corresponding to the d-spacing of the fibril in bundle – corresponding to the collagen fibril and the tropocollagen 5^{th} order collagen peak orientation (Fig. 5A) were homogeneous throughout the leaflet, as expected (Fig. 5B, angle dependency of the orientation encoded in the colour wheel). On the other hand, while the non-calcified explanted leaflet retains to some extent its homogeneous orientation, some areas present low-intensity collagen fibril diameter reflections and a lower degree of orientation for the 5^{th} collagen peak. These changes are visible in the orientation of the bundle structure of the fibirls, the 5^{th} collagen peak (Fig. 5B, parts of the commissures and free edge appear as black), and the scattering pattern (Fig. S12). However, no changes were seen on the collagen nanostructure, as observed from the object orientation in the $0.417 < q < 0.450$ nm^{-1} collange/mineral q-equivalent domains (CNQED) (Fig. 5B), suggesting the fibrillary structure with the nanodomain of the tropocollagen molecules remaining unaffected.

Similarly, heterogeneity was observed in the calcified leaflet even in non-mineralised areas (Fig. 5B), with comparable orientations observed for the collagen diameter and the CNQED (shown in the same colour range in Fig. 5B) for mineralised and non-mineralised areas. This suggests that the structures within

Fig. 5. Collagen network SAXS analysis in bioprosthetic valvular leaflets. *(A) Schematic of collagen structure and diffraction peak plot indicating the collagen diameter, 5th collagen peak and collagen/mineral q-equivalent domain. Black and red curves representing the non-mineralised and mineralised samples respectively (B) Orientation analysis of (I) the d-spacing peak of fibres in bundles (aka collagen diameter) (II) 5th order collagen peak, (III) $0.417 < q < 0.450$ nm^{-1} collagen/mineral q-equivalent domain and (IV) representative scattering patterns of regions marked by a circle, in a non-implanted, a non-calcified explanted and a calcified explanted leaflet. Within this HSV (Hue, Saturation and Value) representation, hue gives information on the orientation according to the colour wheel, saturation on the degree of orientation and the value on the density of the scattering material.*

(Fig. 5B). In these regions, a change in the collagen fibrillar diameter from the healthy diameter calculated to be 144.29 ± 3.09 nm towards 111.16 ± 6.06 nm in the region within the mineralisation front is observed (Fig. S10). Moreover, the characteristic scattering pattern (Fig. S13 and S14) is found to gradually disappear closer to the mineral, suggesting either damages in the tropocollagen helical structure or the formation of an additional overlapping phase suppressing it. Finally, collagen structure changes can be seen from the change in orientation of the 5th collagen peak in regions where the CT does not show any mineralisation (yellow regions on 5th collagen peak orientation) (Fig. 5B). These results illustrate the extent of non-calcific collagen alterations, highlight the impact of implantation on bioprosthetic valvular tissue, and reveal at least a partial connection between such non-calcific alterations and calcific degeneration.

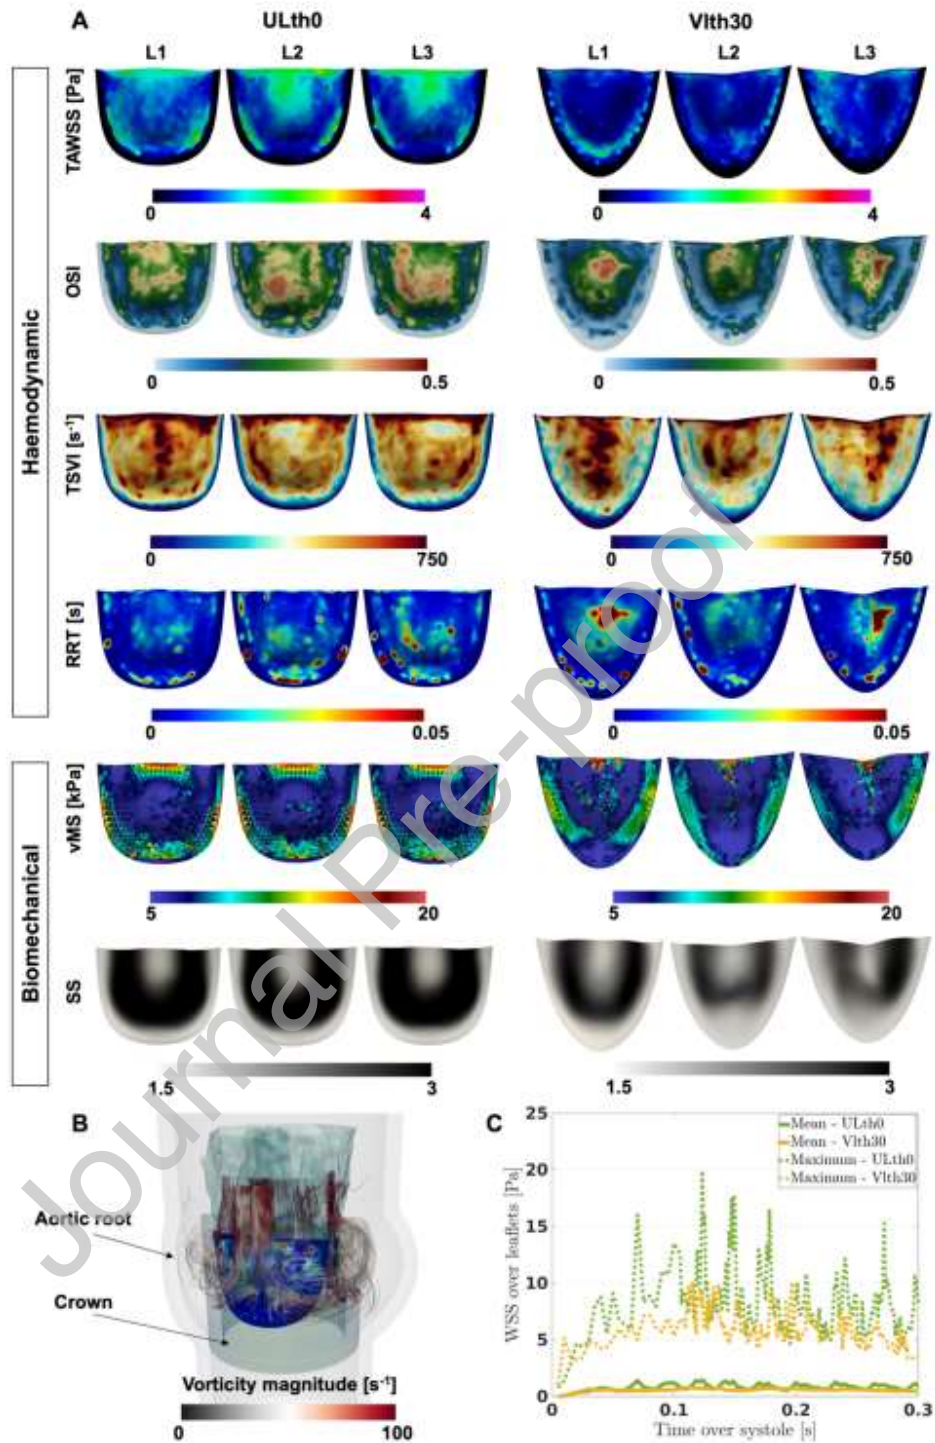
Furthermore, the area with higher TAWSS values at the commissures, fixed edges and annulus on the aortic side (Fig. 6A and S16A) correspond to areas rarely found calcified in the analysed explanted bioprosthetic heart valve specimens. The elevated TAWSS values at the attachment curve and annulus on the aortic side

In relation to the OSI and TSVI indicators, large values were mainly identified in the centre and top parts of the leaflet belly predominantly on the aortic side (Fig. 6A and S16). Higher OSI and TSVI could contribute to the triggering of collagen network alterations, leading to subsequent collagen mineralisation; supporting the hypothesis that time-varying haemodynamic wall shear stresses leading to the repetitive expansion and contraction of the leaflet surface may contribute to valvular failure. In this respect, the TSVI distribution presented similar patterns (with different magnitudes) on both the aortic and ventricular sides, with higher values observed at the top half of the leaflet (Fig. 6B and S16), which is aligned with the mineral content (calcified particles and nodules) observed on the aortic and ventricular leaflet external surfaces as identified through the SEM analysis.

Fig. 6. Spatial distribution on the aortic surface (fibrosa) of the three leaflets using a fibre-reinforced material model and the leaflet geometries referred to as ULth0 and Vlth30. *(A) Distributions of the time-averaged wall shear stress (TAWSS), oscillatory shear index (OSI), relative residence time (RRT), topological shear variation index (TSVI), von Mises stress (vMS), scalar strain (SS) (B) Streamlines coloured with the vorticity magnitude in the vicinity of the leaflets. The leaflet is colour-coded with the relative residence time and an iso-surface of turbulent kinetic energy (equal to 0.08 m²/s²) issuing from the leaflets' free edges is displayed. Distributions in the aortic side of the RRT are shown, and the vorticity*

magnitude of blood in the aortic root. (C) Time evolution of maximum and spatially averaged wall shear stress onto the aortic side of the three leaflets of both valve designs (Vlth30 and ULth0).

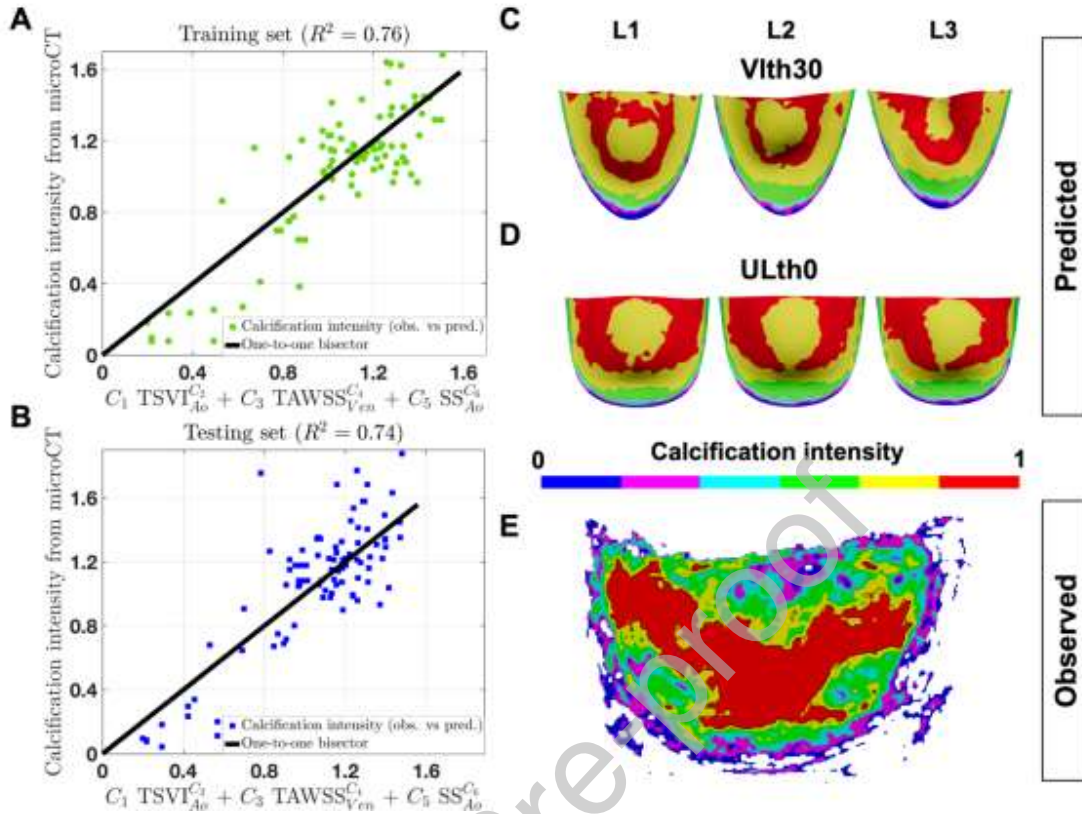
Fig. 7. Comparison between predicted calcification intensity and the observed calcification intensity. *Regression analysis showing a good correlation between the predicted and the observed calcification analysis using a training data set (**A**, $R^2 = 0.76$) and a testing data set (**B**, $R^2 = 0.74$). Predicted calcification intensity in Vlth30 (**C**) and ULth0 (**D**) valve geometries computed using the contribution of the TSVI, TAWSS and SS indicators. (**E**) Observed calcification intensity as observed through the microCT analysis for comparison.*
