G. DUMITRU^{1,} V. ROMANO¹ Y. GERBIG² H.P. WEBER¹ H. HAEFKE²

Femtosecond laser processing of nitride-based thin films to improve their tribological performance

¹ University of Bern, Institute of Applied Physics, Sidlerstrasse 5, 3012 Bern, Switzerland
² CSEM Swiss Center for Electronics and Microtechnology Inc., Jaquet Droz 1, 2007 Neuchâtel, Switzerland

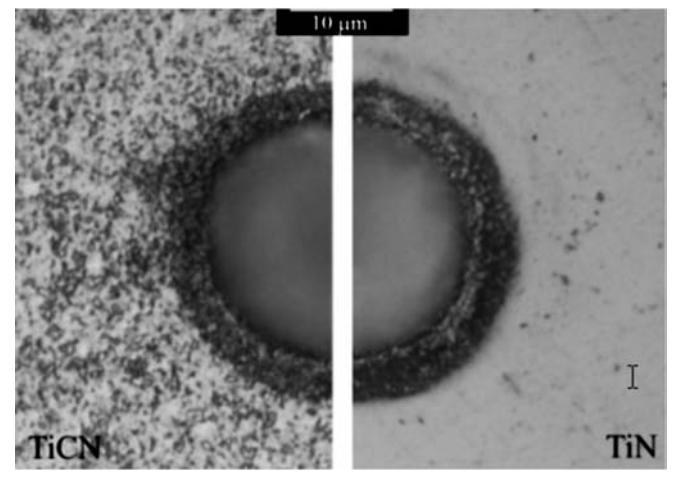
FIGURE 1 Images (optical microscopy) of pores induced in ceramic films $(100 \times 2 \text{ J/cm}^2)$

The optical microscopy investigations of the crater boundary zone, where damage due to laser treatment was apt to appear, did not reveal (Fig. 1) any film cracks, delamination, or other surface modifications. These analyses also showed that the remaining surfaces were not affected by the laser treatment; their roughness values did not change and they could be used as tribological surfaces directly after the fs-laser processing.

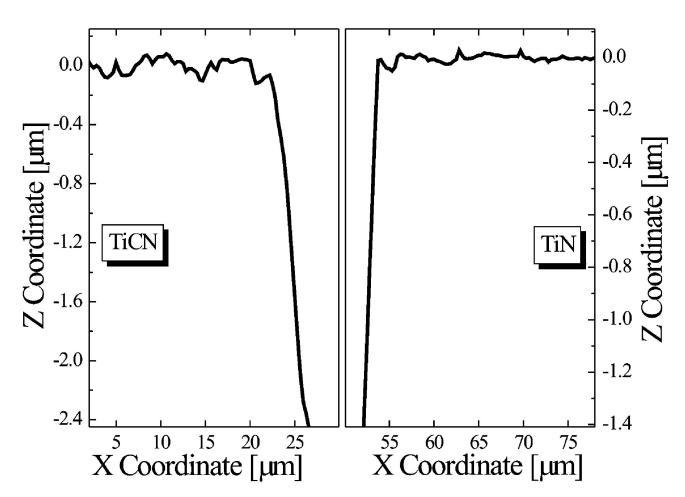
FIGURE 2 AFM profiles along diameters of pores shown in Fig. 1

AFM analyses (Fig. 2) demonstrated a distinct transition between irradiated and non-irradiated film zones, without significant rims at the crater borders. Regarding the transition

zone between the coating and substrate in the case of TiN, (1 μ m thick) smooth pore walls, without any spikes or sharp rims, were noticed. In the case of TiCN, no such points were observed, but in this situation, the film thickness (3.5–4 μ m) was outside the reliability zone for AFM-measured depths.

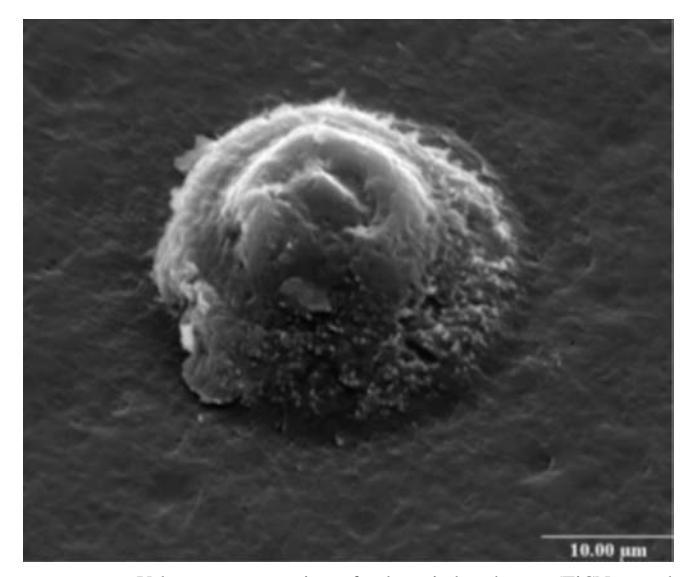
FIGURE 3 Volume representation of a laser-induced pore (TiCN-coated hard metal, $100 \times 2 \text{ J/cm}^2$)

To investigate the actual 3D shape of the laser-induced pores, a replica technique [1] was used to achieve a "negative copy" from microcraters; an SEM image from a replica of a single pore is shown in Fig. 3. Similar shapes were also obtained for pores in the TiN film. Therefore, one can state that the slope change that is noticeable in Fig. 3 is related to laser irradiation factors.

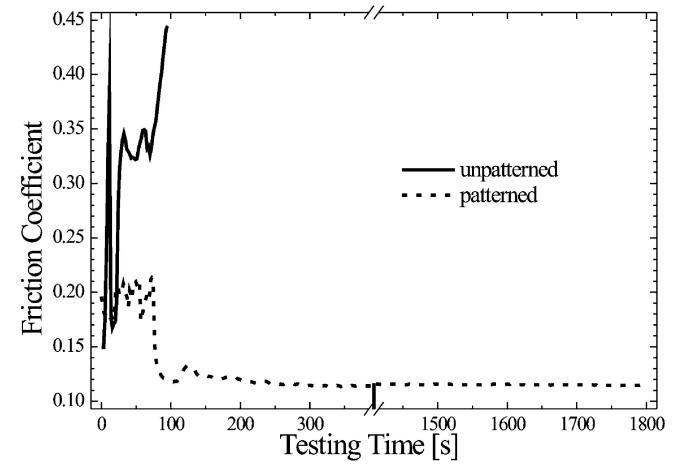
FIGURE 4 Friction curves for laser-patterned and unpatterned TiN-coated surfaces

Typical friction curves for unpatterned and laserpatterned surfaces are depicted in Fig. 4. Significant differences in the friction evolution between the two types of surfaces can be seen. Due to insufficient lubrication of the tribocontact area, the unpatterned surfaces exhibited a continuously increasing friction coefficient that attained the

friction-related stop criterion shortly after the start of the test (100–120 s). In the case of the patterned surfaces, the friction coefficient rose temporarily to values of $\mu \sim 0.2$ in the running-in phase of the tests, but decreased afterwards and remained stable at a level of $\mu \sim 0.11$ until the end of the test; this value is typical for boundary friction [21].

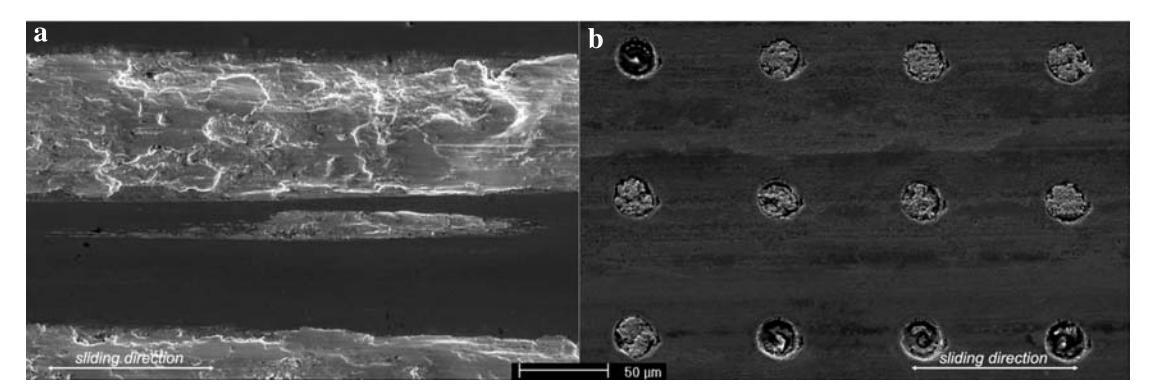
FIGURE 5 SEM images of wear tracks on TiN-coated surfaces: a unpatterned and b patterned

After tribological testing, SEM and energy dispersive X-ray (EDX) investigations were carried out to study the wear tracks generated on the tested surfaces. Representative close-ups of the worn surface regions on the unpatterned and laser-patterned samples are shown in Fig. 5.

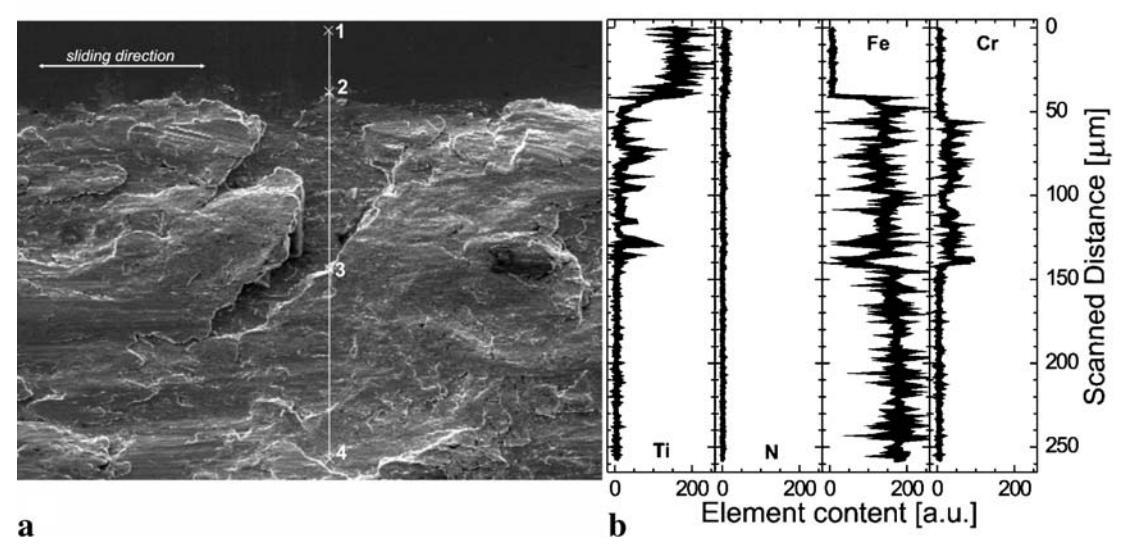
FIGURE 6 Detail from a wear track on a TiN-coated and unpatterned surface: a SEM image and b EDX analysis of elemental content along the *white line* marked in a

To determine the exact nature of the stripe-shaped wear features observed on the unpatterned TiN surface, EDX line scans were performed (Fig. 6). The presence of the chemical elements Fe, Cr, and Ti was proven along a line running from a less worn region to a damaged zone (Ti: protective film, Cr: substrate of coated sample, Fe: substrate of coated sample and counter body).

Along the EDX line scan from points 1 to 4 in Fig. 6, the following features are observed: (i) the Ti content remains constant (150 counts/s) between points 1 and 2; at point 2, the content drops suddenly down to 0 and remains at this value until point 4 is reached; (ii) the Cr concentra-

tion is 0 between points 1 and 2; at point 2, the concentration increases to about 40 counts/s and oscillates around this value until point 3 is passed; between points 3 and 4, the Cr concentration decreases to zero; (iii) there is no detectable Fe signal between points 1 and 2; at point 2, an Fe signal appears suddenly and rises from 150 to 200 counts/s at point 4.

If one considers that the substrate of the coated disk is steel with a high Cr content, but that the counter body is made of non-alloyed steel, an interpretation of these results is that a large number of solid–solid contacts were generated between the sample and counter body, which led to damage and finally to local removal of the coating from the substrate. The contact between the exposed steel substrate (uncoated sample) and the steel counter body sustains excessive material transfer from the counter body to the sample due to adhesive wear processes.

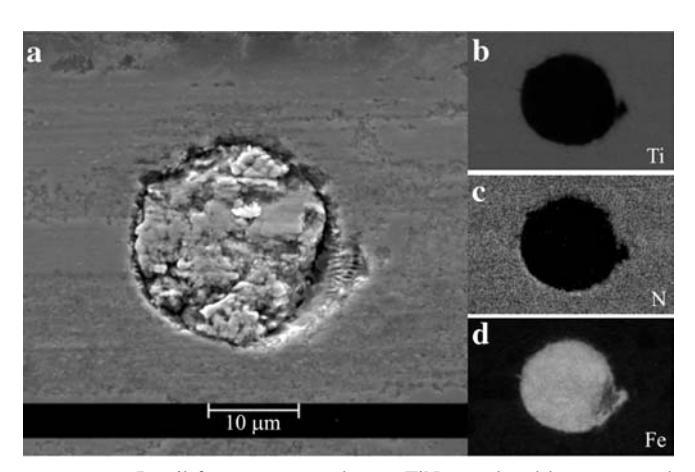
FIGURE 7 Detail from a wear track on a TiN-coated and laser-patterned surface: a SEM image of a filled pore and b-d EDX mappings for various elements

In the case of the laser-patterned surfaces, only slight wear features were noticeable. Noteworthy is the fact that a large part of the pores situated in the wear track were filled to

varying degrees with debris. An SEM image of an almost completely filled pore and its vicinity is shown in Fig. 7. The spatial distribution of the chemical elements Ti, N, and Fe (Ti, N: protective film, Fe: counter body) in the depicted zone was determined through EDX mapping, with a lateral resolution of $0.2 \,\mu\text{m}$. The number of counts indicating the presence of a certain element was converted into gray levels and distribution maps were constructed; they are also depicted in Fig. 7. From these images, one can see the uniform and continuous presence of Ti and N in the pore surroundings and the almost complete absence of Fe from this zone. On the other hand, inside the pore a quasi-total absence of Ti and N and a large Fe amount were detected. These results indicate an unbroken TiN film in the pore surroundings and a large accumulation of debris coming from the counter body in the laser-induced microcraters.
