Enamel loss and adhesive remnants following bracket removal and various clean-up procedures *in vitro*

Sacha Ryf*, Simon Flury**, Senthamaraiselvi Palaniappan***, Adrian Lussi**,
Bart van Meerbeek*** and Brigitte Zimmerli**,***

Departments of *Orthodontics and Dentofacial Orthopedics, **Preventive, Restorative and Pediatric Dentistry, School of Dental Medicine, University of Bern, Bern, Switzerland and ***Leuven BIOMAT Research Cluster, Department of Conservative Dentistry, School of Dentistry, Oral Pathology and Maxillo-Facial Surgery, Catholic University of Leuven, Leuven, Belgium

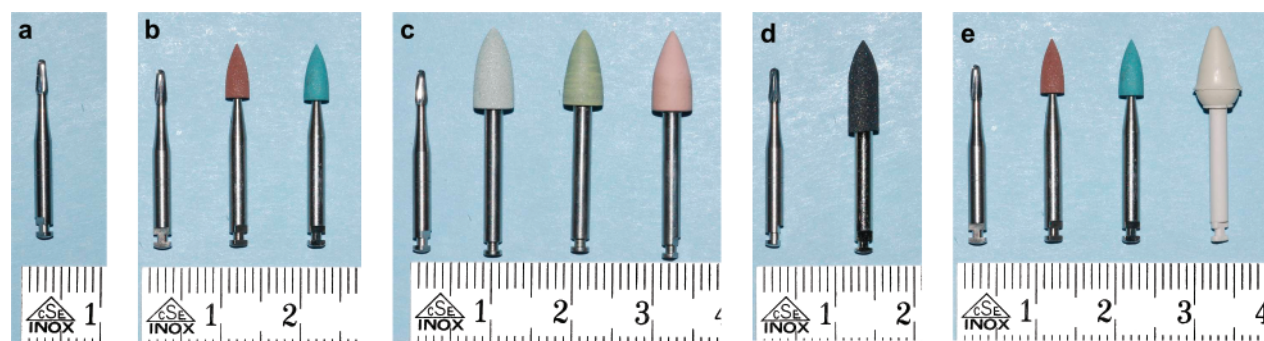
Figure 2 (a) Group 1 (carbide bur). (b) Group 2 (carbide bur, Shofu Brownie and Shofu Greenie). (c) Group 3 (carbide bur, Astropol polishing system: F, P, and HP). (d) Group 4 (carbide bur, Renew System). (e) Group 5 (carbide bur, Shofu Brownie, Shofu Greenie, and PoGo polisher).

The residual adhesive on each tooth in the five groups was removed using one of the five following protocols: group 1, carbide bur (Figure 2a); group 2, carbide bur followed by Brownies and Greenies (Figure 2b); group 3, carbide bur followed by Astropol F, P, and HP polishers (Figure 2c); group 4, carbide bur followed by the Renew System (Figure 2d); and group 5, carbide bur followed by Brownies and Greenies and finished with a PoGo polisher (Figure 2e).

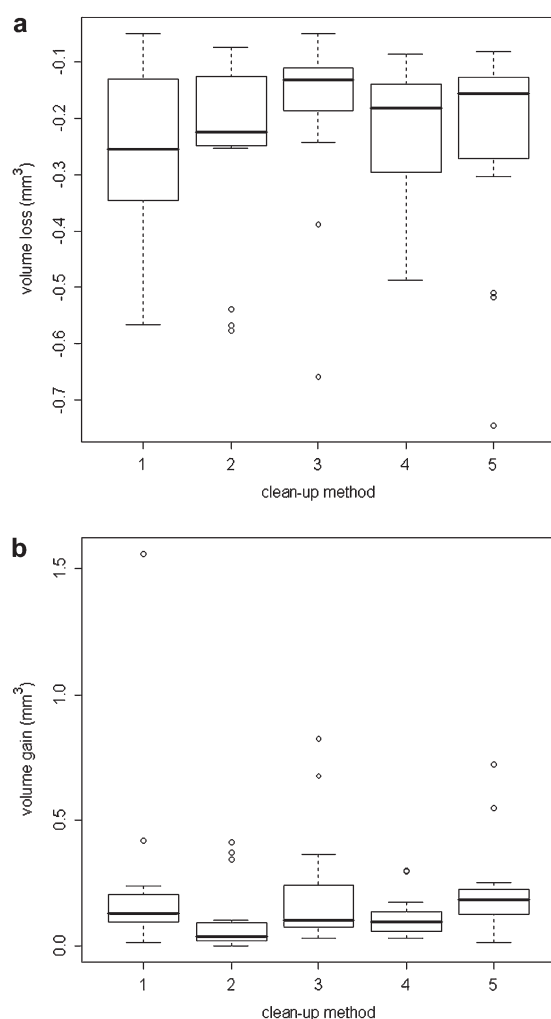
Figure 4 Loss of volume (a) and composite remnants (b) after clean-up with five different methods. Groups as listed in Table 2.
