G. DUMITRU^{1,✉}
V. ROMANO¹
Y. GERBIG²
H.P. WEBER¹
H. HAEFKE²

Femtosecond laser processing of nitride-based thin films to improve their tribological performance

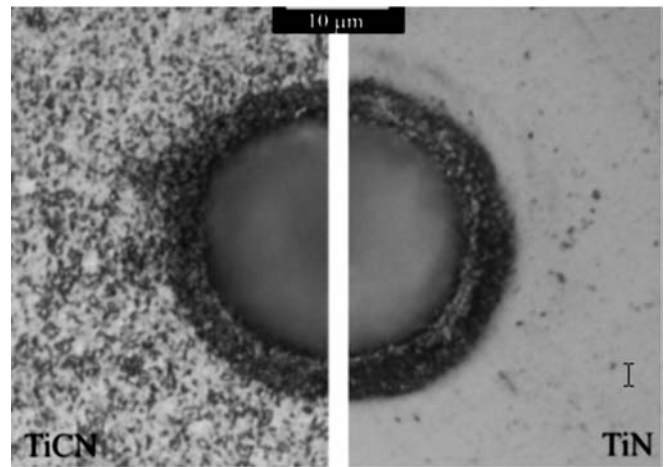
The optical microscopy investigations of the crater boundary zone, where damage due to laser treatment was apt to appear, did not reveal (Fig. 1) any film cracks, delamination, or other surface modifications. These analyses also showed that the remaining surfaces were not affected by the laser treatment; their roughness values did not change and they could be used as tribological surfaces directly after the fs-laser processing.

FIGURE 1 Images (optical microscopy) of pores induced in ceramic films (100 \times 2 J/cm²)

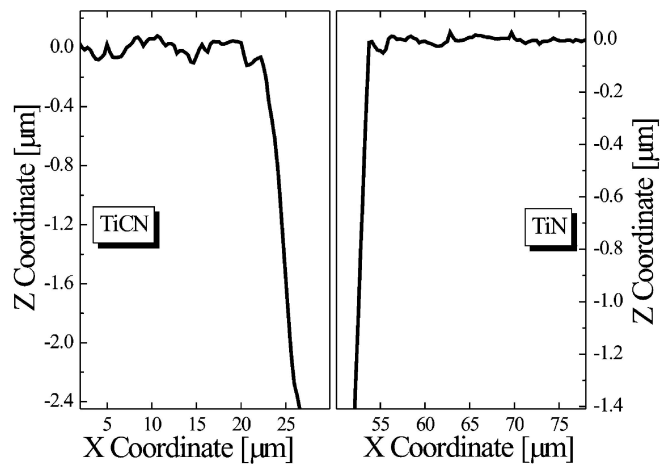
AFM analyses (Fig. 2) demonstrated a distinct transition between irradiated and non-irradiated film zones, without significant rims at the crater borders. Regarding the transition

FIGURE 2 AFM profiles along diameters of pores shown in Fig. 1

zone between the coating and substrate in the case of TiN, (1 μm thick) smooth pore walls, without any spikes or sharp rims, were noticed. In the case of TiCN, no such points were observed, but in this situation, the film thickness (3.5–4 μm) was outside the reliability zone for AFM-measured depths.

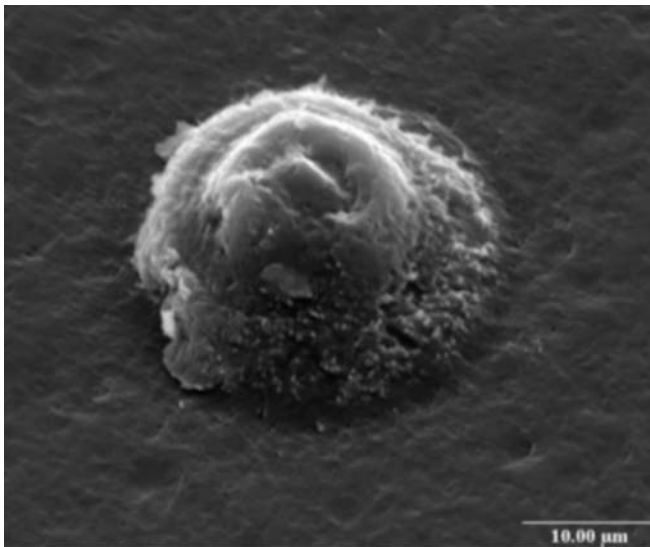
To investigate the actual 3D shape of the laser-induced pores, a replica technique [1] was used to achieve a “negative copy” from microcraters; an SEM image from a replica of a single pore is shown in Fig. 3. Similar shapes were also obtained for pores in the TiN film. Therefore, one can state that the slope change that is noticeable in Fig. 3 is related to laser irradiation factors.

FIGURE 3 Volume representation of a laser-induced pore (TiCN-coated hard metal, $100 \times 2 \text{ J/cm}^2$)

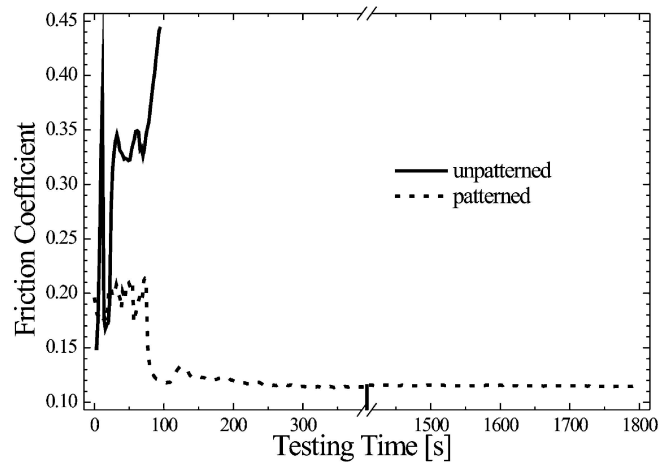
Typical friction curves for unpatterned and laser-patterned surfaces are depicted in Fig. 4. Significant differences in the friction evolution between the two types of surfaces can be seen. Due to insufficient lubrication of the tribocontact area, the unpatterned surfaces exhibited a continuously increasing friction coefficient that attained the

FIGURE 4 Friction curves for laser-patterned and unpatterned TiN-coated surfaces

friction-related stop criterion shortly after the start of the test (100–120 s). In the case of the patterned surfaces, the friction coefficient rose temporarily to values of $\mu \sim 0.2$ in the running-in phase of the tests, but decreased afterwards and remained stable at a level of $\mu \sim 0.11$ until the end of the test; this value is typical for boundary friction [21].

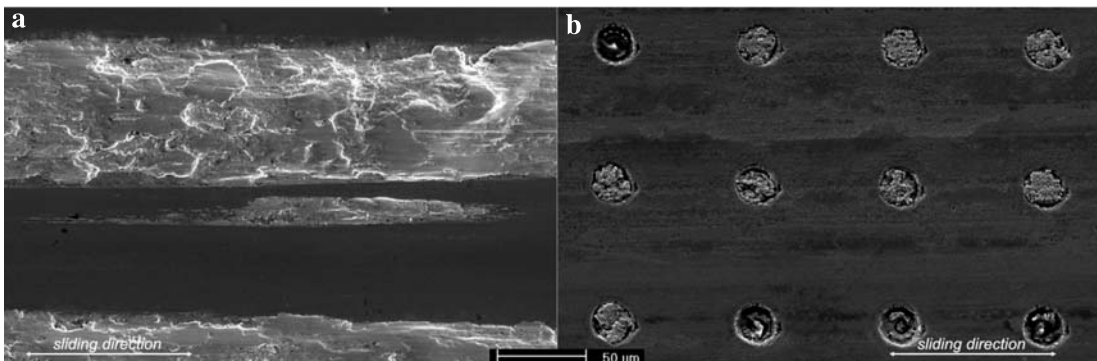
After tribological testing, SEM and energy dispersive X-ray (EDX) investigations were carried out to study the wear tracks generated on the tested surfaces. Representative close-ups of the worn surface regions on the unpatterned and laser-patterned samples are shown in Fig. 5.

FIGURE 5 SEM images of wear tracks on TiN-coated surfaces: **a** unpatterned and **b** patterned

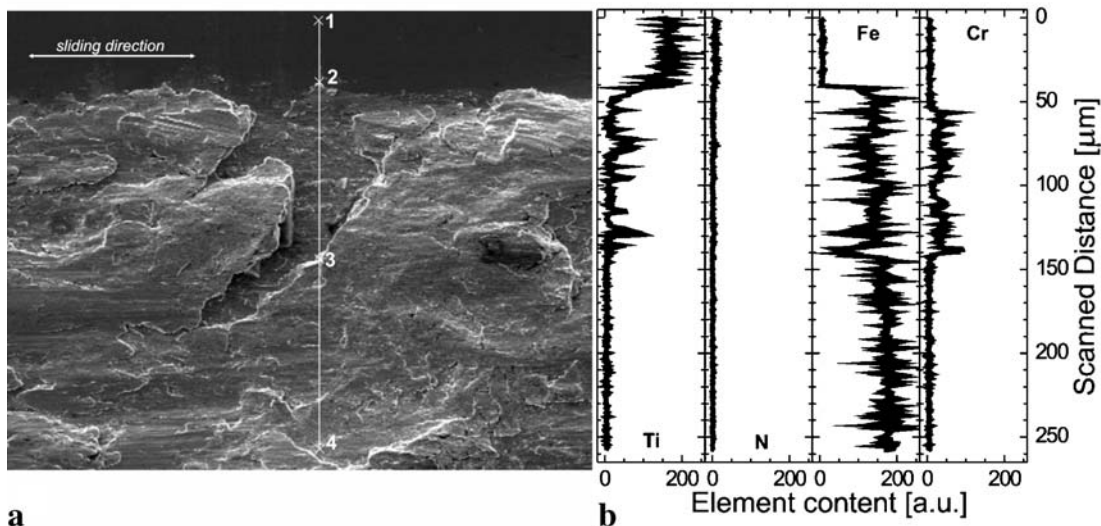
To determine the exact nature of the stripe-shaped wear features observed on the unpatterned TiN surface, EDX line scans were performed (Fig. 6). The presence of the chemical elements Fe, Cr, and Ti was proven along a line running from a less worn region to a damaged zone (Ti: protective film, Cr: substrate of coated sample, Fe: substrate of coated sample and counter body).

Along the EDX line scan from points 1 to 4 in Fig. 6, the following features are observed: (i) the Ti content remains constant (150 counts/s) between points 1 and 2; at point 2, the content drops suddenly down to 0 and remains at this value until point 4 is reached; (ii) the Cr concentra-

FIGURE 6 Detail from a wear track on a TiN-coated and unpatterned surface: **a** SEM image and **b** EDX analysis of elemental content along the white line marked in **a**

tion is 0 between points 1 and 2; at point 2, the concentration increases to about 40 counts/s and oscillates around this value until point 3 is passed; between points 3 and 4, the Cr concentration decreases to zero; (iii) there is no detectable Fe signal between points 1 and 2; at point 2, an Fe signal appears suddenly and rises from 150 to 200 counts/s at point 4.

If one considers that the substrate of the coated disk is steel with a high Cr content, but that the counter body is made of non-alloyed steel, an interpretation of these results is that a large number of solid–solid contacts were generated between the sample and counter body, which led to damage and finally to local removal of the coating from the substrate. The contact between the exposed steel substrate (uncoated sample) and the steel counter body sustains excessive material transfer from the counter body to the sample due to adhesive wear processes.

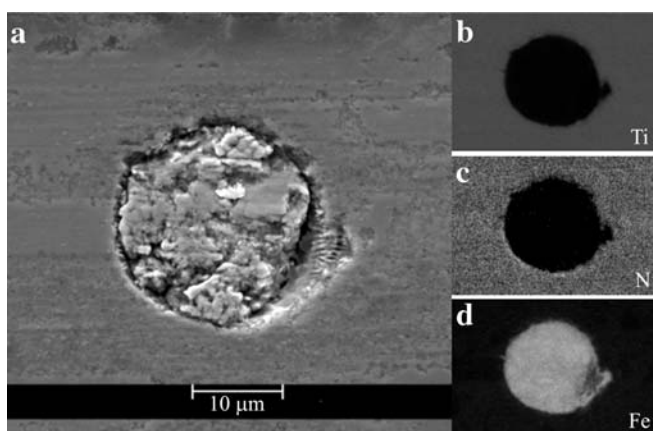
varying degrees with debris. An SEM image of an almost completely filled pore and its vicinity is shown in Fig. 7. The spatial distribution of the chemical elements Ti, N, and Fe (Ti, N: protective film, Fe: counter body) in the depicted zone was determined through EDX mapping, with a lateral resolution of $0.2 \mu\text{m}$. The number of counts indicating the presence of a certain element was converted into gray levels and distribution maps were constructed; they are also depicted in Fig. 7. From these images, one can see the uniform and continuous presence of Ti and N in the pore surroundings and the almost complete absence of Fe from this zone. On the other hand, inside the pore a quasi-total absence of Ti and N and a large Fe amount were detected. These results indicate an unbroken TiN film in the pore surroundings and a large accumulation of debris coming from the counter body in the laser-induced microcraters.

FIGURE 7 Detail from a wear track on a TiN-coated and laser-patterned surface: **a** SEM image of a filled pore and **b–d** EDX mappings for various elements
