Article

Comparison of Different Locking Mechanisms in Total Hip Arthroplasty: Relative Motion between Cup and Inlay

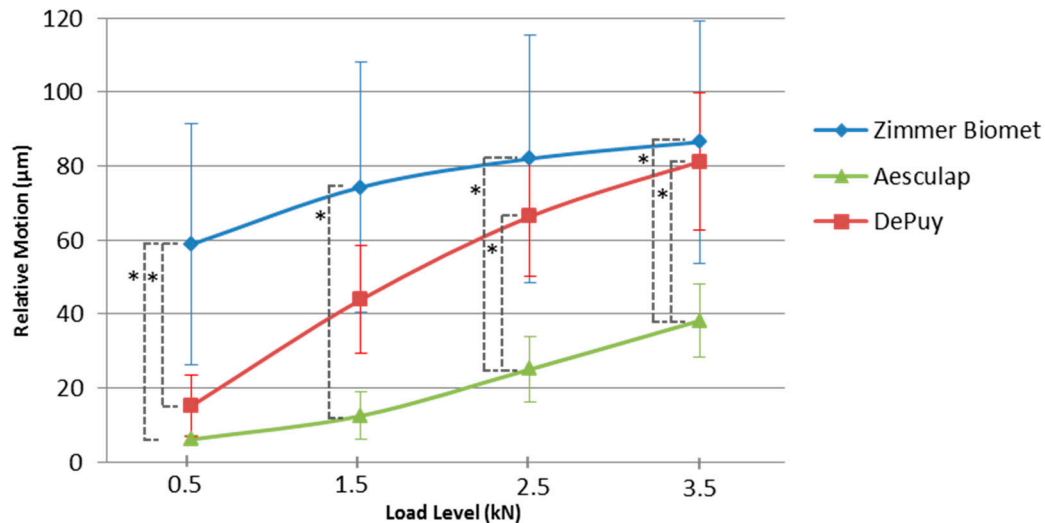
The mean resulting maximum relative motion in XYZ-direction for each load level and all investigated cup designs are shown in Table 1 and Figure 5.

**Figure 5.** Resulting maximum relative motion, * showed significant difference.

For the load level of 0.5 kN the Bonferroni-adjusted post-hoc analysis revealed a significant difference ($p = 0.001$) for mean resulting maximum relative motion of the Zimmer Biomet and the Aesculap group (52.67, 95%-CI [82.85, 22.49]) and also between the Zimmer Biomet and DePuy group ($p = 0.004$) (43.61, 95%-CI [13.43, 73.79]). There was no significant difference ($p = 1.0$) for the relative motion between the Aesculap and DePuy groups. The load level of 1.5 kN showed a significant difference ($p < 0.001$) for the relative motion between the Zimmer Biomet and the Aesculap group (61.75, 95%-CI [28.31, 95.18]). There was no significant difference between the Zimmer Biomet and DePuy groups ($p = 0.082$) or between the Aesculap and DePuy groups ($p = 0.070$). The load level of 2.5 kN showed a significant difference ($p = 0.001$) between the Zimmer Biomet and Aesculap groups (56.85, 95%-CI [22.52, 91.18]) and between the Aesculap and DePuy groups ($p = 0.017$) (41.23, 95%-CI [6.90, 75.56]). There was no statistically significant difference for the relative motion between the Zimmer Biomet and DePuy groups ($p = 0.718$). For the load level of 3.5 kN, the Bonferroni-adjusted post-hoc analysis revealed a significant difference ($p = 0.006$) for the mean resulting maximum relative motion between the Zimmer Biomet and Aesculap groups (48.28, 95%-CI [13.41, 83.14]) and between the Aesculap and DePuy groups ($p = 0.014$) (42.92, 95%-CI [8.06, 77.79]). There was no statistically significant difference for the relative motion between the Zimmer Biomet and DePuy groups ($p = 1.0$). The repeated measures ANOVA with a Greenhouse–Geisser correction determined that the load levels showed a significant influence on the relative motion, $F(1.264, 18.964) = 309.886$, $p < 0.001$.

Our data also showed considerable differences between cup and PE liner. Regardless of the implant design and loading situation, the range was between 6.2 ± 1.1 μm and 86.5 ± 32.7 μm . The Zimmer Biomet hip cup system with a circular snap-fit mechanism, in combination with two spikes in the inner polar region of the cup, showed relative motion between 58.8 ± 32.6 μm and 86.5 ± 32.7 μm (0.5 and 3.5 kN). The DePuy system with a central dome region and a taper lock mechanism plus grooves at the rim of the shell showed relative motion between 15.2 ± 8.3 μm and 81.1 ± 18.5 μm (0.5 and 3.5 kN). For the Aesculap system with a conical locking mechanism and a locking free contact with the base of the cup we found relative motion between 6.2 ± 1.1 μm and 38.2 ± 9.9 μm (0.5 and 3.5 kN).

For the initial load level of 0.5 kN, the DePuy and the Aesculap cups showed no significant differences ($p = 1.0$). The Zimmer Biomet cup showed significantly higher values compared to the Aesculap and DePuy cups ($p = 0.001$, $p = 0.004$). At the highest load level of 3.5 kN, the Zimmer Biomet group and DePuy system no longer showed any significant difference ($p = 1.0$). However, the Aesculap system still showed significantly lower values compared to the Zimmer Biomet and DePuy cups ($p = 0.006$, $p = 0.014$). The locking mechanism of the Aesculap system showed the lowest relative motion between cup and PE liner for the investigated load levels compared to the Zimmer Biomet and DePuy cup. A retrieval study conducted by Wasielewski et al. evaluated the backside of 55 polyethylene liners [22]. At this juncture, a distinction was made between micromotion caused by rotational instability of the insert in the shell and micromotion induced through elastic or plastic deformation. A total of 52 of the 55 inserts showed polyethylene wear on the backside in varying degrees. The most severe wear occurred in the posterior-superior and anterior-superior areas. In addition, five of six patients with acetabular osteolysis showed a high grade of backside wear, which was mainly attributed to elastic or plastic deformation related micromotion [22].
