Article

# Comparison of Different Locking Mechanisms in Total Hip Arthroplasty: Relative Motion between Cup and Inlay

Sebastian Jaeger <sup>1,\*</sup>, Maximilian Uhler <sup>1,\*</sup>, Stefan Schroeder <sup>1</sup>, Nicholas A. Beckmann <sup>2,3</sup> and Steffen Braun <sup>1</sup>

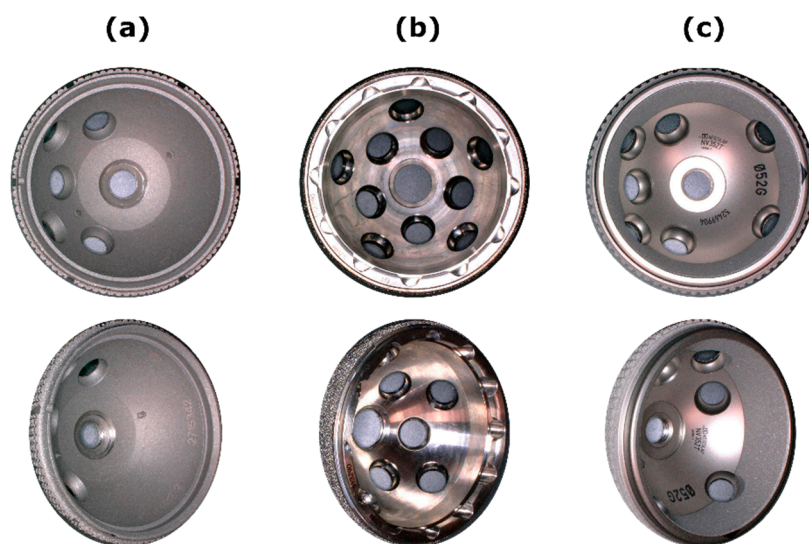
Three acetabular titanium hip cup designs, with different inner designs to fixate the PE liner, were investigated (Figure 1): (A) Allofit<sup>®</sup>-S Alloclassic<sup>®</sup> with a cross-linked Durasul<sup>®</sup>-PE liner (Zimmer Biomet, Warsaw, IN, USA), (B) Pinnacle<sup>®</sup>-Multihole combines with a cross-linked Marathon<sup>®</sup>-PE liner (DePuy Synthes, Warsaw, IN, USA), (C) Plasmafit<sup>®</sup> Plus7 with a conventional ultra-high-molecular-weight polyethylene (UHMWPE) liner (Aesculap, Tuttlingen, BW, Germany). All hip cup systems were non-cemented with an outer cup diameter of 52 mm and a corresponding 32 mm PE liner. In each group, six acetabular hip cups with corresponding PE liners were used.

**Figure 1.** Acetabular titanium hip cup components. (a) Zimmer Biomet, (b) DePuy Synthes, (c) Aesculap.

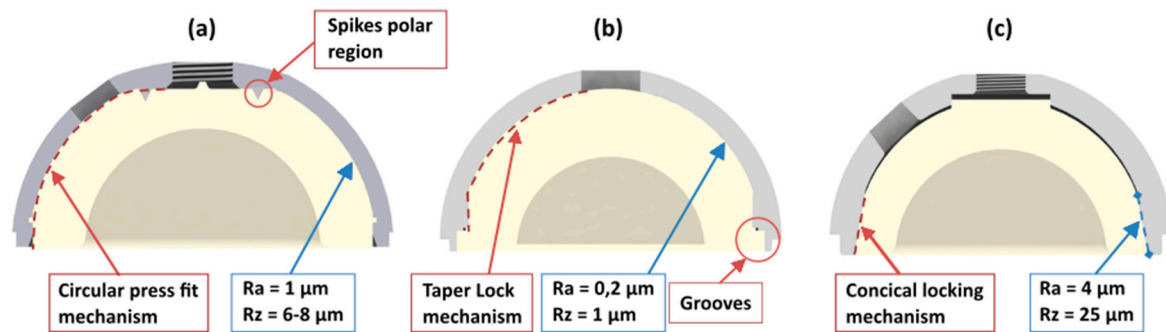
The PE liner of the hip cup system Allofit<sup>®</sup>-S Alloclassic<sup>®</sup> is fixed by a circular press fit mechanism. In addition, two spikes in the inner polar region of the cup on which the PE liner is inserted improve rotational stability. The inner anchoring surface of the cup is spherical, and has a smooth surface ( $R_a = 1 \mu\text{m}$ ;  $R_z = 6\text{--}8 \mu\text{m}$ ) [15].

The anchoring of the PE liner of the hip cup system Pinnacle<sup>®</sup>-Multihole is realised by a central dome region and a taper lock mechanism. Additionally, 12 grooves are placed at the rim of the shell. Corresponding to the grooves, six tabs on the liner were found to improve rotational stability. The inner anchoring surface of the cup showed values of  $R_a = 0.2 \mu\text{m}$  and  $R_z = 1 \mu\text{m}$ .

The PE liner of the hip cup system Plasmafit<sup>®</sup> Plus7 is fixed by a conical locking mechanism. The cup shows a rough inner surface ( $R_a = 4 \mu\text{m}$ ,  $R_z = 25 \mu\text{m}$ ) [9,15].

**Figure 2.** Locking mechanisms and surface specifications of the different cup systems. (a) Zimmer Biomet, (b) DePuy Synthes, (c) Aesculap.

An overview of the locking mechanisms and the surface specifications of the different cup systems are shown in Figure 2.

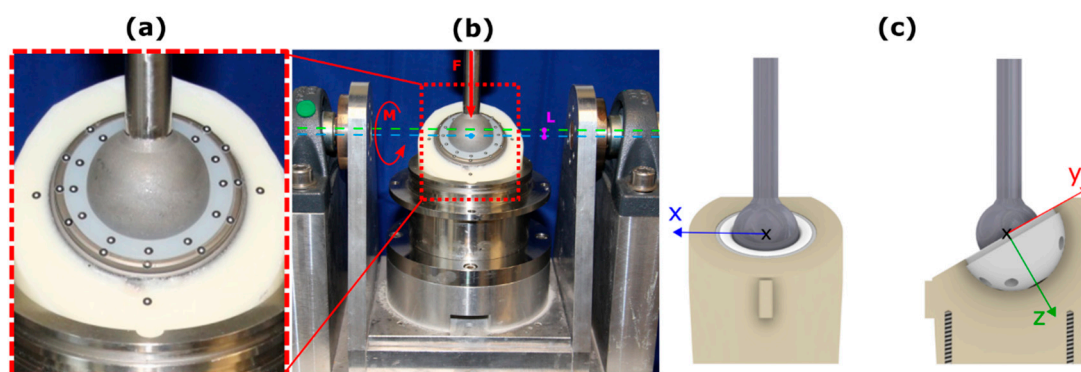
In order to carry out a standardized PE liner stability test, the cups were fixed according to Braun et al. in polyurethane (RenCast FC 53 A/B, Gößl & Pfaff GmbH, Karlskron, Germany) at an angle of 30 degrees to the vertical load axis [9]. A loading scenario was implemented using a uniaxial servo hydraulic testing machine (Bosch Rexroth, Lohr am Main, Germany). The components were loaded with an increasing dynamic load at a frequency of 1 Hz and a sinus shaped wave form. The initial load level started at 0.5 kN and increased incrementally with each load level by 1 kN, up to the maximum load of 3.5 kN. The cyclic load at each load level was maintained over 1000 cycles. The fixed acetabular cups were integrated into the testing machine and mounted on a rocker (Figure 3b). The rocker was placed on a free linear bearing to prevent transverse forces [9,15].

A rigid connection was generated between femoral head and PE liner. This, in combination with a 2 mm offset (Figure 3b L) between the centre of the implant and the rotational axis (Figure 3b green) of the rocker, initiated torque in the cup-system (Figure 3b) [9,15]. In combination with the axial compression a theoretically torque of 1, 3, 5 and 7 Nm were applied.

**Figure 3.** (a) Arrangement of the optical marker; (b) Relative motion measurement setup; (c) Camera coordinate system.

The determination of relative motion was performed by placing optical markers (uncoded passive white markers, diameter 0.8 mm, GOM Item Number: 21874; GOM GmbH, Braunschweig, Germany) along the rim of the hip cup and PE liner (Figure 3a). These markers were detected using a stereo camera system and a triangulation algorithm to calculate the 3D marker position ( $x$ -,  $y$ -, and  $z$ -axes). Based on the measured marker motion in the respective spatial direction ( $x$ ,  $y$  and  $z$  direction), the resulting vector was calculated using the equation  $XYZ = \sqrt{(X^2 + Y^2 + Z^2)}$ . In a next step, the cup and PE liner markers were separated and the resultant relative motion XYZ between both components was calculated. This calculation was carried out for every measurement time point. In a further step,

the maximum of the resulting relative motion (XYZ) was determined for each individual load cycle in order to calculate the mean value of the maximum resulting relative motion for each load level (0.5, 1.5, 2.5 and 3.5 kN) [16]. The coordinate system was defined as shown in Figure 3c. The relative motion between the components was measured at cycles 10, 100, 300, 500, 800 and 995 for each load level.

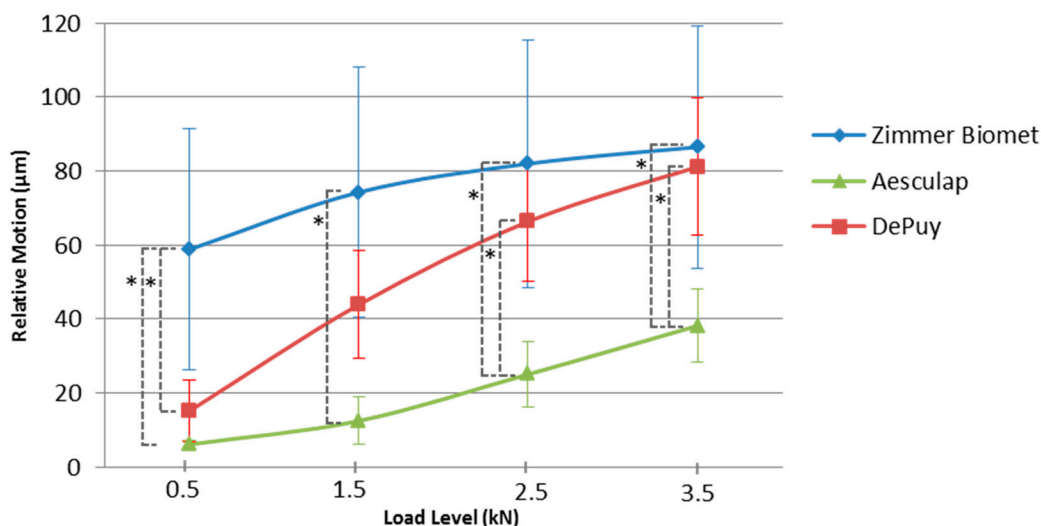
The mean resulting maximum relative motion in XYZ-direction for each load level and all investigated cup designs are shown in Table 1 and Figure 5.

Load Level (kN)	Zimmer Biomet	DePuy	Aesculap
0.5	58.8 $\pm$ 32.6	15.2 $\pm$ 8.3	6.2 $\pm$ 1.1
1.5	74.3 $\pm$ 33.7	43.9 $\pm$ 14.5	12.5 $\pm$ 6.4
2.5	82.8 $\pm$ 33.5	66.3 $\pm$ 16.1	25.1 $\pm$ 8.8
3.5	86.5 $\pm$ 32.7	81.1 $\pm$ 18.5	38.2 $\pm$ 9.9

**Figure 5.** Resulting maximum relative motion, \* showed significant difference.

For the load level of 0.5 kN the Bonferroni-adjusted post-hoc analysis revealed a significant difference ( $p = 0.001$ ) for mean resulting maximum relative motion of the Zimmer Biomet and the Aesculap group (52.67, 95%-CI [82.85, 22.49]) and also between the Zimmer Biomet and DePuy group ( $p = 0.004$ ) (43.61, 95%-CI [13.43, 73.79]). There was no significant difference ( $p = 1.0$ ) for the relative motion between the Aesculap and DePuy groups. The load level of 1.5 kN showed a significant difference ( $p < 0.001$ ) for the relative motion between the Zimmer Biomet and the Aesculap group (61.75, 95%-CI [28.31, 95.18]). There was no significant difference between the Zimmer Biomet and DePuy groups ( $p = 0.082$ ) or between the Aesculap and DePuy groups ( $p = 0.070$ ). The load level of 2.5 kN showed a significant difference ( $p = 0.001$ ) between the Zimmer Biomet and Aesculap groups (56.85, 95%-CI [22.52, 91.18]) and between the Aesculap and DePuy groups ( $p = 0.017$ ) (41.23, 95%-CI [6.90, 75.56]). There was no statistically significant difference for the relative motion between the Zimmer Biomet and DePuy groups ( $p = 0.718$ ). For the load level of 3.5 kN, the Bonferroni-adjusted post-hoc analysis revealed a significant difference ( $p = 0.006$ ) for the mean resulting maximum relative motion between the Zimmer Biomet and Aesculap groups (48.28, 95%-CI [13.41, 83.14]) and between the Aesculap and DePuy groups ( $p = 0.014$ ) (42.92, 95%-CI [8.06, 77.79]). There was no statistically significant difference for the relative motion between the Zimmer Biomet and DePuy groups ( $p = 1.0$ ). The repeated measures ANOVA with a Greenhouse–Geisser correction determined that the load levels showed a significant influence on the relative motion,  $F(1.264, 18.964) = 309.886, p < 0.001$ .

Our data also showed considerable differences between cup and PE liner. Regardless of the implant design and loading situation, the range was between  $6.2 \pm 1.1$   $\mu\text{m}$  and  $86.5 \pm 32.7$   $\mu\text{m}$ . The Zimmer Biomet hip cup system with a circular snap-fit mechanism, in combination with two spikes in the inner polar region of the cup, showed relative motion between  $58.8 \pm 32.6$   $\mu\text{m}$  and  $86.5 \pm 32.7$   $\mu\text{m}$  (0.5 and 3.5 kN). The DePuy system with a central dome region and a taper lock mechanism plus grooves at the rim of the shell showed relative motion between  $15.2 \pm 8.3$   $\mu\text{m}$  and  $81.1 \pm 18.5$   $\mu\text{m}$  (0.5 and 3.5 kN). For the Aesculap system with a conical locking mechanism and a locking free contact with the base of the cup we found relative motion between  $6.2 \pm 1.1$   $\mu\text{m}$  and  $38.2 \pm 9.9$   $\mu\text{m}$  (0.5 and 3.5 kN).

For the initial load level of 0.5 kN, the DePuy and the Aesculap cups showed no significant differences ( $p = 1.0$ ). The Zimmer Biomet cup showed significantly higher values compared to the Aesculap and DePuy cups ( $p = 0.001$ ,  $p = 0.004$ ). At the highest load level of 3.5 kN, the Zimmer Biomet group and DePuy system no longer showed any significant difference ( $p = 1.0$ ). However, the Aesculap system still showed significantly lower values compared to the Zimmer Biomet and DePuy cups ( $p = 0.006$ ,  $p = 0.014$ ). The locking mechanism of the Aesculap system showed the lowest relative motion between cup and PE liner for the investigated load levels compared to the Zimmer Biomet and DePuy cup. A retrieval study conducted by Wasielewski et al. evaluated the backside of 55 polyethylene liners [22]. At this juncture, a distinction was made between micromotion caused by rotational instability of the insert in the shell and micromotion induced through elastic or plastic deformation. A total of 52 of the 55 inserts showed polyethylene wear on the backside in varying degrees. The most severe wear occurred in the posterior-superior and anterior-superior areas. In addition, five of six patients with acetabular osteolysis showed a high grade of backside wear, which was mainly attributed to elastic or plastic deformation related micromotion [22].

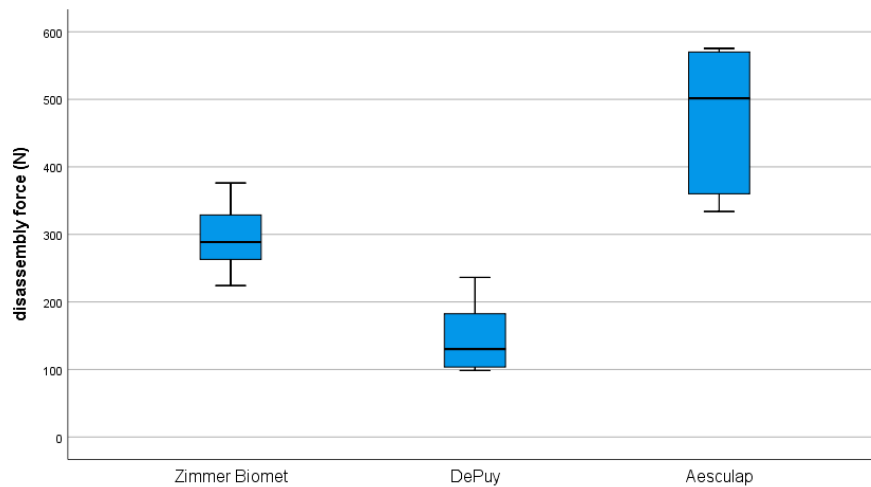
The mean maximum axial disassembling forces showed the highest values for the Aesculap group at  $473.7 \pm 94.6$  N, followed by the Zimmer Biomet group at  $294.8 \pm 48.2$  N and the DePuy group at  $146.8 \pm 49.8$  N (Figure 6). The mean maximum force differed statistically significantly for the investigated cup designs,  $F(2, 15) = 29.25, p < 0.001$ .

**Figure 6.** Resulting maximum axial disassembling forces.

The Bonferroni-adjusted post-hoc analysis revealed a significant difference for the mean maximum disassembling force between the Aesculap and Zimmer Biomet groups ( $p = 0.002$ ), (178.90, 95%-CI

[63.60, 294.20]) and between the Aesculap and DePuy groups ( $p < 0.001$ ), (326.90, 95%-CI [211.60, 442.20]). There was also a significant difference between the Zimmer Biomet and DePuy groups ( $p = 0.011$ ), (148.00, 95%-CI [32.70, 263.30]).

Another aspect besides the relative motion between cup and PE liner was the maximum disassembly force with regard to the risk of dislocation. Therefore, the maximum disassembly force was determined according to ASTM F1820-13 standard [17]. The maximum disassembling force showed the highest values for the Aesculap group with  $473.7 \pm 94.6$  N, followed by the Zimmer Biomet with  $294.8 \pm 48.2$  N and DePuy with  $146.8 \pm 49.8$  N. In comparison, the Aesculap group showed significantly higher forces compared to the Zimmer Biomet and DePuy groups ( $p = 0.002$ ,  $p = 0.001$ ). There was also a significant difference between the Zimmer Biomet and DePuy groups ( $p = 0.011$ ). In a comparative study of eight different cup systems, Tradonsky et al. determined a disassembly force between 129 N and 2950 N [23]. Our data are in the lower third compared to Tradosky et al. However, acetabular liner dissociation is a rare complication following [24].
