Case Report

Accessory carpal bone fracture repair by means of computer-assisted orthopaedic surgery in a Warmblood stallion**M. de Preux[†], E. van der Vekens[‡], J. Racine[†], D. Sangiorgio[§], M. D. Klopfenstein Bregger[†], H. P. Brünisholz[†] and C. Koch^{†,*}**

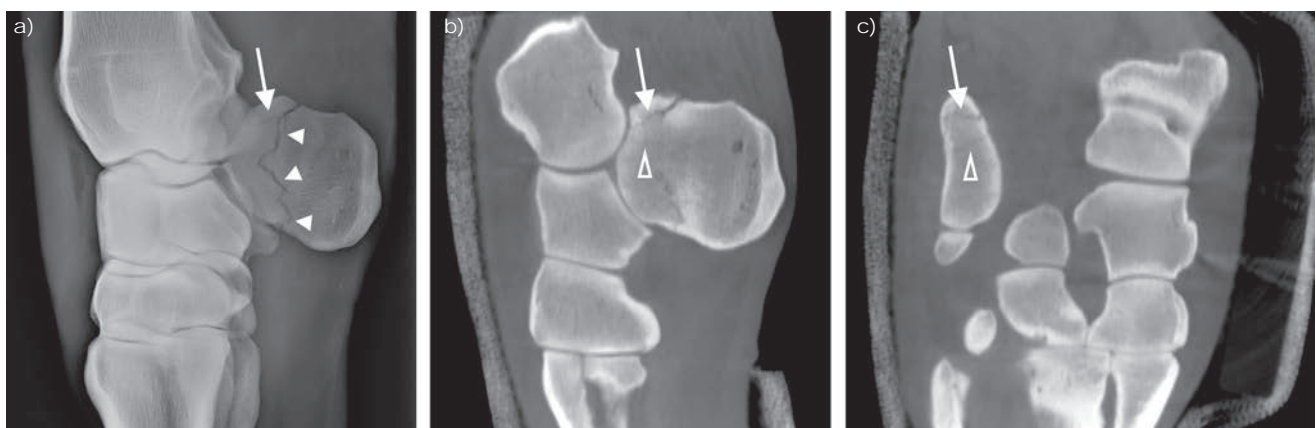
Fig 1: Lateromedial radiograph (a) of the right carpus showing a zigzag shaped, complete and mildly comminuted fracture (arrowheads) in the dorsal third of the accessory carpal bone (ACB), with minimal palmar displacement. An additional thin radiolucent line (arrow), originating from the main fracture, is present in the proximal fourth of the dorsal fragment, suspected to represent an incomplete fracture. (b) Sagittal and dorsal reconstructed images from an immediate preoperative CBCT under general anaesthesia show this last described fracture line in A (arrow) is complete and intra-articular. In addition, a second, intra-articular fracture line (open arrowhead), with a transverse orientation is present in the proximal half of the dorsal fragment.

The region palmar to the right carpus was warm and slightly swollen, but the carpal sheath was not distended. The horse clearly resented flexion of the right carpus. Radiographs of the carpus (lateromedial, dorsopalmar, dorsal 45° lateral-palmaromedial oblique and dorsal 45° medial-palmarolateral oblique projections) were performed. On the lateromedial projection, a complete, minimally displaced dorsal plane fracture in a zigzag pattern was present, with the dorsal fragment measuring approximately 30% of the ACB's dorsopalmar distance (**Fig 1a**). An additional incomplete fracture line was observed in the proximal aspect of the dorsal fragment.

The CBCT images confirmed the presence of a nondisplaced dorsal plane fracture of the ACB. Moderate comminution with a larger, i.e. $16 \times 10 \times 7$ mm fragment was present at the dorsoproximal aspect of the ACB, involving the articulation with the distal radius (Fig 1b). An additional thin fracture line with a transverse orientation was observed in the dorsal fragment, just distal to the previously described dorsoproximal fragment (Fig 1b and c). Given the lack of displacement and the interdigitation of the fragments, the surgeons hoped to stabilise these fragments *in situ* with the planned lag screw repair. With the aid of the navigated pointer (sharp pointer, Medtronic Navigation), the appropriate positions for the skin incisions were determined. For each cortex screw, a 1.5 cm longitudinal incision was made through the skin reaching the palmar surface of the ACB, followed by drilling a 2.5 mm pilot hole. Drill orientation and penetration depth were closely monitored on the screen of the StealthStation navigation (Fig 3). After ensuring the correct placement and orientation of the pilot holes by acquisition of an intraoperative CBCT scan, they were enlarged for the placement of a 4.5 mm cortex screw (48 mm in length) proximally and a 3.5 mm cortex screw (50 mm in length) distally. The proximal pilot hole was over-drilled with a navigated 4.5 mm drill bit to create the glide hole and then a navigated 3.2 mm drill bit to create the thread hole of

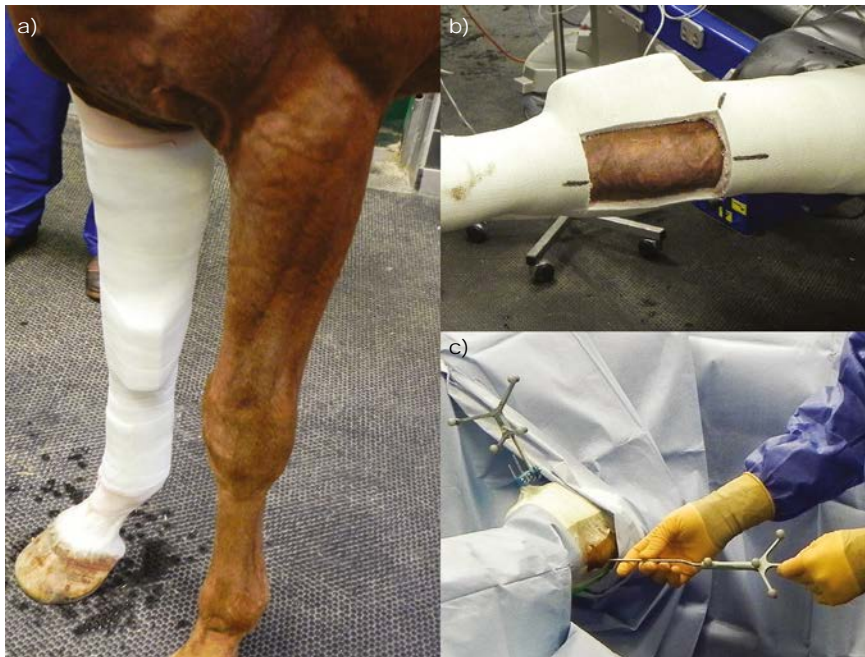
Fig 2: Photographs of the preoperatively placed fibreglass cast utilised to facilitate the computer-assisted surgical repair of the accessory carpal bone (ACB) fracture. (a) The cast was placed prior to induction and with the horse standing to ensure immobilisation of the carpus in a fully extended position. Note: a piece of hardwood has been incorporated to allow the placement of the patient tracker. (b) Fenestration of the cast over the palmar aspect of the carpus to allow for surgical access to the ACB. (c) Intraoperative photograph showing the patient tracker anchored to the cast with two 3.2 mm pins. The operating surgeon utilises the navigated pointer to determine the appropriate site for placing the skin incisions. The patient tracker and the pointer are both equipped with light-reflecting spheres, which are detected by an infrared optical digitiser and camera array (not shown).

As soon as the horse reached an appropriate level of sedation, a fibreglass cast extending from the distal metacarpus to the proximal radius and incorporating a 10 × 3 × 2 cm piece of hardwood on the medial aspect of the carpus was applied (**Fig 2a**). Once the fibreglass cast material had fully cured, general anaesthesia was induced with a combination of ketamine (2.5 mg/kg IV, Ketazol-100, Dr E Graeb AG) and diazepam (0.05 mg/kg IV, Valium, Roche Pharma AG) and was maintained with isoflurane. The anaesthetised horse was placed in the right lateral recumbency. A window overlying the ACB of approximately 10 cm² in area was created in the cast using an oscillating cast saw (**Fig 2b**). Two self-tapping, threaded, 3.2 mm pins were placed in the piece of hardwood incorporated in the cast and served to tightly anchor the patient tracker (Medtronic Navigation) equipped with infrared reflective spheres to the medial aspect of the cast (**Fig 2c**). This was followed by aseptic preparation of the surgical field and draping.

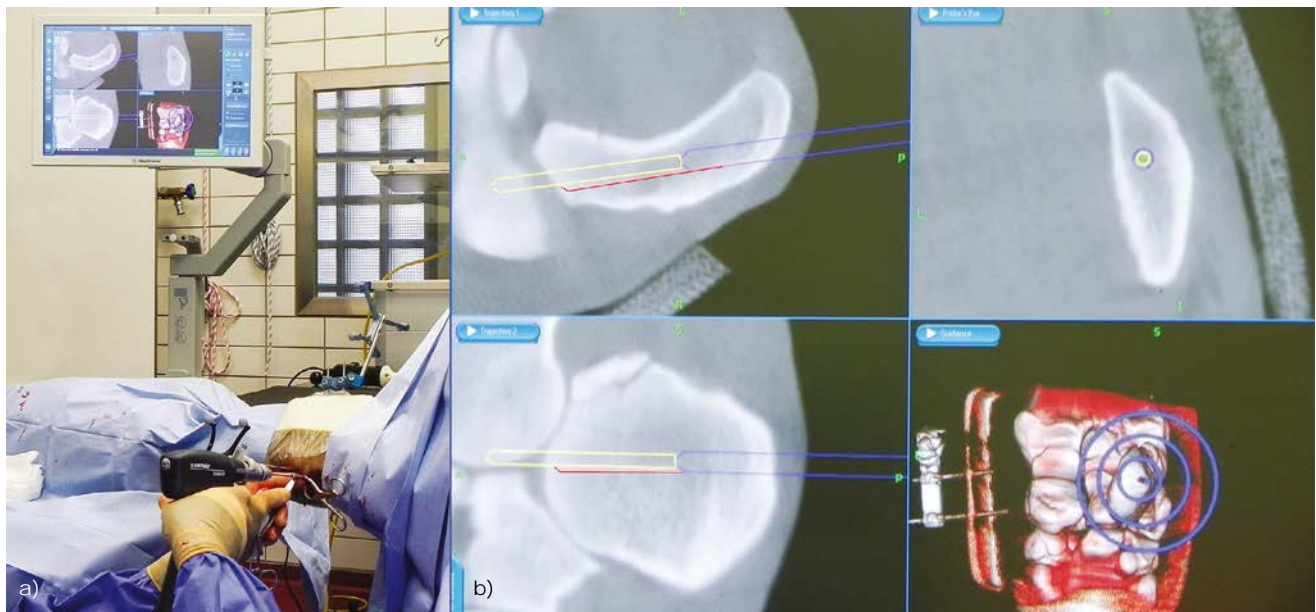
Fig 3: Computer-assisted, navigated drilling for the repair of an accessory carpal bone (ACB) fracture. (a) Intraoperative photograph depicting the drilling procedure. The drill orientation and penetration depth are monitored on the screen of the navigation system. (b) Close-up view of the screen. The ACB is projected in three planes (top left, transverse; bottom left, sagittal; top right, dorsal). The red cylinder, partially obscured by the virtual drill bit (blue cylinder), represents the planned screw position. The drill bit has penetrated the near cortex but has not yet passed the fracture line. The projection of the drill bit (yellow cylinder) and a target-grid (bottom right) are utilised for navigation.

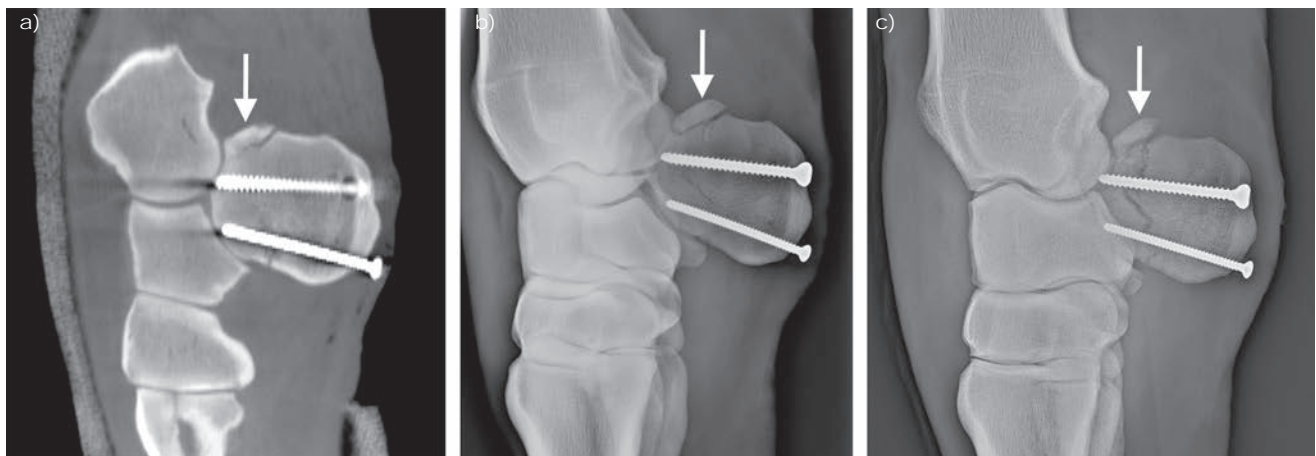
Fig 4: Sagittal reconstructed CBCT image and lateromedial radiographs of the carpus made at the end of the surgery (a) and 4 days (b) and 39 days (c) postoperatively, respectively. Note the gradual increase in proximal displacement of the dorsoproximal fragment (arrow). The widening of the main fracture gap in image C represents a normal stage of fracture healing. No signs of implant failure were observed. Note the streak artefacts in the distal radius and intermedial carpal bone due to the presence of metallic implants in the accessory carpal bone.

Immediately following recovery from general anaesthesia, the cast was removed, and the limb was placed in a full-limb bandage with a fitted dorsal splint made out of fibreglass cast material and reaching up to the proximal antebrachium. Radiographs were acquired to assess the progression of fracture healing (**Fig 4a**). The limb remained immobilised in the splinted bandage for a total of 3 weeks, followed by another 3 weeks in a full-limb bandage without the splint. Skin sutures were removed 10 days after surgery, and the horse was discharged from the hospital 2 weeks after surgery. The

The horse was re-examined 6 weeks postoperatively. Surgical incisions had healed without complications, and the horse was sound at walk. Control radiographs were made and revealed no signs of implant failure (**Fig 4b**). The fracture gap was mildly widened when compared with the immediate postoperative phase, with evidence of fracture gap remodelling which was deemed to be normal. However, there was increased proximal displacement of the separate dorsoproximal ACB fragment compared with that of the previous examination. Therefore, it was decided to remove this fragment in order to reduce the risk of developing antebrachiocarpal osteoarthritis and/or excessive callus formation at that site.

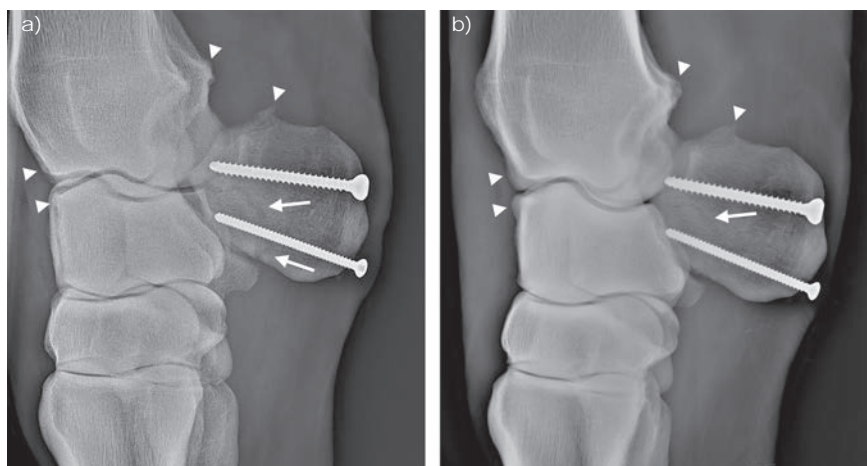
Fig 5: Lateromedial projections of the right carpus made 6 months (a) and 1 year (b) after the surgery, respectively, showing progressive fracture healing (arrows). The main fracture line is only slightly visible on the last control radiograph. Mild osteophyte formation (arrowheads) are present at the dorsal and palmar aspects of the antebrachio-carpal joint, but show smooth and rounded contours and minimal progression 1 year postoperatively.

Six months after osteosynthesis, the horse was performing light exercise under saddle with short sessions of trot and canter without lameness. Control radiographs showed partial bony union of the fracture (**Fig 5a**). Moderate signs of bone remodelling were present in the articular region of the distolateral aspect of the radius and at the proximal border of the ACB, adjacent to the previous ACB fracture (**Fig 5a**). Minimal osteophyte formation was observed at the

dorsal aspect of the antebrachiocarpal joint. The horse was re-examined one year after osteosynthesis. At that time, the horse had returned to full athletic activity and regularly started in dressage competitions on a regional level. The decision to compete the horse in dressage rather than showjumping was made for reasons unrelated to the injury, as the owner had changed her focus to that discipline. Nonetheless, she was still regularly jumping the horse for pleasure and training purposes, and without notable differences to its performance prior to the accident. During this period, the horse had not shown any lameness and neither the antebrachiocarpal joint nor the carpal sheath were distended. This was confirmed by the veterinary follow-up examination performed at the ISME Equine Clinic Bern where the horse was found to be sound on a straight line and circle on hard and soft ground at walk, trot and canter. Passive flexion test of the right carpus was negative. Repeat radiographic examination and a standing CBCT revealed neither signs of implant failure nor loosening. Remodelling noticed during the last examination remained minimal, with neither signs of excessive callus formation nor progression of osteoarthritis present (**Fig 5b**).
