# Risk-conscious Reconstruction in Pakistan-administered Kashmir

## A Case Study of the Chakhama Valley

Markus N. Zimmermann<sup>1\*</sup> and Shireen S. Issa<sup>2</sup>

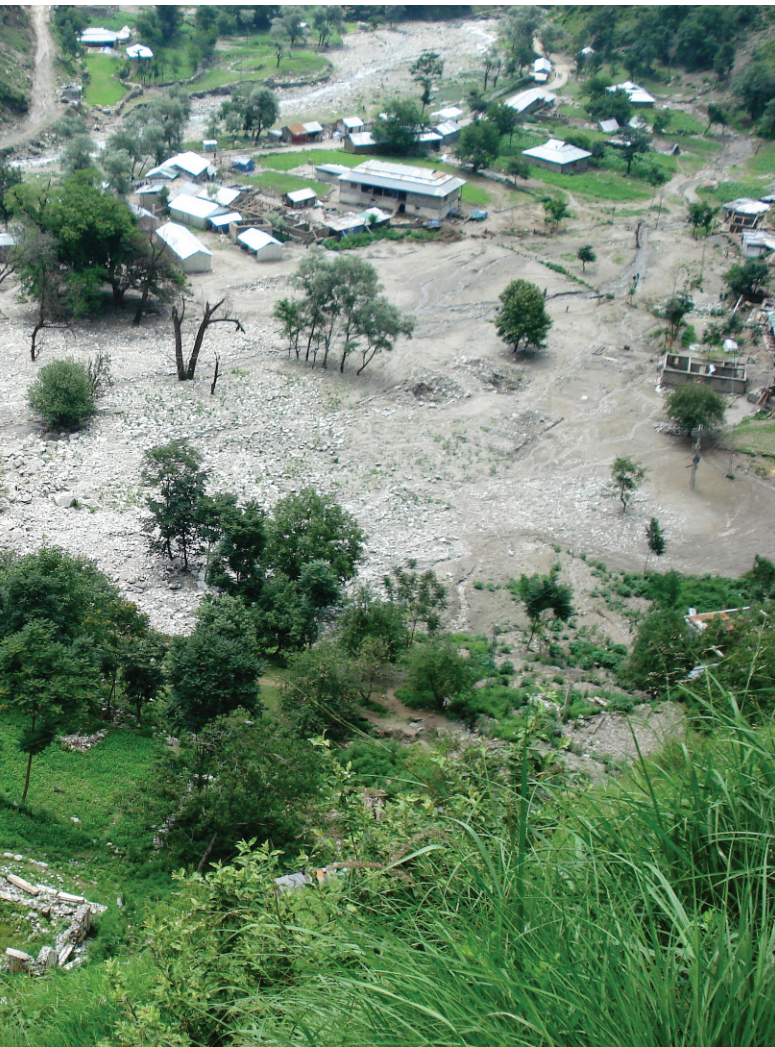
**FIGURE 2** Debris flow in March 2007 caused further damage to shelters built after the earthquake at Nardajian (upper valley). (Photo by Markus Zimmermann, 15 July 2007)

- The probability of landslides, rockfall, and flooding increased (Figure 2).

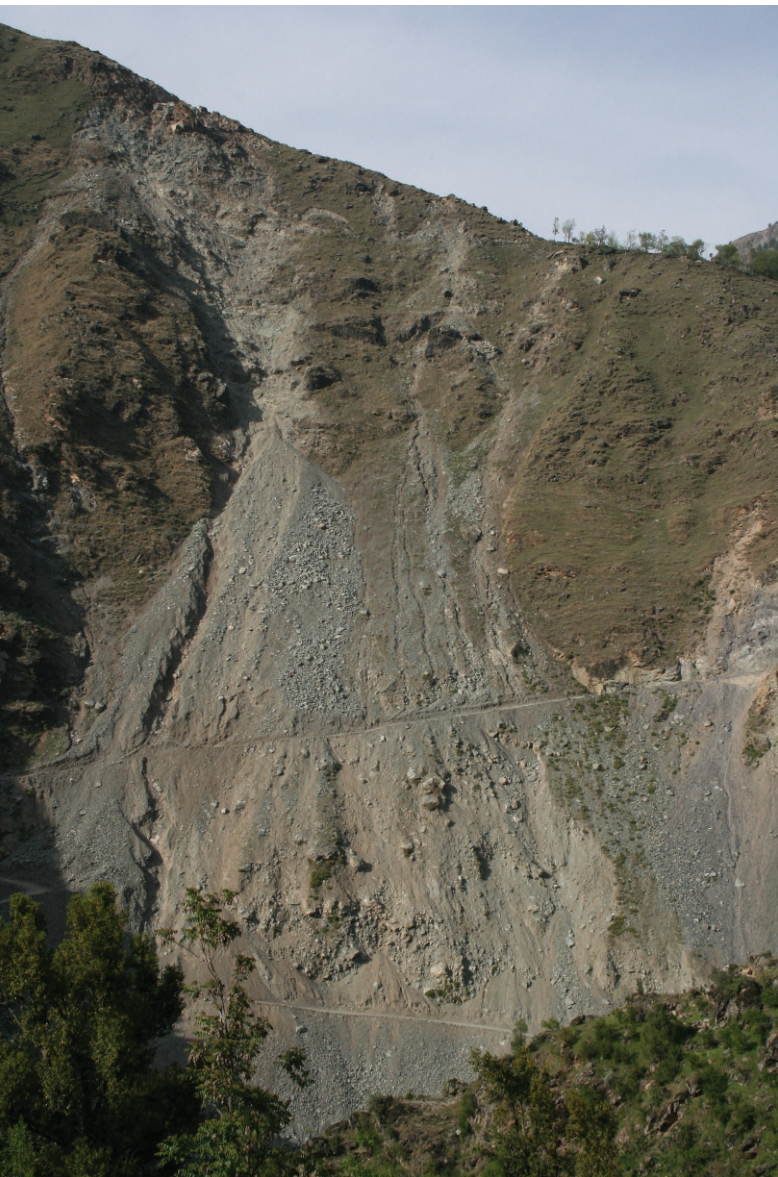
**FIGURE 3** Landslide affecting the road to the upper Chakhama Valley. (Photo by AKDN, 4 April 2007)

The footzone of the Himalayas in Pakistan-administered Kashmir possesses a medium to high degree of landslide hazard, according to the World Bank’s hot spot study (World Bank 2006). In Chakhama, rock formations in the vicinity of the fault lines are highly deformed, fractured, and sheared. The intense shaking of the recent earthquake caused new openings of pre-existing fractures and cracks. Infiltration and percolation of rainwater and snowmelt within the system of fractures increased substantially after the earthquake (GeoConsult 2007). Due to more frequent saturation of the soil and rock formations, their strength has declined significantly, resulting in numerous slope movements such as bank collapse, landslides, rockfalls, and large-scale debris flows (Figure 3).

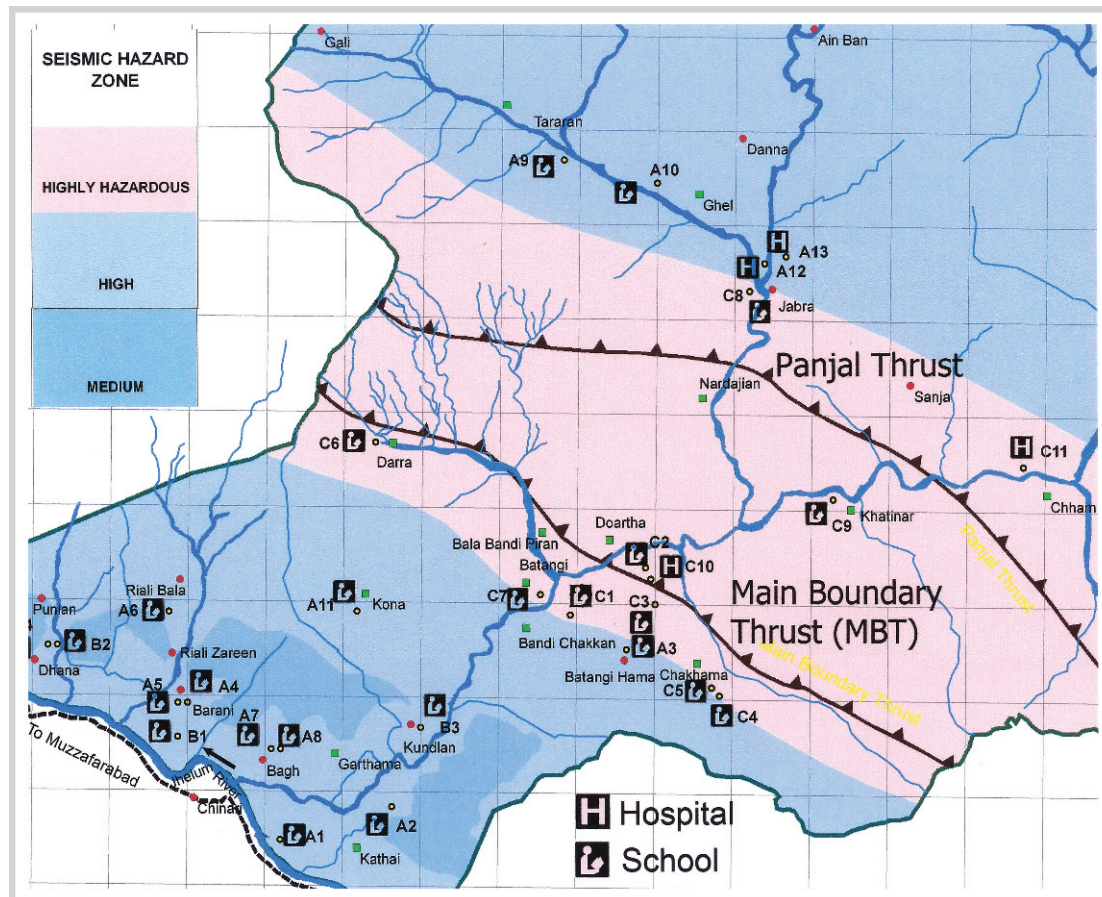
**FIGURE 4** Earthquake microzonation map for Chakhama with main fault lines and essential infrastructure (schools, basic health units). Maps at a scale of 1:10,000 and 1:25,000 are also available for effective planning. (Source: NESPAK 2007, original scale 1:50,000)

Microzonation of the program area was commissioned to enable estimation of the total seismic hazard from ground shaking and related phenomena by taking into account local site conditions (geological, geomorphological, geotechnical, and seismological aspects). The study produced, inter alia, a microzonation map that classified the Chakhama Valley into three seismic hazard zones: medium, high, and highly hazardous (NESPAC 2007; Figure 4). The study also provided general guidelines for new and existing construction for each of these hazard zone categories.

Bandi Chakan is located about 1 km southwest of one of the main fault lines (MBT; see Figure 4). Part of the village is categorized as being in a highly hazardous seismic zone, with the remaining area lying in the high seismic zone category. Earth shaking has resulted in significant slope instability in the areas above the village.

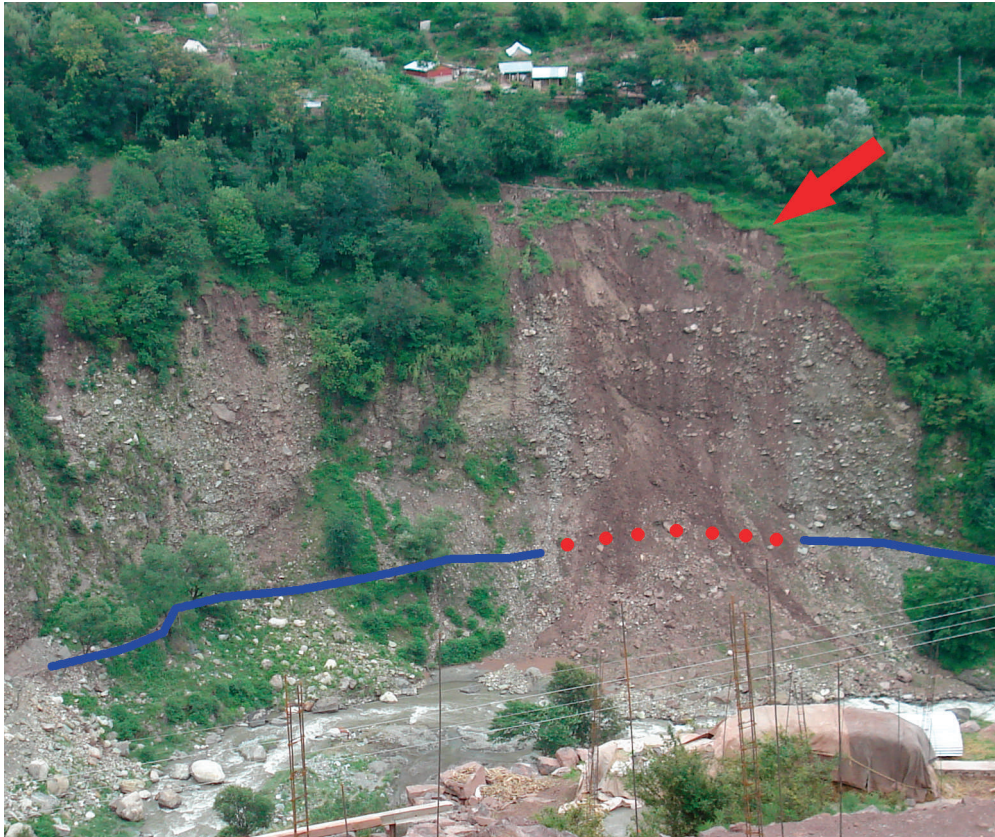
**FIGURE 6** Kathai irrigation canal (blue line); most critical section for rehabilitation (red dots) with highly unstable slope above (arrow). (Photo by Markus Zimmermann, 3 July 2007)

Postearthquake reconstruction of the Kathai canal was completed in late 2006. The canal, which is 6 km long, 1 m wide, and 0.6 m deep, stretches from beyond Bandi Chakan village to the base of the valley beyond Kathai village. The canal is expected to provide about 0.2 m<sup>3</sup>/s of water and irrigate between 200 and 300 hectares of land for about 250 households in 2 villages. Reconstruction work involved canal widening and proper lining for seepage control.

The slopes along the canal are of an alluvial nature, comprising gravel, cobbles, and boulders with sand and silt. The slopes are generally stable in dry conditions but begin to move when saturated, particularly in the upper portions. Landslides, slope failures, and falling debris after heavy rains in early 2007 caused significant damage to the canal (Figure 6).

At critical points where landslides were a particular threat (Figure 6), the canal was protected with concrete slabs so that debris could flow over the covered/slabbled section of the canal. Retaining walls were constructed where required. In the most critical section, the freshly accumulated debris in the canal was carefully stabilized for rehabilitation.
